The High Temperature Damage of DV – 2 Turbine Blade Made from Ni – Base Superalloy

Abstract—High pressure turbine (HPT) blades of DV – 2 jet engines are made from Ni – based superalloy. This alloy was originally manufactured in the Soviet Union and referred as ŽS6K. For improving alloy's high temperature resistance are blades coated with Al – Si diffusion layer. A regular operation temperature of HPT blades vary from 705°C to 750°C depending on jet engine regime. An overcrossing working temperature range causes degradation of the protective coating as well as base material which microstructure is formed by the gamma matrix and strengthening phase gamma prime (forming small particles in the microstructure). Diffusion processes inside the material during exposition of the material to high temperatures causes mainly coarsening of the gamma prime particles, thus decreasing its strengthening effect. Degradation of the Al – Si coating caused its thickness growth. All the microstructure changes and coating layer thickness growth results in decreasing of the turbine blade operation lifetime.

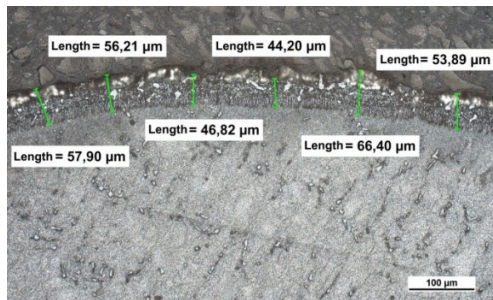
Fig. 4 Al – Si protective layer thickness measurement, non-etched specimen: (a) leading edge with average coating thickness of 50 μm , (b) turbine blade back with average coating thickness of 36 μm , (c) flow edge with average coating thickness of 45 μm

The Al – Si layer on the surface of blade is significantly coarsened and lost its homogeneity due to high temperature degradation and abrasive wearing. Degradation as itself shows in layer thickness increasing. Al – Si layer thickness h depending from spraying thickness at its application and can be easily determined from dependence $h = 0.7\delta$, where δ is for spraying thickness. Then for starting stage Al – Si layer thickness is around $h = 24.5 \mu\text{m}$ (an optimum spraying thickness for annealing at 950°C is up-to $\delta = 35 \mu\text{m}$). The thickness of Al – Si layer is higher in all observed areas what indicates higher temperature of loading than reported 751°C. The highest degree of degradation was observed at three areas from all four observed, namely leading edge with average thickness 50 μm , Fig. 4 (a); turbine blade back with average thickness 36 μm , Fig. 4 (b); and flow edge (in some parts of flow edge was not Al – Si layer identified at all, a huge degradation due to abrasive wearing at high temperatures) with average thickness of 45 μm , Fig. 4 (c).

- Protective Al – Si layer is significantly degraded all around the surface, its thickness on leading edge is average $50 \mu\text{m}$, and on the back is $36 \mu\text{m}$ and flow edge with average thickness $45 \mu\text{m}$, so Al – Si layer is inconvenient. A needle like Cr rich carbides and blocky form of primary Ti rich carbides are forming. In this area is a high expectation of crack initiation at further working cycle of blades.
- Base material, Ni – base superalloy ŽS6K, also shows significant level of degradation, especially on strengthening intermetallic precipitate γ' , which has formed *rafts* and changes its morphology, from cubic to spheroidal shape. The morphology changing of γ' has influence on creep rupture life of blades due to decreasing of precipitation hardening effect and increasing of γ/γ' mismatch.

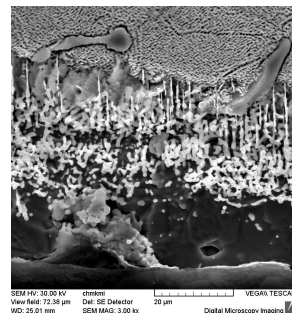
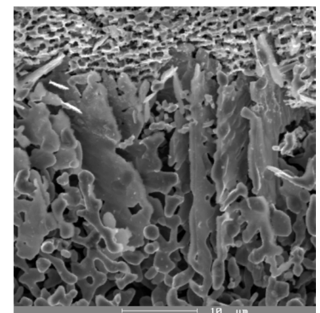
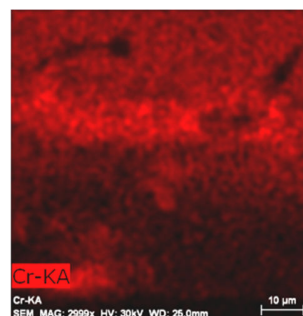
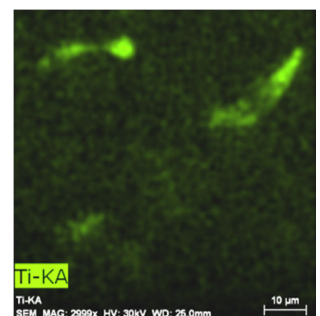
The next problem with Al – Si layer degradation is forming a needle like Cr rich carbides and blocky form of primary Ti rich carbides in layer – base material zone. Fig. 5 reports such carbide formation confirmed also by chemical SEM mapping.

Fig. 5 Chemical analyses of layer – base material zone with Cr and Ti rich carbide formation: (a) overall view, (b) detail of Cr rich carbides, (c)-(d) SEM mapping, etch. MARBLE, SEM microprobe Bruker

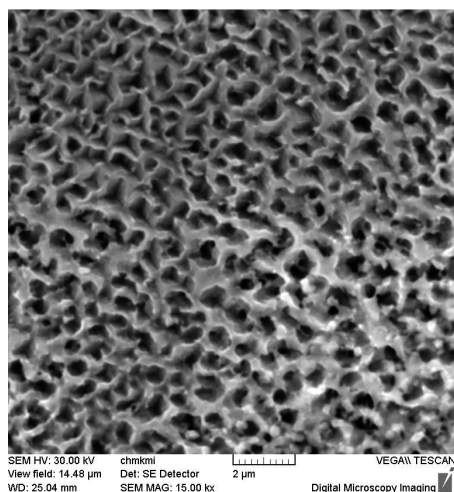
secondary $M_{23}C_6$ carbides formed and lowering creep resistance of base material. The strengthening intermetallic γ' precipitate also degrades by changing its morphology from previous cubic shape like onto coarse spheroidal particles with average size $0.6 \mu\text{m}$, Fig. 6.

Fig. 6 Degradation of γ' precipitate at high temperature ($751^\circ\text{C}/2\text{s}$) loading compared to starting stage microstructure: (a) γ' - phase morphology, initial stage, (b) after $751^\circ\text{C}/2\text{s}$ for 600 hours of loading, etch. Marble, SEM

This shape and size changes cause decreasing creep rupture life of alloy, Fig. 7 [8]. As a matter of a fact, creep at high temperatures is driven mainly by diffusion mechanism and deformation rate increases with higher amount of dislocations and their easier slip, which have been previously blocked by tight distribution of cubic morphology of γ' precipitates. Coarsening and spheroiding of γ' precipitates leads to creation of wider channels between γ' particles and dislocations can easier move, so deformation of base material can propagate.

All reported changes indicate that temperature of overheating was not $751^\circ\text{C}/2\text{s}$. This kind of degradation occurred after longer time exposition at temperatures close to 900°C .
