Directing the Forensic Investigation of a Catastrophic Structure Collapse: The Jacksonville Parking Garage Collapse

W. C. Bracken

Keywords—Catastrophic structure collapse, collapse investigation, Jacksonville parking garage collapse, forensic investigation.

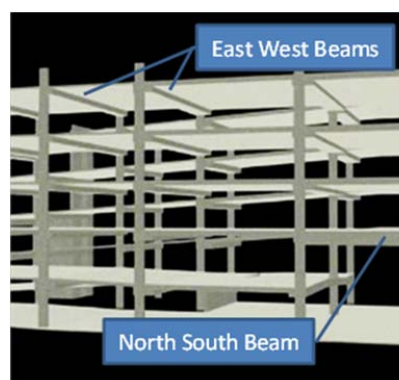
Fig. 1 Beam Configuration

The design called for the beams to run from each outside columns to its corresponding interior column. With one exception, the design only called for beams in the East West direction. The beams were simply reinforced and heavily post-tensioned using up to as many as 78 mono strand tendons. The beams were discontinuous at their center and their dimensions varied. The largest beam measured 84cm (33 in) deep by 152 cm (60 in) wide and the smallest measured 69 cm (27 in) deep by 46 cm (18 in) wide. These beams spanned between 12 m to 17.6 m (40 to 58 ft). The North South beam measured 183 cm (72 in) deep by 76 cm (30 in) wide and spanned 18.3 m (60 ft). An isometric view of the beam configurations is depicted in Fig. 1.

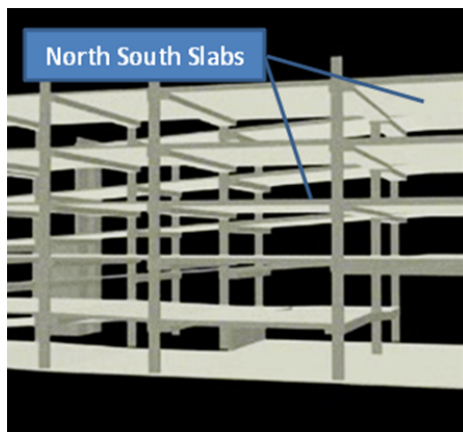
Fig. 2 Slab Configuration

The slabs were designed as one-way slabs spanning North to South and supported atop the East West beams. These slabs contained very little mild reinforcing but were heavily post-tensioned with up to one mono strand spaced at 7.5 cm (3 in) on center running the entire North South length of the

structure, 75 m (246 ft) in length. The slab configuration is depicted in Fig. 2.

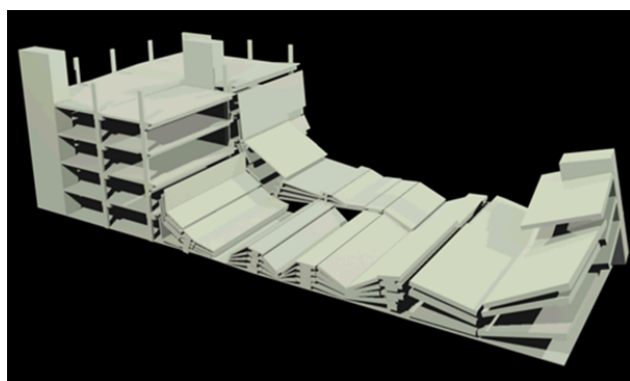
Fig. 3 Collapse Configuration

When the structure collapsed, more than 60% (the entire Northern portion) collapsed straight down in what rescue engineers described as a "pancake collapse". The portion left standing at the South end was badly damaged and ultimately required that it be razed. The disposition of the structure in its collapsed state is depicted in Fig. 3.

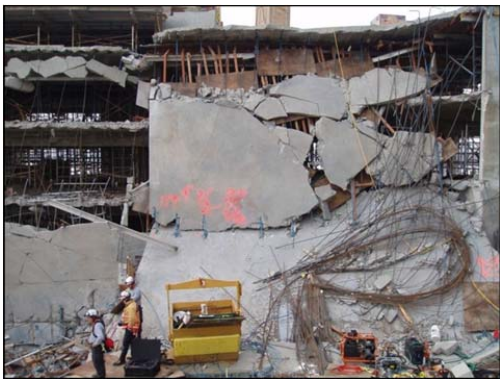
Fig. 4 Hanging Slabs

After a major structural collapse safety is the obvious primary concern. As seen in Fig. 4, a photo of the collapse immediately prior to the commencement of the investigation, the precarious nature of the debris was compounded by the number of potential secondary collapse hazards. Safety is accomplished through control of the scene. Control is accomplished by not just installing fences, guards and cameras but also through well-developed protocols that are published to all parties.
