Failure Analysis of Pipe System at a Hydroelectric Power Plant

Ali Göksenli, Barlas Eryürek

Keywords— Failure analysis, hydroelectric plant, water-hammer, crack, welding seam.

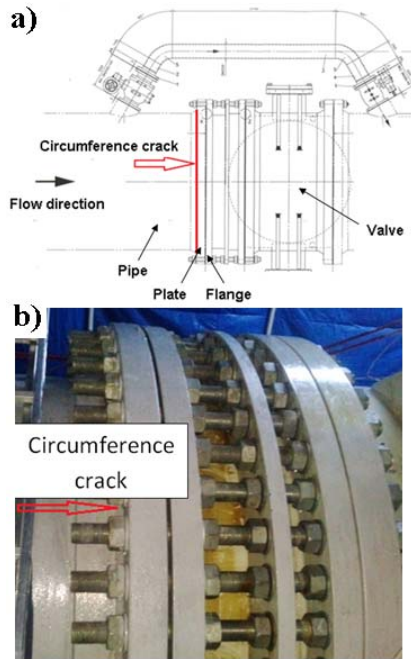
damaging forces [11]. In our case, for maintenance the butterfly valve was shut down resulting in a hammer like noise increase which had lasted for 10 minutes. After the waterfall incident, a circumference crack was detected at the flange-pipe welding zone. Investigations were carried out to determine the procedure after the crack formation.

As can be seen in Fig. 2, circumference crack had been constituted at the flange-pipe welding zone.

Fig. 2 General view of the flange-plate-pipe system and circumference crack

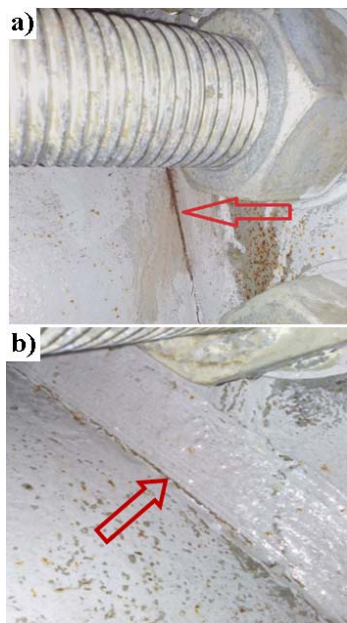
Fig. 3 Crack formation in pipe-plate welding zones

After detailed investigation it is concluded that crack had been propagated in pipe-plate welding zones (Fig. 3) and in pipe-flange plate welding zones (Fig. 4).

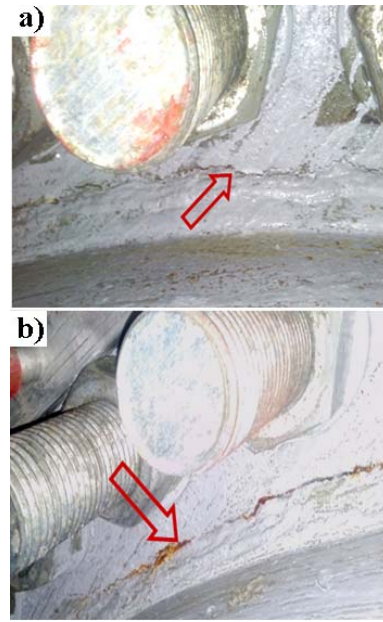
Fig. 4 Crack formation in pipe-flange welding zones

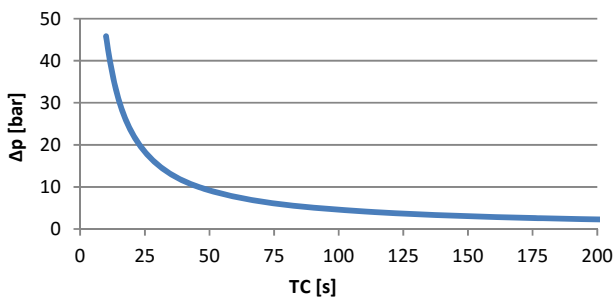
Fig. 6 Relation between pressure rise due to water hammer (Δp) and time to close the main valve (T_C)

As can be seen in Fig. 6, even a valve closing time of one minute will cause a pressure increase of 7.6 bar. The valve closing time at the accident day is not clear, but it is certain that the shut down time of the valve was not considered by the operator, which had resulted in a water-hammer effect.

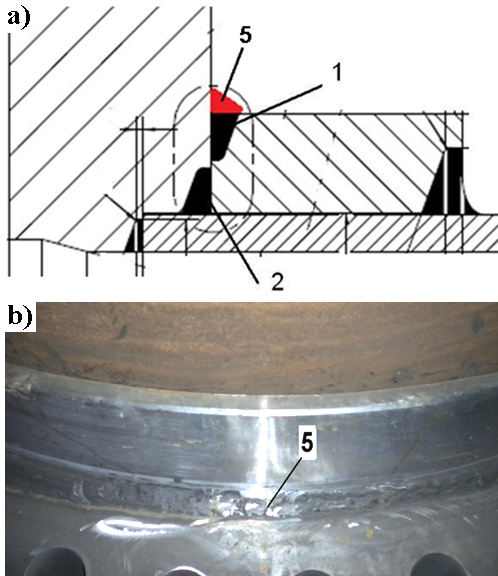
Weld seams 1 and 2 are applied between plate and flange, weld 3 between plate and pipe and weld 4 between pipe and flange as can be seen in Fig. 7. For further detailed weld analysis it is investigated if these mentioned four weld seams are applied correct as can be seen in Fig. 7. During observation an additional weld seam, which was not mentioned in assembly drawing in Fig. 7 was detected, as can be seen in Fig. 8.

Fig. 8 Weld seam no.5 (b), which was not mentioned in assembly drawing as can be seen in Fig. 7

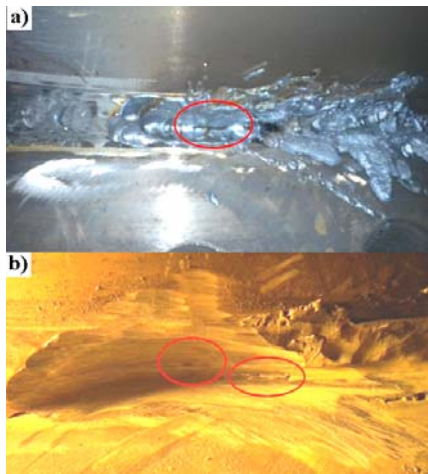
To analyze weld seam 1 and 2, weld seam 5 was grinded. After grinding it is detected that weld groove for weld 1 and 2 was constituted, but no welding process for weld 1 and 2 was applied, as can be seen Fig. 9. Therefore, a gap under weld 5 existed.

After weld seam analysis it is concluded that assembly of the plate-flange-pipe system was not applied correctly. Weld seams 1 and 2 were not applied; only weld grooves of weld 1 and 2 were constituted. The unfilled grooves 1 and 2 acted as inside cracks resulting in a strong notch effect. Stresses raised at this region caused crack propagation to the weld seam 5. By further investigation it is detected that weld groove for weld 3 was prepared incorrect. Groove angle was 70° instead of 20°. This had resulted in an increase of weld thickness from 25 mm to 110 mm, as can be seen in Fig. 10. This has resulted in a decrease of safety of the pipe-plate system, due to the low strength and high brittleness of weld seam according to base material.

Fig. 9 Weld groove of weld seam 1 and no welding process

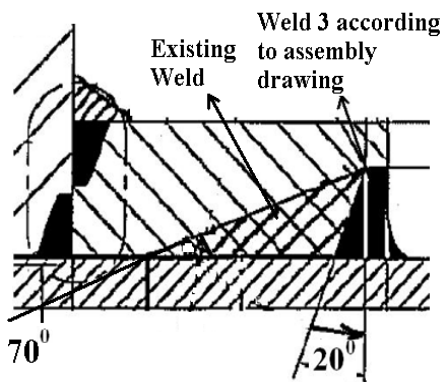
Fig. 10 Incorrect weld groove of weld seam 3
