# Investigating Causes of Pavement Deterioration in Khartoum State, Sudan

Magdi M. E. Zumrawi

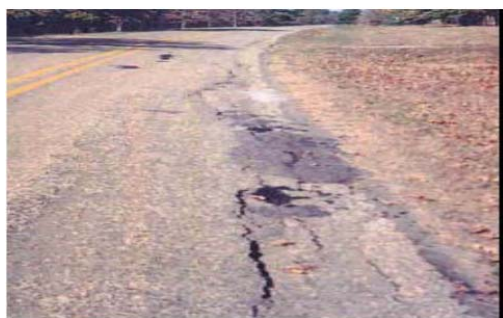
Expansive soil as road subgrade is considered one of the most common causes of pavement distresses. Longitudinal cracking results from the volumetric change of the expansive subgrade, is one of the most common distresses form in low volume roads (see Fig. 1). This type of cracking is initiated from the drying highly plastic subgrade ( $PI > 35$ ) through the pavement structure during the summer [18], [19]. Other forms include fatigue (alligator) cracking, edge cracking, rutting in

Fig. 1 Longitudinal cracking and failure, [19]

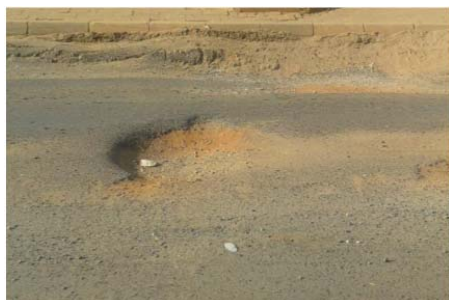
Both the northbound and southbound lanes were examined. On the southbound lanes, the majority of the damage is due to high severity rutting leads to large potholes mostly concentrated to the wheel path of heavy traffic as shown in Fig. 2. There is also significant damage due to medium severity transverse cracking mostly occurring in edge lane.

Fig. 2 Severe rutting leading to large potholes in Algaba road

The results from field survey of the three roads with different defects are presented and discussed here. Fig. 2 shows the photo of pavement having rutting surface and potholes. From figure, the rutting happened to occur on the wheel path and the potholes appeared in the middle of roadway. This pavement receives heavy load traffic every day because it is one of the main routes for buses and trucks. From

field observation, this road experience very poor drainage. The data recorded (as given in Table I) indicated that the faulty pavement design parameters, the paving was designed using underestimated traffic loads, the use of low quality materials in base and subbase construction, inappropriate pavement design procedures were followed. Therefore, insufficient thickness and poor drainage may become the reasons of these defects to occur.

- Slight ruts (< 8mm deep) can generally be left untreated. Pavement with deeper ruts should be leveled and overlaid.
- The optimal treatment of a pothole is a surface patch.

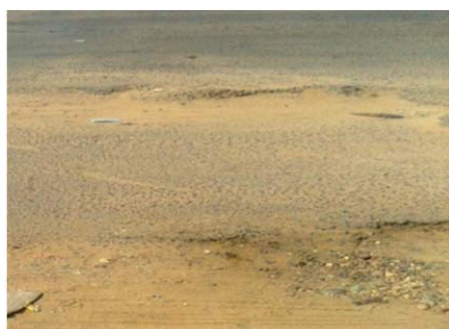
It is a major road located at the western part of Khartoum North. This road has been experiencing considerable pavement failures. The road narrows to one lane in each direction. It was observed that the majority of the damage is large potholes. In addition, there are large areas of moderate fatigue cracking associated with depressions and heave. Most of the cracks and potholes are considered severe and located along the road edges (see Fig. 3).

Fig. 3 Severe potholes and damaged edge in Shambat west road

Fig. 3 is the photo taken from pavement that having bumps, cracks, and edge failures at the middle and side edges of the road carriageway. The defect area is quite large and obstructs the traffic flow. It appears that failures may simply be due to weak subgrade soil. The problems associated with heave and edge failures were likely associated with problems in the subgrade soils along the alignment. Distresses related to expansive soils exist throughout the road alignment, but significant damages concentrations are located in a certain sections of about 1.6 km length. A lack of adequate surface drainage is another critical factor leading to problems with expansive subgrade soils in this road.

- For narrow roads without shoulders, road widening is suggested as a cost-effective edge repair solution than patching.
- For small, localized areas of corrugation or shoving, it is recommended to remove the distorted pavement and patch. Large corrugated or shoved areas are repaired by removing the damaged pavement and overlay.

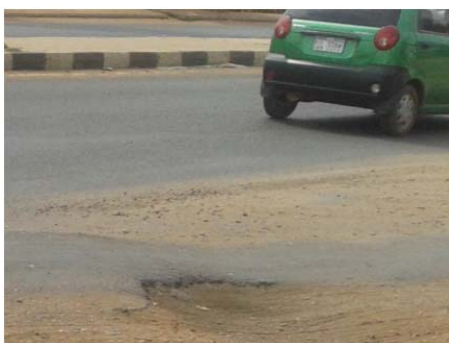
This road connects Omdurman town with Khartoum and is located in the eastern part. The damage was observed mainly in the middle portion of the road length, particularly in the edge lane of the eastern carriage. The majority of the damage was moderate to severe edge cracking. Raveling is also present and appears to be worse. The severe raveling has led to potholes and depression areas where the top surface has delaminated from the road structure as clearly shown in the photograph of Fig. 4.

Fig. 4 Severe surface damage along the edge lane in Alarbeen road

Fig. 4 shows the asphalt layer has delaminated from the top surface of the road structure. This defect area is adjacent to the side drain, shows significant depression. It was observed that the side drain was full with refuse dumps. The inlets on the curb were blocked with soil accumulation as shown in Fig. 5. It is clear that the surface runoff water penetrated through the cracks and potholes cause a progressive inward penetration of the zone of soil movement leading to soil depression and ultimately failure of the pavement. From the on-site observation and the result above, it is clearly seen that the major cause of pavement deterioration is inadequate drainage.

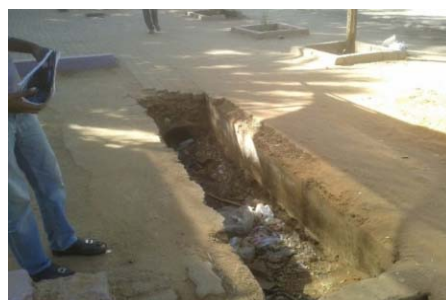
It was observed that the eastern carriageway of the road is connected with side drain. In general, most of the drain is covered with concrete slab and damaged manhole covers. The drain has small cross section of 1m width and not more than 1m depth. The condition of the drain and its structures is very poor and getting deteriorated by the passage of time. The drain suffered from low capacity, natural siltation, absence of inlets, lack of proper maintenance and over and above disposal of solid waste into the drain and the crossing culverts. The drain blocked with silt and sand accumulation, debris and vegetation as shown in Fig. 5. It is clear that the drain being converted to dumpy place and subsequently obstructed the water flow.

Fig. 5 Side drain of damaged cover full with debris in Alarbeen road
