# Condition Monitoring for Controlling the Stability of the Rotating Machinery

**Abstract**—In this paper, the experimental study for the instability of a separator rotor is presented, under dynamic loading response in the harmonic analysis condition. The global measurement and analysis of vibration on the cement separator RC500 is carried, the points of measurement used are radial dots, vertical, horizontal and oblique. The measures of trends and spectral analysis for reconnaissance of the main anomalies, the main defects in the separator and manifestation, the results prove that the defects effect has a negative effect on the stability of the rotor. Experimentally the study of the rotor in transient system allowed to determine the vibratory responses due to the unbalances and various excitations.

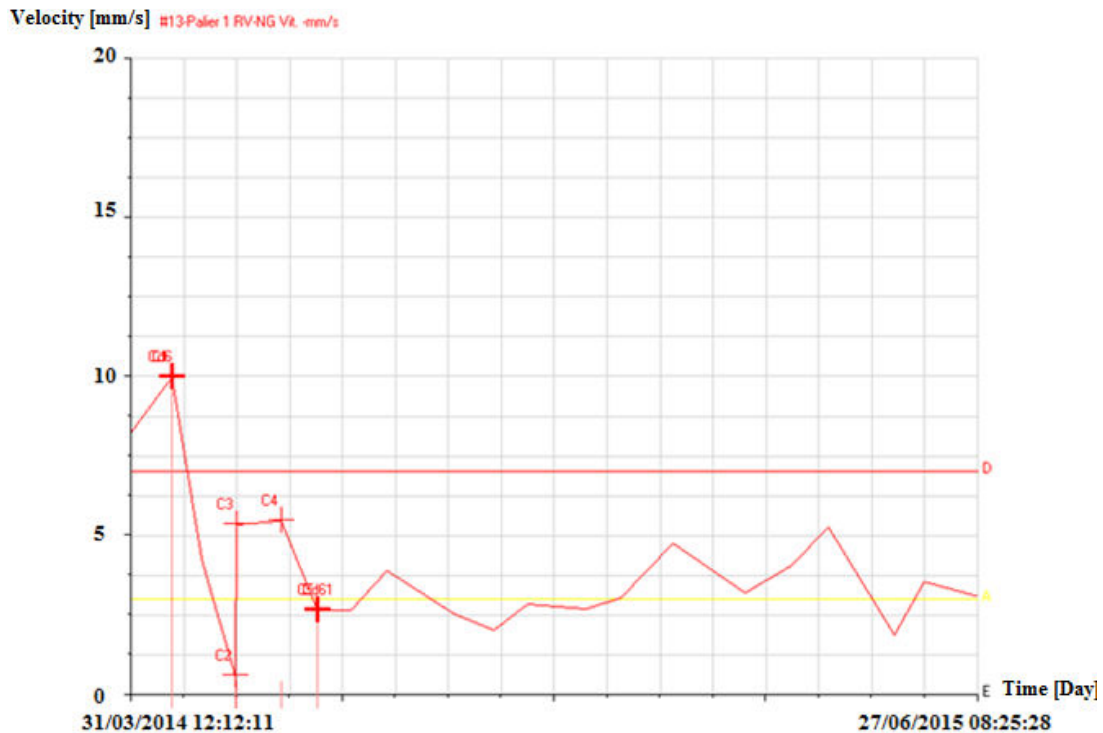
Fig. 4 Trend curve of bearing (01) RV-NG

The trend curve for the bearing N°01 (mm/s) is presented. There was an increase vibratory velocity level which exceeds the alarm threshold in point C4 (5.49 mm/s) which shows the presence of an anomaly, but we do not know their origin, after repair a speed decrease is observed with a reduction in (2.84 mm/s), for diagnosing the origin of the excess passes to spectral analysis.

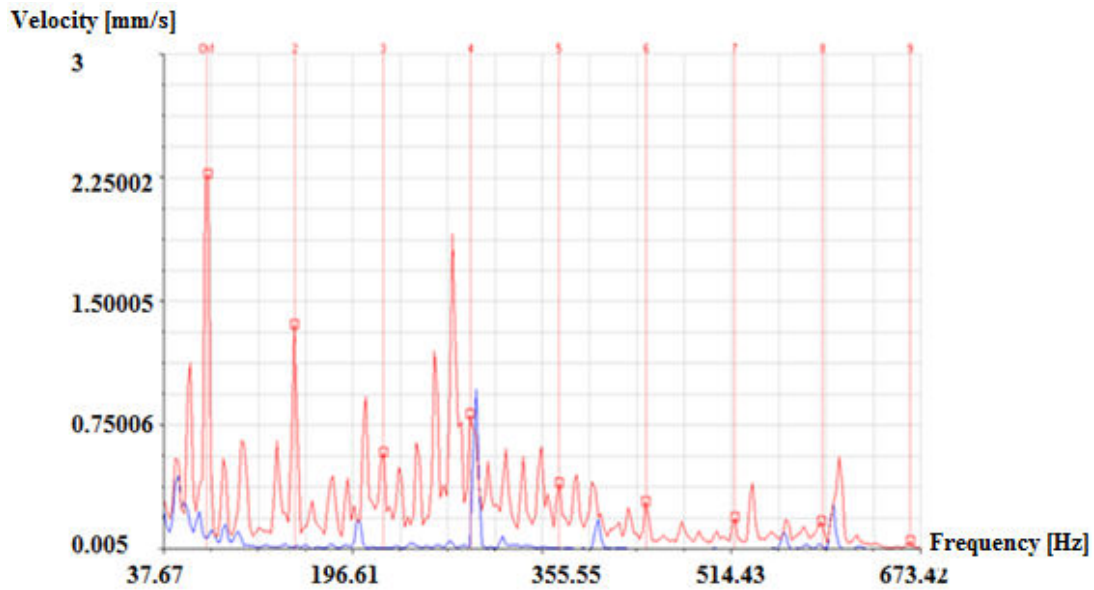
Fig. 5 Linear spectral image superimposed on bearing N°01 RV

■: spectrum before repair → net level rise in speed  
 ■: spectrum after repair → net improvement in speed level

The spectral signature represents a net increase of vibrational amplitude level of speed (red spectrum) in the medium frequency domain, corresponds to the frequency value equal to 73.05 Hz, this value corresponds at the same time to the frequency internal bearing ring, which shows a fault bearing inner ring. The recommendation is to change the bearing N°01.

After the repair performed (change bearing) we notice (blue spectrum) a net decrease in the speed level (the fault disappears), which confirms the accuracy of diagnosis.

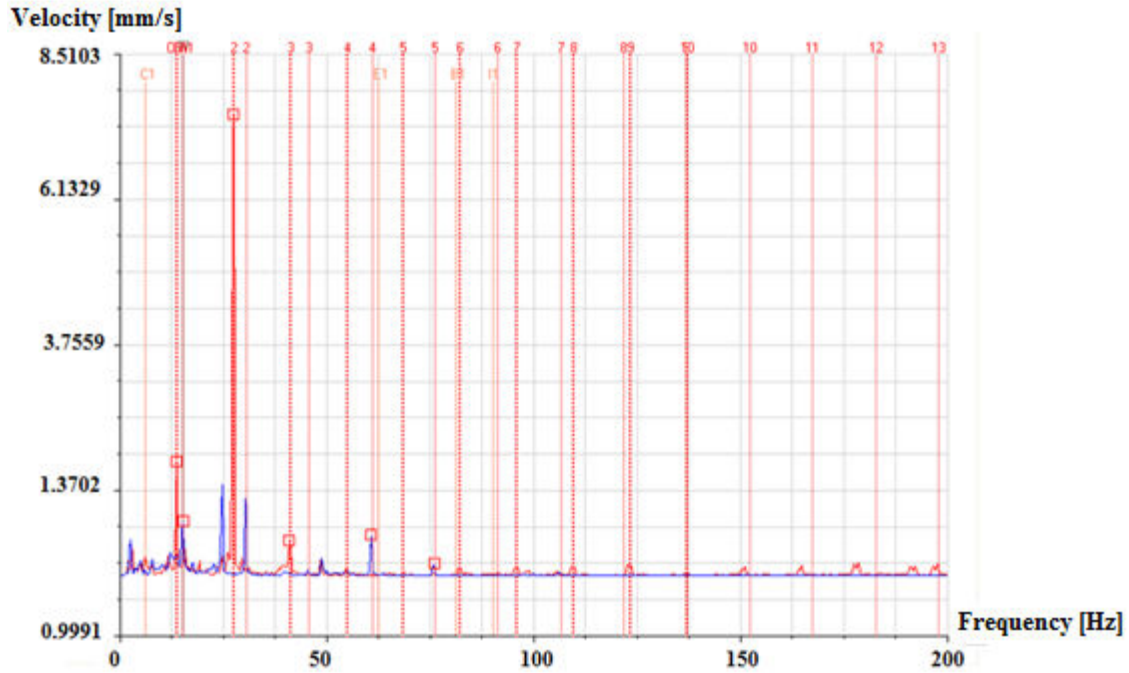
Fig. 6 Spectral Image superimposed on bearing N°02 RH

Concerning the Bearing N°02, through the Trend curve we noticed a speed level of increase that exceeds the danger threshold Cd1 points (9.25 mm/s), indicating the presence of an anomaly but does not know their origin, this anomaly is more danger. According repair a speed decrease is observed with a reduction in (6.27 mm/s), for diagnosing the cause of the excess passes to spectral analysis. The spectrum N°02 (mm/s) is given in Fig. 6.

The spectral signature (red spectrum) represents a net increase in amplitude equal (7.51mm/s) in the low frequency

range corresponding to a frequency value equal to 27.41 Hz, this value corresponds to the 2nd harmonic of the rotation frequency of the motor shaft, which is a misalignment between the motor and reducer. The recommendation is the lineage of the line engine transmission – gearbox and the coupling change.

After the repair carried out (the coupling change) we notice (blue spectrum) a net decrease in the speed level (the fault disappears), which confirms the accuracy of diagnosis. The spectrum N°03 (mm/s) is given in Fig. 7.

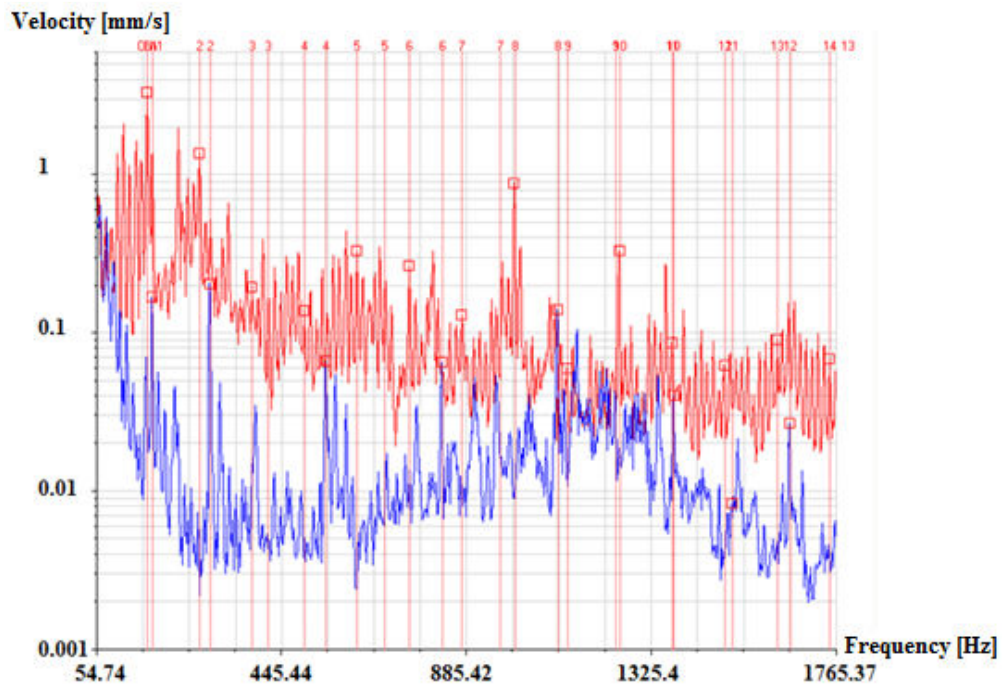
Fig. 7 Spectral Image superimposed on the logarithmic scale on bearing N°03 RO

The spectral signature (red spectrum) represents a net increase of amplitude in the medium frequency domain corresponds to a second frequency value that equals 250 Hz, this value corresponds to one of the first train of the gear meshing defect (pinion). The recommendation is changing the gearbox.

After the repair carried out (the gear change) we notice (blue spectrum) a net decrease in the speed level (the fault disappears), which confirms the accuracy of diagnosis.

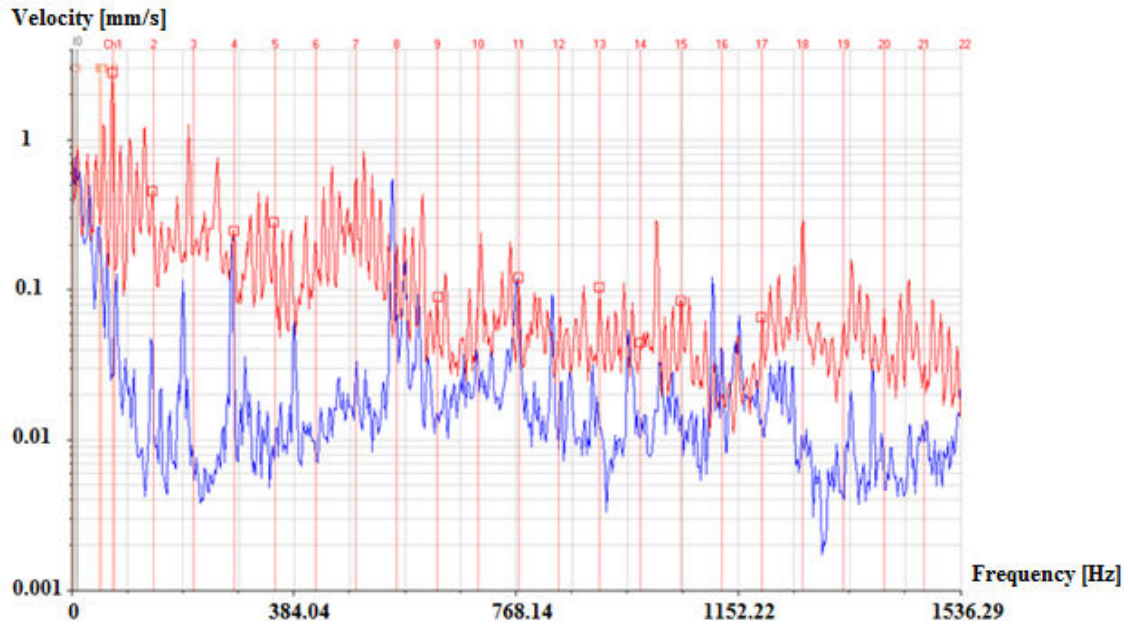
Fig. 8 Spectral Image logarithmic scale superimposed on bearing N°04 RO.

For the bearing N°04, According to the trend line oblique radial extent in remarks at point C2 (4.80 mm / s) an alarm threshold is exceeded, after repairing a decrease until Cd11 (1.86 mm/s), to diagnose original passes to frequency analysis.

The spectrum N°04 (mm/s) is given in Fig. 8. The spectral signature (red spectrum) represents a net increase of amplitude in the medium frequency domain corresponds to a frequency value equal to Ch1 = 70.15 Hz, this value corresponds to a discharge failure of the internal bearing ring.

The recommendations are changing the rolling bearing No 04. After the repair carried out (the gear change) we notice (blue spectrum) a net decrease in the speed level (the fault disappears), which confirms the accuracy of diagnosis.

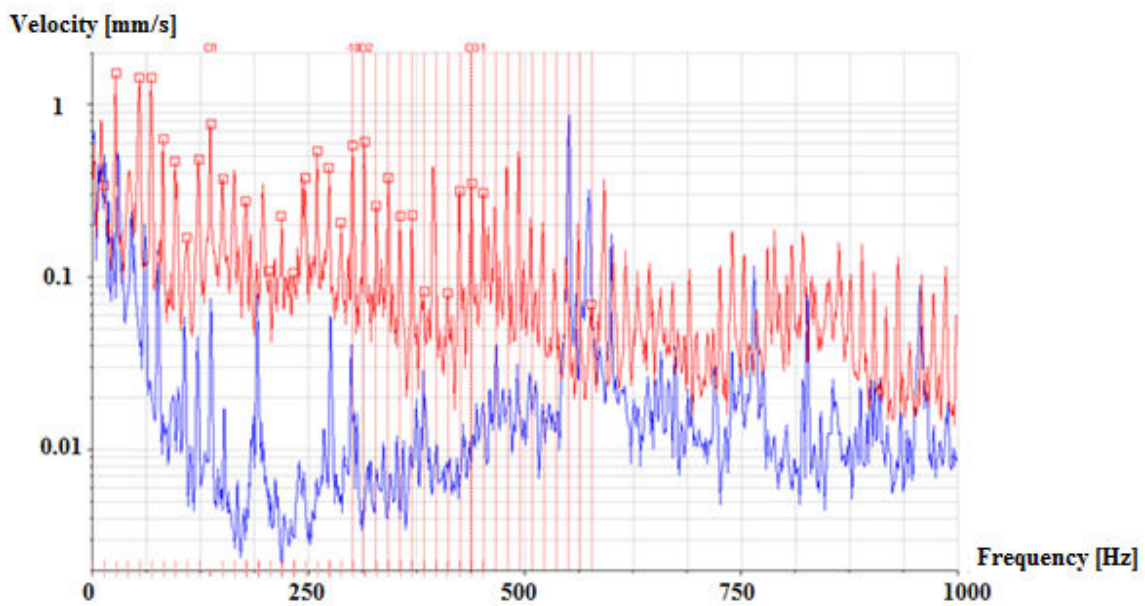
Fig. 9 Spectral Image superimposed on a logarithmic scale on bearing N°05 RO.

For the bearing N°05, According to the oblique radial extent of the bearing 05, we note that the point C2 (4.08 mm / s) an alarm threshold is exceeded, after repair decreased to C3 (1.86 mm / s) is observed. The spectrum of bearing N°05 (mm/s) is given in Fig. 9.

The spectral signature (red spectrum) represents a net increase of the average amplitude in frequency domain corresponding to a shock to the frequency of rotation of the motor on the bearing supporting the shaft of the separator.

The recommendation is changing the rolling bearing No 05. After the repair performed (the change bearing and gearbox) we notice (blue spectrum) a net decrease in the speed level (the fault disappears), which confirms the accuracy of diagnosis.
