Rock Slope Stabilization and Protection for Roads and Multi-Storey Structures in Jabal Omar, Saudi Arabia

Ibrahim Abdel Gadir Malik, Dafalla Siddig Dafalla, Abdelazim Ibrahim

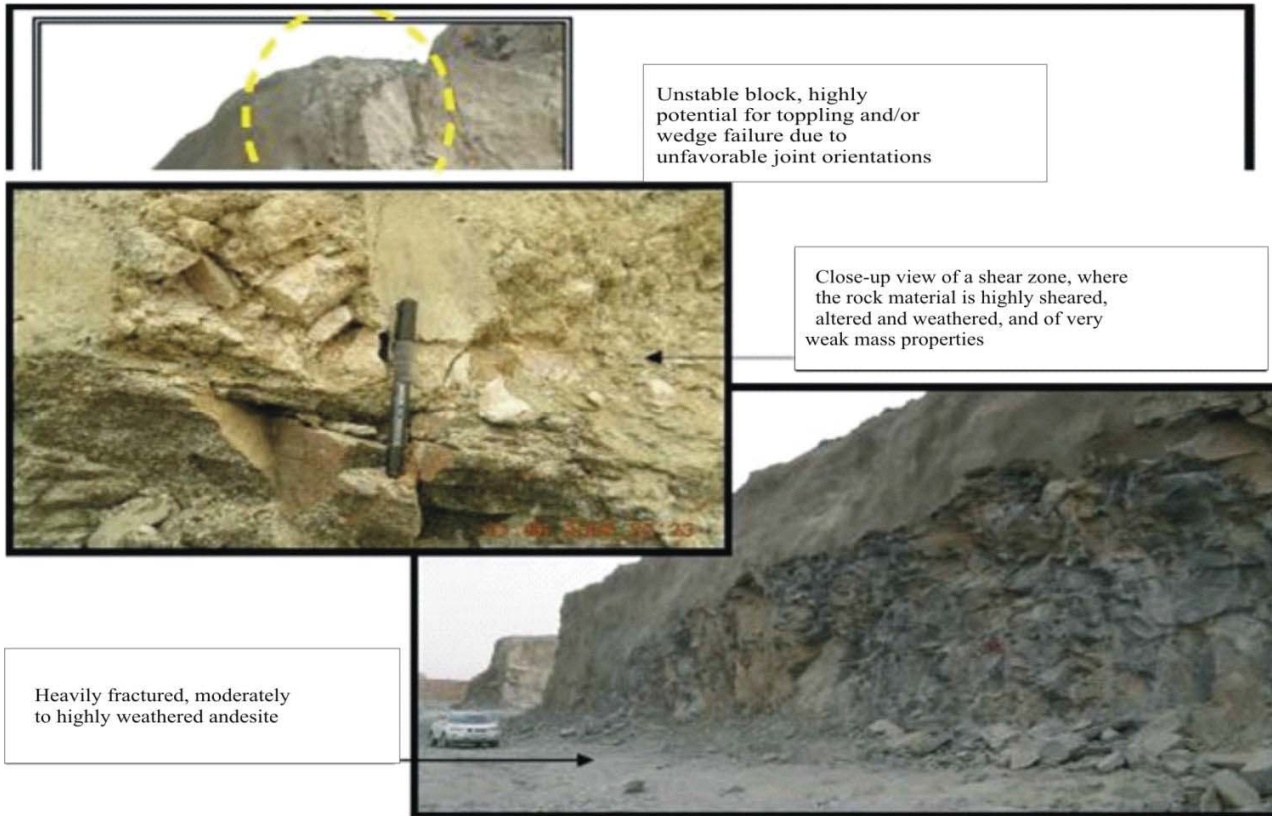
In general, the rocks are heavily jointed, faulted and sheared due to tectonic deformation [7]. Along the shear and fault zones, the rocks are commonly highly fractured and sheared with some degree of alteration and are highly weathered.

Fig. 1 Some of the common geological features of the rock mass along the Site

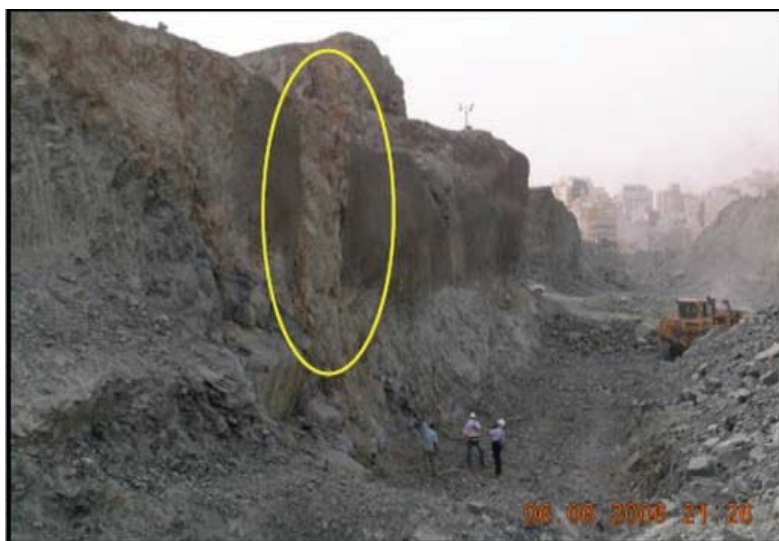
The site was selected as a critical area since the exposed bedrocks by recent rock cutting are generally in very poor condition, heavily jointed and sheared. Based on information from the Resident Engineer on site, rock slope failures occurred recently at the upper portion of the cut slopes which covered by "concrete spray" (Fig. 2).

Fig. 2 View of the site condition of the site, the yellow circle indication the failure section

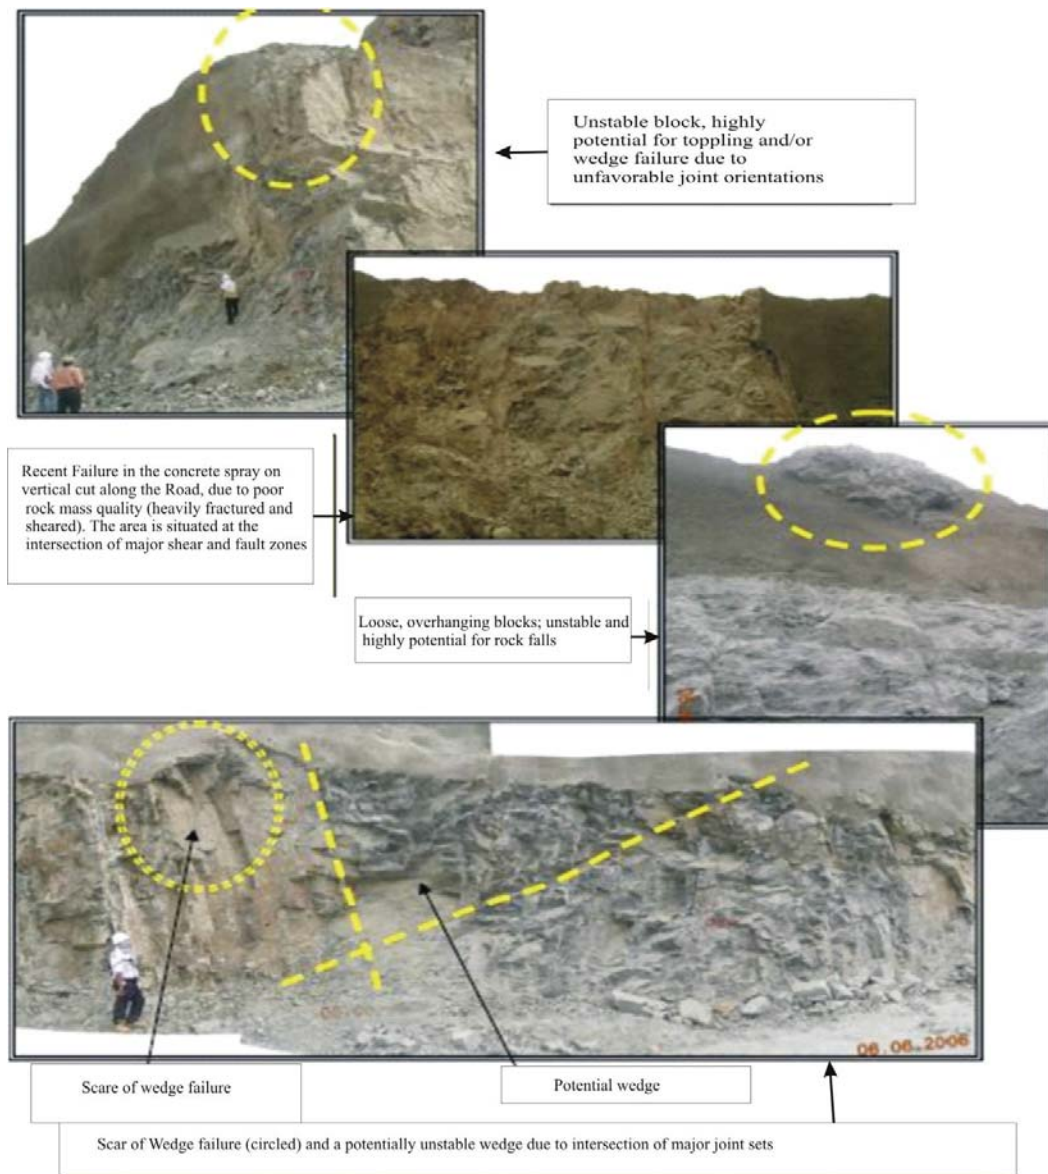
unsuccessful. Wedge failures, rock falls, and tension cracks had since developed, suggesting that the "concrete spray" was inadequate and could not support the vertical cut in poor rock mass and thus some other slope protection measures have to be adopted. From a brief survey, it was also found that the cut slopes along the site are potentially unstable and are very likely to fail either in the form of wedge, toppling and/or rock falls. Some of the identified critical spots are shown in Fig. 3.

Fig. 3 Examples of some of the identified geotechnical problems associated with vertical cut in poor rock mass along the site

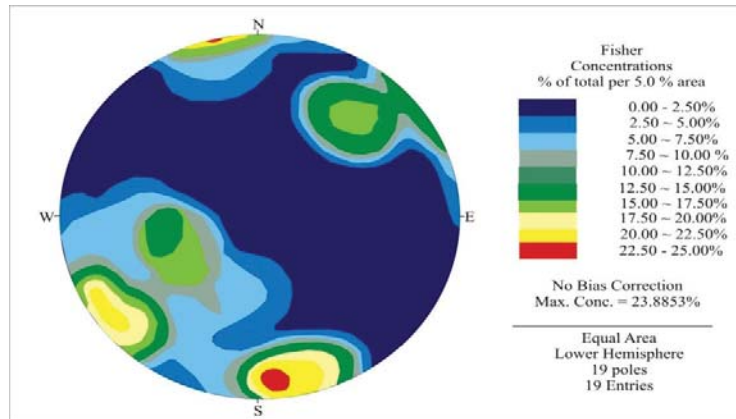
Geological mapping works was carried out in the vicinity of the unstable slope shown in Fig. 3 (a) in order to assess and to verify its stability. The discontinuity data orientation was plotted into lower hemisphere stereographic projections and analyzed (Fig. 4). The results of the analysis (Fig. 5) confirmed the presence of unstable blocks, which is defined by the intersection of three (3) major sets of joints (H: 340/35; J2: 322/90, and B: 256/78). The toppling failure is made possible by the intersection of the steeply dipping J2 with plane H acting as the basal sliding plane. The failure may also take place in the form of wedge due to the intersection of J3 and J1 [6] and [9].

Fig. 4 Stereographic plot the discontinuities of the failed slope

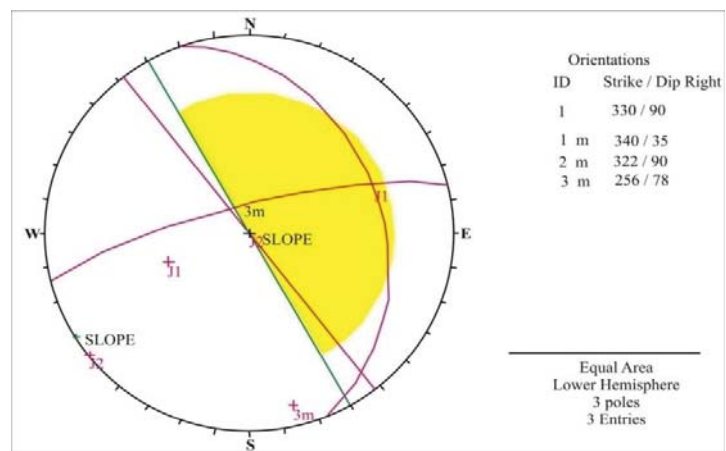
Fig. 5 Kinematic stability analysis of the rock slope at the site, Sta. 0+160

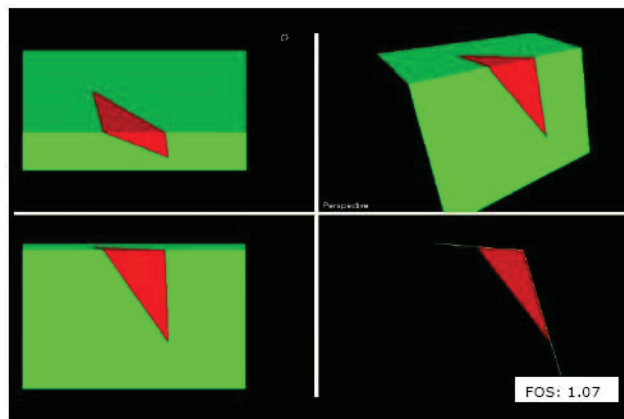
The wedge failure identified from the kinematics stability analysis (Fig. 5) was further modeled by using SWEDGE v4 of Rocscience in order to determine its factor of safety during the failure. In this back analysis, it is assumed that the friction angle along the discontinuity plane is 36° and the failure took place in dry condition. Results of the analysis (Fig. 6) suggested that the factor of safety was 1.07.

Fig. 6 Back analysis modeling of the unstable wedge, by using SWEDGE v4 program

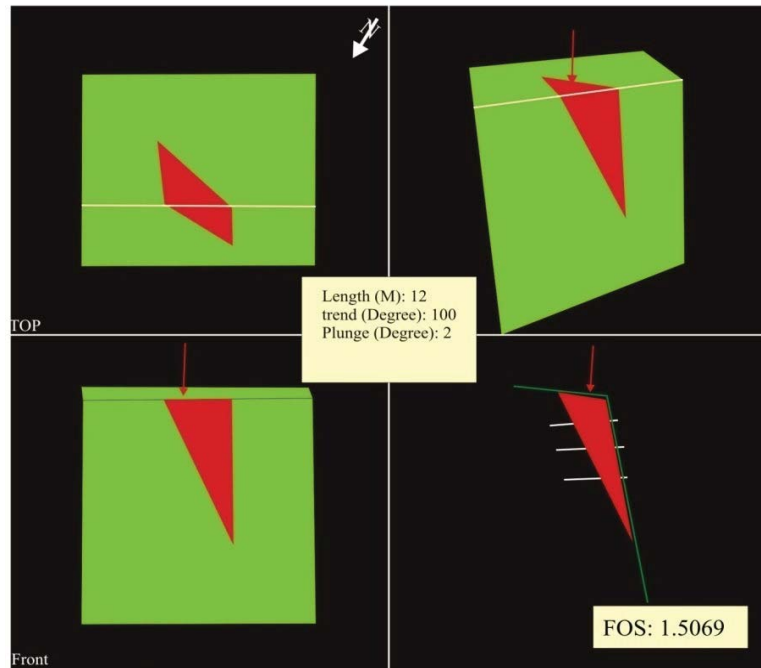
Fig. 7 Detail analysis to determine suitable length of the rock bolts

Detail wedge failure analysis was also carried out in order to determine the best possible methods of stabilization (Fig. 7). Patterned-bolting was proposed as a stabilization measures. The analysis results suggest that the wedge could be stabilized and its factor of safety can be increased to 1.5069 by installing at least 12m long, Y32 bars with capacity of 30 tons of rock bolts.

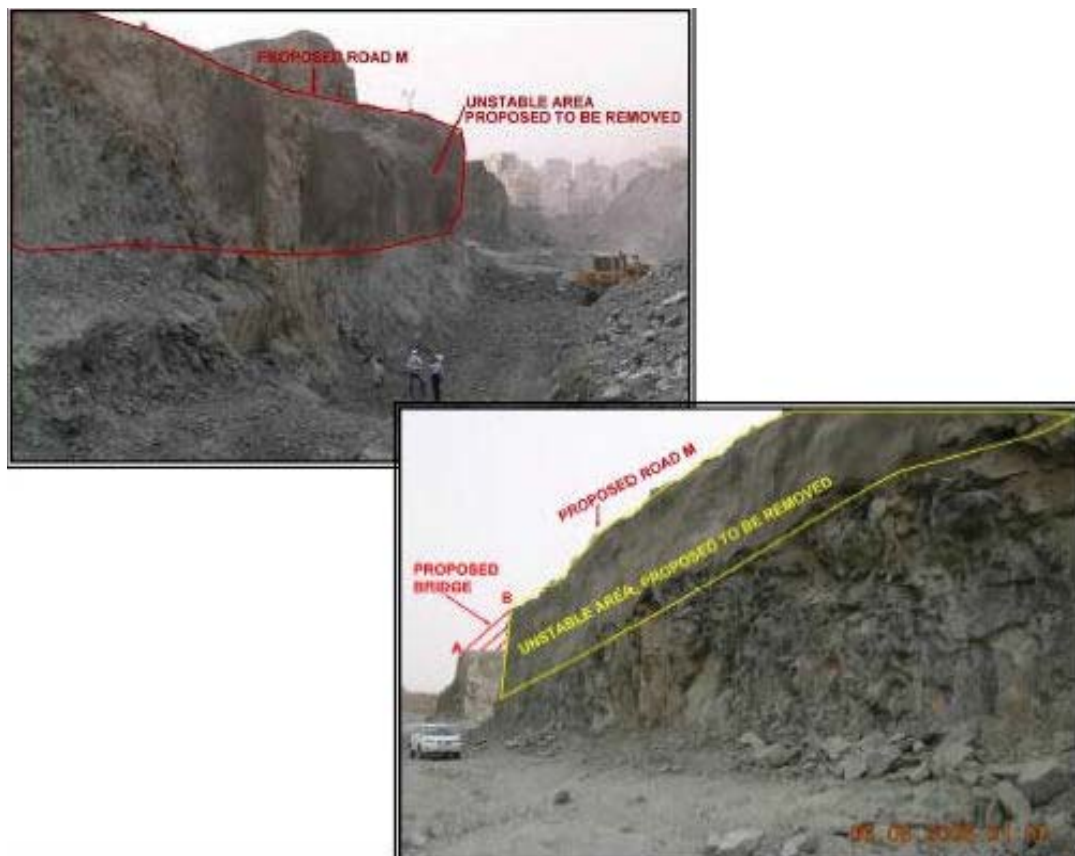
Fig. 8 The proposed mitigation measures for the unstable slope along the site - the concrete-covered upper part of the slope to be removed, supported with MSE wall and backfill with suitable fill materials

- The upper part of the slope, which is highly weathered and heavily jointed, is proposed to be removed because the existing "concrete spray" cover has hindered detailed mapping of the geological structures, identification of the critical areas and proper selection of suitable protection/stabilization measures (Fig. 8).
- The mechanically stabilized earth wall such as VSL, Nehemiah or RE Wall can be applied to create vertical wall and to maintain the original platform design for site. The wall should be founded on sound rock and this has to be identified by the geologist on site. The wall is to be tied back to the slope prior to backfilling with suitable materials (Fig. 9)
- Shotcrete - the shotcrete shall be reinforced with steel wire mesh and tied back to the slope with rock dowels/bolts.
- Rock bolts - Patterned-bolting can be applied to the heavily jointed areas.

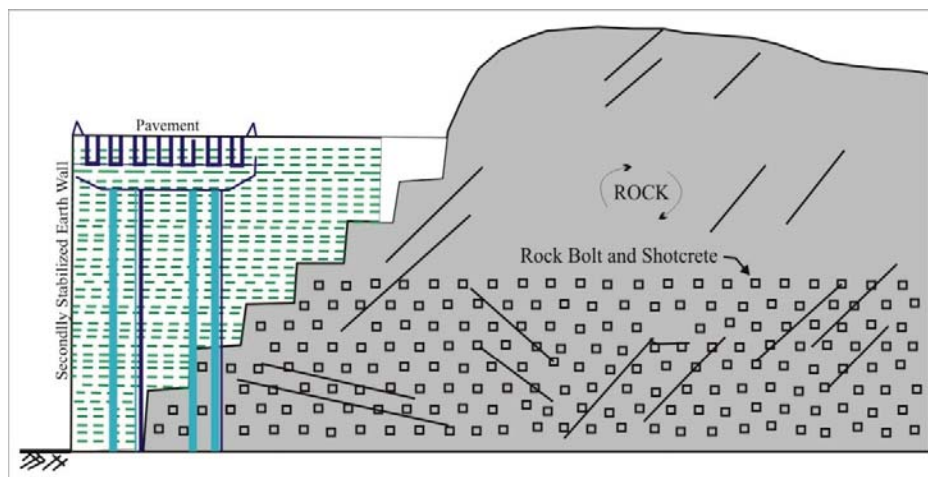
Fig. 9 Schematic diagram showing the proposed stabilization measures for the rock slope along the site

Spacing and length of the patterned-bolting should base on the results of detailed slope mapping by an experienced geologist. Passive rock bolts are preferred because the nature of the heavily fractured/jointed rock mass is unfavorable for application of active rock bolts. Combination of these stabilization and protection methods is schematically summarized in the cross-section along the site as shown in Fig. 9.

The failed section below the proposed bridge abutment along the site has to be trimmed and stabilized with patterned-bolting in combination with shotcrete. The results of this study indicated that the rock slope for the foundation of the bridge abutments is unstable; the proposed bridge at the site shall be

designed on a stand-alone structure (bridge pier) as shown in Fig. 9. The structure should be founded on sound bedrock.
