# Investigation of Failures in Wadi-Crossing Pipe Culverts, Sennar State, Sudan

Magdi M. E. Zumrawi

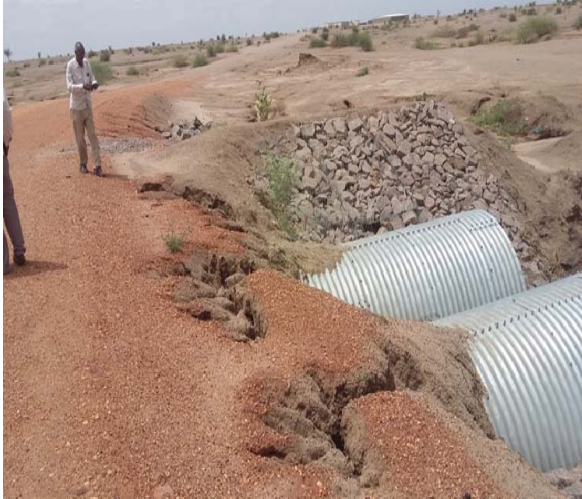
Severe cracks and potholes were clearly seen on top embankment especially at the edges nearby the pipes inlets and outlets. Also the head walls of the pipes showed severe failures and collapse of the gabion mesh used to protect the embankment around the pipes as shown in Fig. 6. The gabion mesh was placed between the pipes only without any link between them. The gabion mesh was fall down when the embankment failure occurred due to water erosion.

Fig. 6 Severe cracks and potholes on embankment edges due to water erosion

The most probable cause of culverts failures may be due to improper design. The gabion mesh used as wall protection for the pipes have no link with each other. As embankment failure occurred by water erosion, the gabion meshes were completely fall down due to shear forces. Thus leading to collapsing and wash away with water at inlets and outlets sides. The design of the culverts is inadequate for the following reasons.

- 2) Headwalls around the culvert inlet and outlet serves to protect the embankment on top of the culvert pipes. Together with the wing walls, the head walls also act as collectors, directing the water to the pipes. The gabion mesh used for headwalls protection has proved instable and impractical technique because when erosion occurred in embankments of the headwalls it was collapsed. While the gabion mesh used for wing walls lining showed better condition because of the relatively large surface area with reasonable slope. The gabion mesh used for head walls protection for the pipes have no link with each other. As embankment failure occurred by water erosion, the gabion meshes were completely fall down due to shear forces, thus, leading to collapsing and wash away with water at inlets and outlets sides.

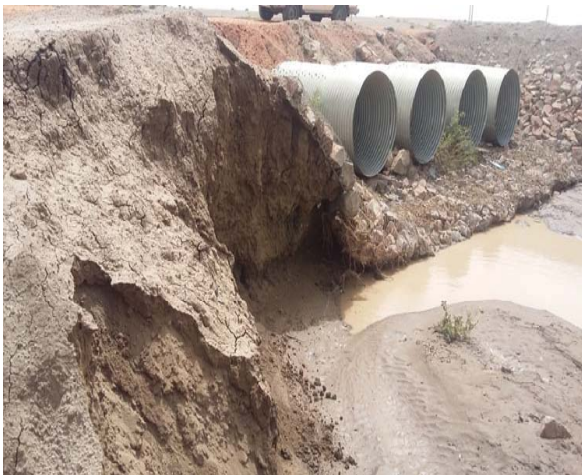
Fig. 7 Collapse and failure of wing walls embankment due to water scouring

It was observed also partial breaching and weakening of the wing wall embankments at inlets and outlets of culverts which may result in complete collapse. This embankment weakening was happening mainly due to scouring effect of the incoming wadi which flows adjacent to the embankment section parallel to the crossing axis. This scouring has caused the embankment slope to get steeper and has increased the wadi depth which has increased the embankment height that can lead to failure. During the rainy season, this steeper section was falling into the wadi where it got saturated and washed downstream. In

some crossings, the embankment has changed its original section, dimension and shape throughout the entire length of the crossing where the top embankment is narrowed and the side edges with severe cracks and potholes and the slopes at inlets are flattened in some sections and steeped at others (see Fig. 7).

The embankment close to the wing walls of culverts got saturated due to excessive seepage. It was eroded, producing small slumps/slides presenting relatively steep faces which once again became saturated by seepage from the inlets and slumped again, forming slightly higher and unstable faces. This raveling process kept on going until the remaining portion of the embankment became too thin to withstand the water pressure, thus leading to the collapse of embankment

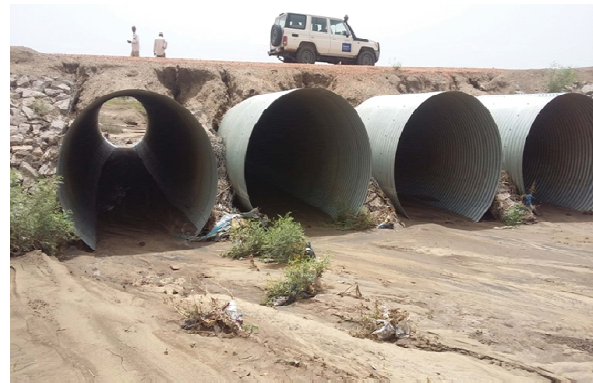
In addition to breaching and weakening of the embankment, the other concern observed in the crossings is sediment deposition and vegetation in the apron area of outlets. The sediment deposition has reduced the storage capacity of the pipes by significant volume. This is mainly due to huge sediment load from the catchment area which leads to reduction in pipes capacity (see Fig. 8).

Fig. 8 Sediment deposition and vegetation in the apron area

- For sustainability of the crossing culverts, regular maintenance is needed. Government authorities should consider providing a specific budget on an annual basis for both maintenance and improvement works. Also a program for cleaning out the pipes is essential. Inlets and outlets of culverts need to be cleaned and maintained regularly.

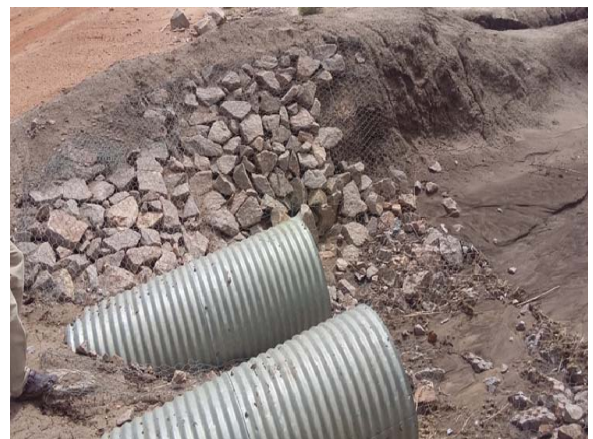
In most crossings, it was observed that the wing walls of the inlets and outlets which are protected by gabion mesh showed better performance than the head walls as shown in Fig. 9. While in very few crossings, the mesh of the gabion missed or opened and some of the stones were thrown away from the walls. This problem may adversely affect the stability of embankment slope.

Fig. 9 The gabion mesh used for lining of wing walls

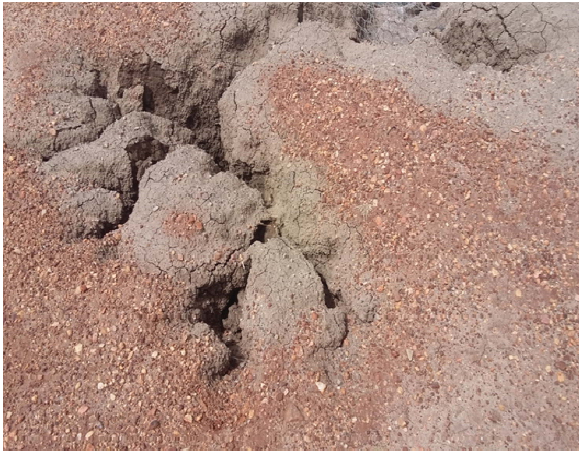
It is clearly observed from Fig. 10 that the subbase layer laid on the embankment is becoming very thin (i.e. thickness less than 20 cm) to support the traffic loading and partially accumulated at the sides. As a result, the underneath

embankment of clayey soil suffered from severe cracking and potholes occurred at edges above the pipes inlets and outlets.

Fig. 10 Sever cracks and potholes on Subbase and embankment layers

- 3) The embankment used above the pipes has thickness about 60 cm for large pipe diameter 2.4 m. This thickness is too small to resist traffic loads as previously explained in the literature.

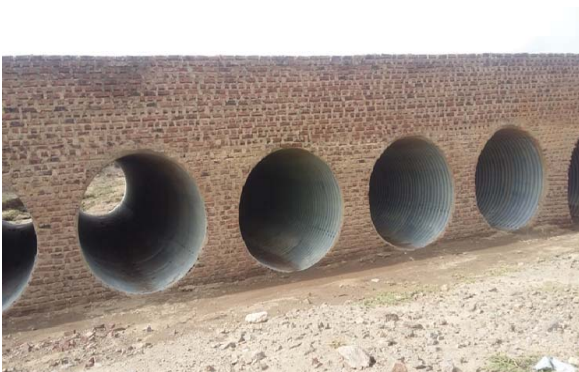
It was noticed that the Fresh crossing in west Aldindir was properly design and constructed. The pipes are protected with a head wall build of brickworks and the side wing walls are lined with stone pitching as shown in Fig. 11. It is clearly observed that the crossing is in a good condition particularly in the inlets and outlets of the pipes.

Fig. 11 Head and wing walls of the Fresh crossing are in good condition
