Investigation on the Physical Conditions of Façade Systems of Campus Buildings by Infrared Thermography Tests

N. Türkmenoğlu Bayraktar, E. Kishali

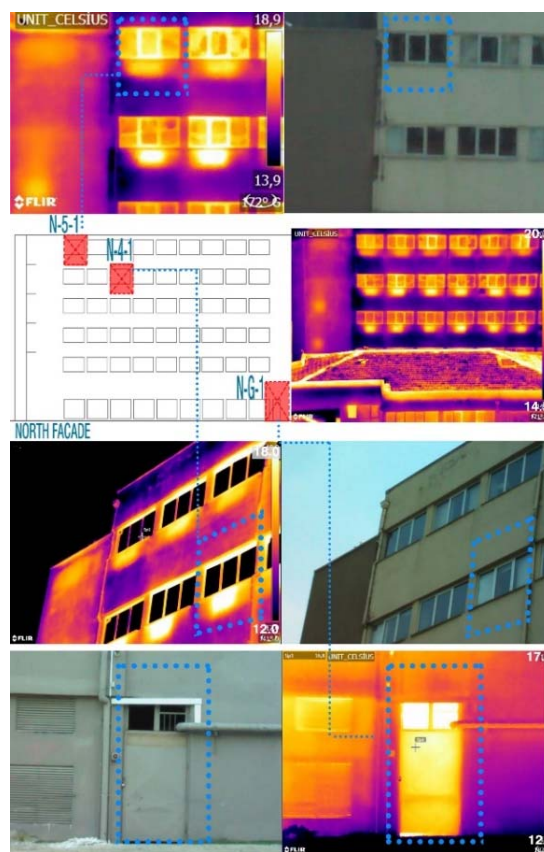
Fig. 7 IRT captures on North Elevation of Faculty of Architecture and Design

Moisture induced anomalies were also observed via IRT technique. Infiltration from the roof where staircase and the building connected in the north-east part building was observed. The insufficient downspout and rain drain influence hygrothermal conditions of the offices located at the top floor oriented to the North; efflorescence and biological growth were observed on the interior surface of the most North-east office of the building even by direct investigation (N-5-1 in Fig. 7). Outside surface temperature was logged between 4.5°C and 7°C on the outside surface; the highest value obtained on the envelope where radiator heats the zone, whereas interior air temperature was logged as 18°C. It is deduced that heat loss phenomenon occur with higher amount compared to other offices. The northern parapet of the roof display lower outside surface temperature with respect to other parts of the elevation; especially, the top level of the north-east area of the elevation is highly exposed to direct and wind-driven rain phenomenon. Contrarily, capillary rise based degradations were not detected on both elevations by IRT technique (N-G-1 in Fig. 7; S-G-1 and S-G-2 in Fig. 8).

façade and higher heat losses enable to map these areas easily (N-4-1 in Fig. 7). It was also determined on the northern envelope that interventions on the openings of toilets were executed.

In consideration of the obtained data, refurbishment strategies towards increasing energy efficiency of building envelope are necessary. The insulation is required to prevent heat losses from the north façade. More detailed assessment need to be conveyed at the roof level. Rain drain and

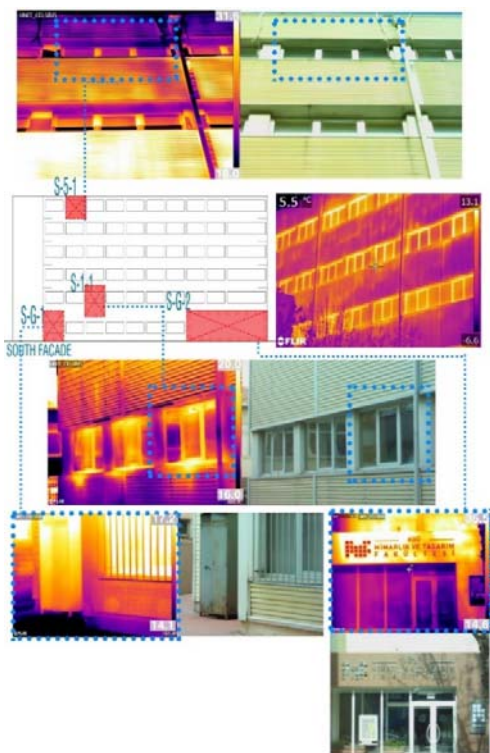
Fig. 8 IRT captures on South Elevation of Faculty of Architecture and Design

On the other hand, South façade with vinyl finishing displayed better thermal performances compared to the North façade (Figs. 7 and 8). Active heating with heat losses were easily observed when the façade was examined via IRT captures. Outside surface temperature of south envelope for the S-5-1 was measured between 5.5°C and 6.5°C; concurrently interior ambient temperature was logged as 22°C. In spite of the better performance of the South façade, the patchy view and non-homogeneous surface temperature distribution was obtained. Additionally, close-up captures indicate that heat losses from window framings occurred in the South of building. It is proved that heat losses occur there as well (S-5-1 and S-1-1 in Fig. 8).

infiltration issue should be blocked since relative humidity level and mold growth influences the health of users. It is recommended that the vinyl coat and windows framing be changed in order to prevent heat losses. The enhancement of energy efficiency by adding insulation to the architectural composition would provide benefit to the building and the economy.
