Structural Analysis and Strengthening of the National Youth Foundation Building in Igoumenitsa, Greece

Chrysanthos Maraveas, Argiris Plesias, Garyfalia G. Triantafyllou, Konstantinos Petronikolos

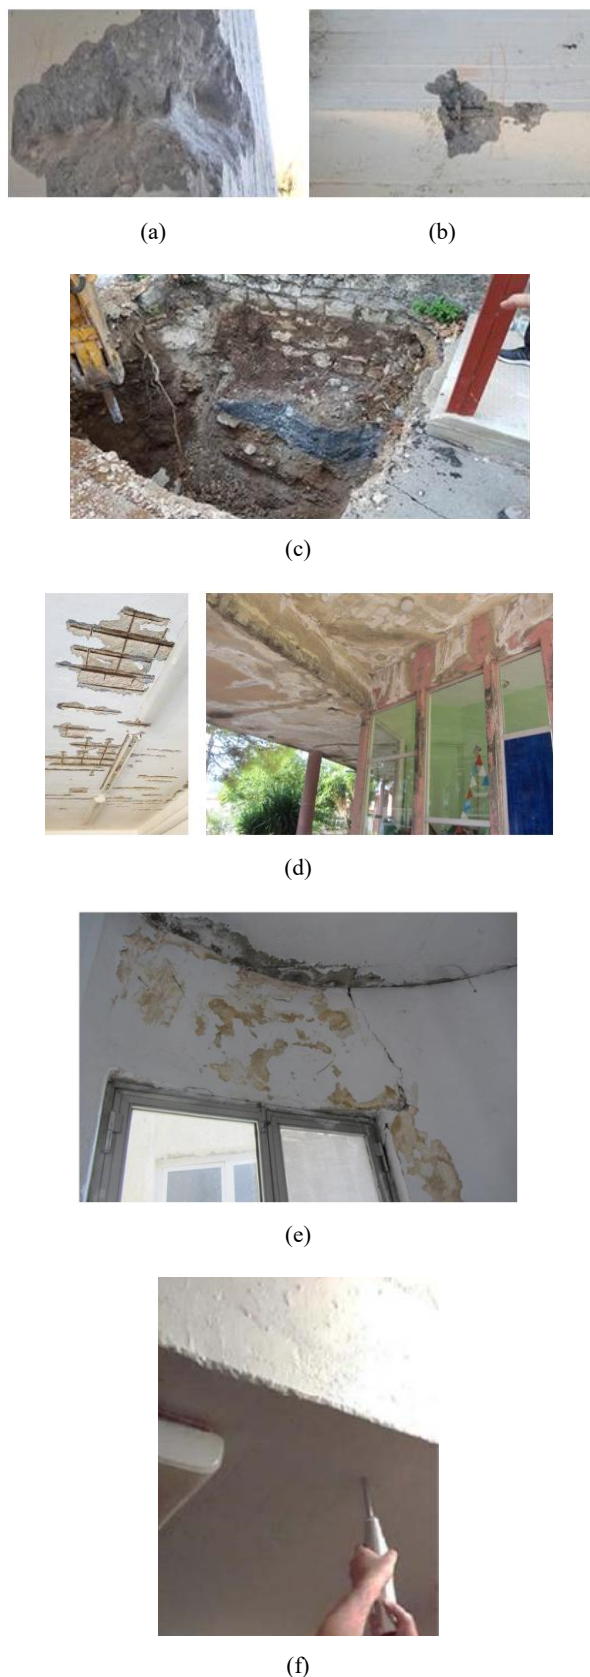
The main objectives of this study were to evaluate the structural adequacy and plan a retrofit of Buildings II and IV, as well as to perform a seismic assessment according to KAN.EPE [1]. In-situ, non-destructive and destructive tests were conducted to further assess the structural condition and details. The cover was removed in order to assess the reinforcement at selected column and beam locations. Locations from the initial construction phase and from the concrete jacketing intervention were accessed in order to verify reinforcement details, as shown in Figs. 3 (a) and (b). A sample excavation was performed to reveal the foundations in a column of Building IV, as presented in Fig. 3 (c). Areas with localized damage were also inspected, as shown in Figs. 3 (d) and (e).

Fig. 3 Disclosure of steel reinforcement materials (a,b), disclosure of the foundation in a column (c), localized damage (d,e), and a non-destructive test (f)

The experimental results from the non-destructive and destructive tests indicated that the compressive strength of the concrete varied with both the structural element and the time period of its incorporation into the structure. More specifically, the average compressive strengths of cube specimens from the floor slabs of A' and B' in Buildings I, II, and III were 24.60 MPa and 26.22 MPa, respectively. They exhibited standard deviations of 5.99 MPa and 4.50 MPa, respectively. The average compressive strength of concrete in the beams within Building II was 26.86 MPa. The concrete specimens from the folded concrete slab shell from the ground floor of Building IV presented an average compressive strength of 15.33 MPa and standard deviation of 4.31 MPa. The compressive strengths of the concrete jackets placed around columns and beams during the strengthening project were even lower. The average compressive strength of these cube specimens was 15.14 MPa, with a standard deviation of 3.19 MPa. This differentiation in compressive strength between the old and the new concrete was also confirmed via in-situ non-destructive tests with the Schmidt hammer in the relevant positions.

The configuration of the reinforcement materials was captured via local disclosure of steel rebar. Ribbed steel rebar of quality StIII with an average tensile strength $f_{ym} = 460$ MPa was identified in the main steel reinforcement. Smooth steel rebar of quality St I with an average tensile strength $f_{ym} = 260$ MPa was identified for the stirrups. Typically, the steel rebar in the supports for the Building IV slab (edge of beam) presented surface corrosion. In addition, significant moisture was noted on the surface of the concrete in the same positions. Corrosion activity was tested by measuring the half-cell potential of the steel reinforcement. The experimental results indicated that the probability of corrosion was over 90% for 54% of the surface of the soffit floor of Building I. The probabilities of corrosion were lower in the soffit slabs of Buildings II and III. Higher concrete carbonation depths were observed in the unprotected parts of the slab near the supports. The long period of abandonment and low-intensity use of the building complex had significant effects on its durability in the face of environmental factors. Despite the successful crack repairs, the ensuing lack of maintenance led to development of moisture, gradual corrosion of some elements, and detachment of the concrete cover. The corrosion half-cell potential measurements indicated further evolution of corrosion, leading to progressive degradation of the load-bearing capacity of the structure.
