# Structural Analysis and Strengthening of the National Youth Foundation Building in Igoumenitsa, Greece

Chrysanthos Maraveas, Argiris Plesias, Garyfalia G. Triantafyllou, Konstantinos Petronikolos

**Abstract**—The current paper presents a structural assessment and proposals for retrofit of the National Youth Foundation Building, an existing reinforced concrete (RC) building in the city of Igoumenitsa, Greece. The building is scheduled to be renovated in order to create a Municipal Cultural Center. The bearing capacity and structural integrity have been investigated in relation to the provisions and requirements of the Greek Retrofitting Code (KAN.EPE.) and European Standards (Eurocodes). The capacity of the existing concrete structure that makes up the two central buildings in the complex (buildings II and IV) has been evaluated both in its present form and after including several proposed architectural interventions. The structural system consists of spatial frames of columns and beams that have been simulated using beam elements. Some RC elements of the buildings have been strengthened in the past by means of concrete jacketing and have had cracks sealed with epoxy injections.

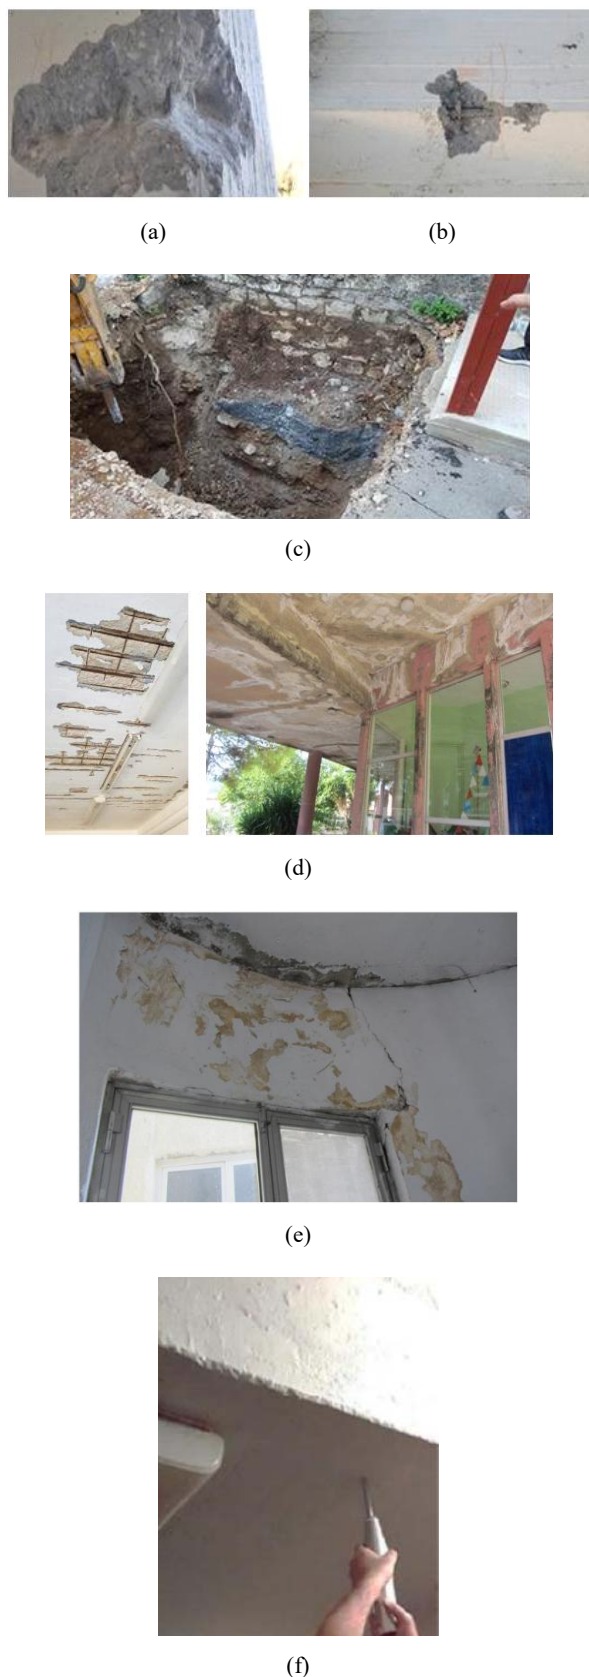
The main objectives of this study were to evaluate the structural adequacy and plan a retrofit of Buildings II and IV, as well as to perform a seismic assessment according to KAN.EPE [1]. In-situ, non-destructive and destructive tests were conducted to further assess the structural condition and details. The cover was removed in order to assess the reinforcement at selected column and beam locations. Locations from the initial construction phase and from the concrete jacketing intervention were accessed in order to verify reinforcement details, as shown in Figs. 3 (a) and (b). A sample excavation was performed to reveal the foundations in a column of Building IV, as presented in Fig. 3 (c). Areas with localized damage were also inspected, as shown in Figs. 3 (d) and (e).

Fig. 3 Disclosure of steel reinforcement materials (a,b), disclosure of the foundation in a column (c), localized damage (d,e), and a non-destructive test (f)

The configuration of the reinforcement materials was captured via local disclosure of steel rebar. Ribbed steel rebar of quality StIII with an average tensile strength  $f_{ym} = 460$  MPa was identified in the main steel reinforcement. Smooth steel rebar of quality St I with an average tensile strength  $f_{ym} = 260$  MPa was identified for the stirrups. Typically, the steel rebar in the supports for the Building IV slab (edge of beam) presented surface corrosion. In addition, significant moisture was noted on the surface of the concrete in the same positions. Corrosion activity was tested by measuring the half-cell potential of the steel reinforcement. The experimental results indicated that the probability of corrosion was over 90% for 54% of the surface of the soffit floor of Building I. The probabilities of corrosion were lower in the soffit slabs of Buildings II and III. Higher concrete carbonation depths were observed in the unprotected parts of the slab near the supports. The long period of abandonment and low-intensity use of the building complex had significant effects on its durability in the face of environmental factors. Despite the successful crack repairs, the ensuing lack of maintenance led to development of moisture, gradual corrosion of some elements, and detachment of the concrete cover. The corrosion half-cell potential measurements indicated further evolution of corrosion, leading to progressive degradation of the load-bearing capacity of the structure.

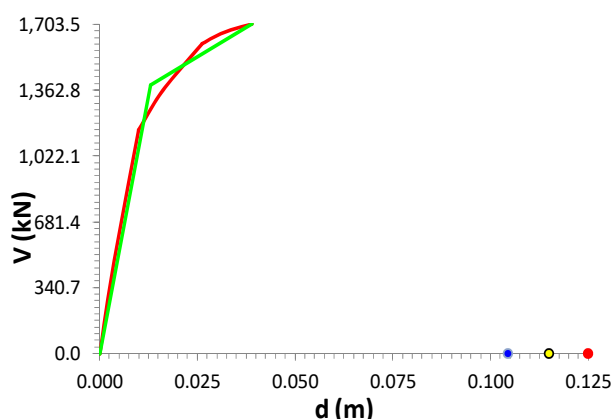
average relative displacement between the nodes of the floor, the average relative displacement at x floors, the average relative displacement at z floors and the morphological regularity of the building were not satisfied. However, the criterion that references the upper limits of the building eigenperiods was satisfied. Based on these results, the only feasible method of further evaluation was the inelastic static method (pushover). Pushover analysis confirmed the results of the preliminary test with regard to the inability of the building to withstand seismic deformation at the selected performance level (B1). For at least one load combination, the building was unable to reach the design displacement limit and collapsed as mechanism. This case concerns triangular load distribution of the seismic combination  $F_x+0.3F_z$ . As can be seen in Fig. 6, the building is unable to reach the target displacement.

Fig. 6 Force–displacement curve of Building II for a triangular load distribution of the seismic combination  $F_x+0.3F_z$

The main direction of the earthquake changes the requirements for retrofitting and strengthening of the vertical elements significantly. It is obvious that the overall stiffness in the transverse x direction (East–West) is reduced due to the formation of the structure (thin, elongated North–South concrete walls). In summary, Building II required structural strengthening measures in each case, as the structure could not carry the seismic load and meet the minimum requirements for performance level B1.

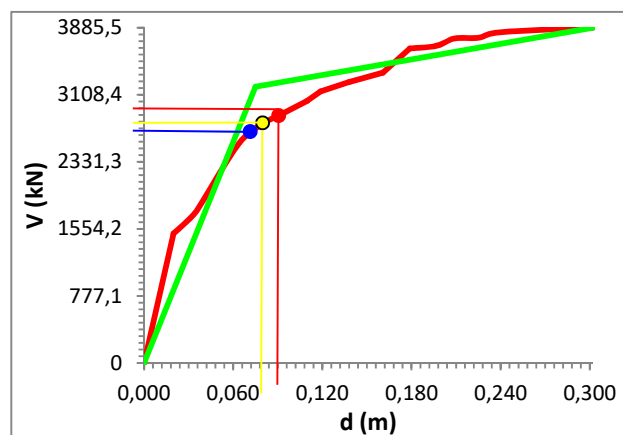
confirmed the significant number of plastic hinge positions and hence the retrofit requirement identified by the preliminary analysis. The results indicate that the direction of the earthquake does not affect the retrofits that are required. In conclusion, Building IV exhibited damage to several structural elements. Retrofitting and strengthening are thus required. The locations where strengthening is required include existing strengthened elements, including beams. This introduces additional difficulties. The force-displacement curve of Building IV for a triangular load distribution of the seismic combination  $F_x+0.3F_z$  is illustrated in Fig. 7.

Fig. 7 Force-displacement curve of Building IV for a triangular load distribution of the seismic combination  $F_x+0.3F_z$

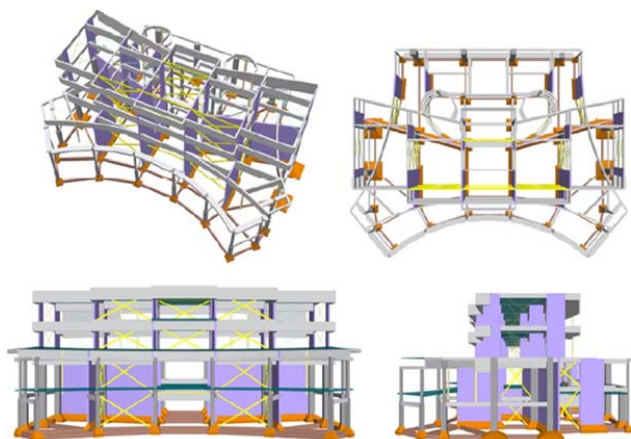
Fig. 8 Building II strengthening proposal with type X steel braces for modeling purposes. The type  $\Lambda$  steel braces allow the access under them

The analytical results indicate that solution c) is the most efficient, as it lets the building achieve the design displacement for each load combination, the global response is improved, and point interventions are reduced. The retrofitting scenario proposed for Building II is shown in Fig. 8.

For Building II, the plan is to strengthen the slabs with shotcrete concrete with embedded steel reinforcement and to strengthen beams and ground floor concrete walls via concrete jacketing. The reinforcement design also calls for construction of an entrance ramp and demolition of the canopy roof and stairs. Furthermore, the corroded concrete surfaces are to be repaired by applying anti-corrosion measures. The structural interventions for the construction of the new frame elements to be inserted between the RC elements include type  $\Lambda$  or K steel braces that consist of horizontal and vertical elements, as well as diagonal configuration links of the desired morphology. The total cost of restoring and strengthening Building II is thus estimated to be approximately 450.000€.

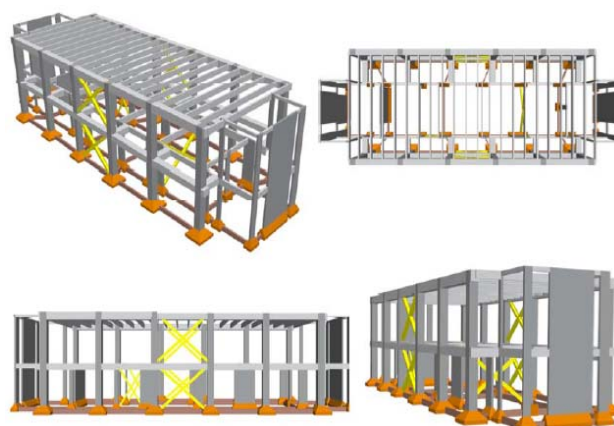
Fig. 9 Building IV strengthening proposal with type X steel braces for modeling purposes

The analytical results indicate that solution c) is the most efficient, as it provides better building performance. The number of point interventions is reduced and most importantly, retrofitting of members that were previously strengthened via concrete jacketing is avoided. A presentation

The retrofit plan for Building IV includes strengthening the slabs with shotcrete concrete, demolishing concrete surfaces, and repairing corroded concrete surfaces by applying anti-corrosion measures. Two scenarios are proposed for strengthening of the beams and concrete walls. The first includes construction of concrete jacketing for both beams and concrete walls, while the second includes concrete jacketing for beams and construction of new metal frames and concrete elements. The total cost of restoring and strengthening Building IV following the first scenario is estimated to be approximately 200.000€, whereas the cost of the second scenario is estimated to be approximately 210.000€.
