Metallurgical Analysis of Surface Defect in Telescopic Front Fork

Souvik Das, Janak Lal, Arthita Dey, Goutam Mukhopadhyay, Sandip Bhattacharya

Keywords—Telescopic front fork, induction welding, hook crack, internal oxidation.

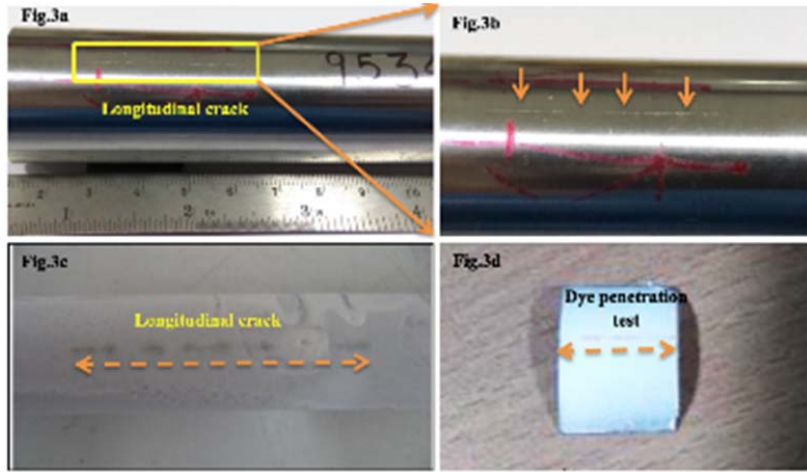
Sample #1: Visual observation of the failed fork showed small longitudinal crack along the length of the tube at the circumference close to the weld (Figs. 3 (a) and (b)). The crack was about 4 cm in length and very thin and difficult to detect easily. Crack was very shallow in depth and difficult to detect, so it was detected by dye penetration test (Figs. 3 (c) and (d)).

Fig. 3 (a) and (b) Longitudinal crack along the length of the tube, longitudinal crack was detected through dye penetration test

Sample #1: Visual observation of the failed fork tube showed presence of small cracks along the length of the tube at the circumference adjacent the weld flow lines. The crack was about 5 cm in length. The unetched microstructure of crack showed 'J' type hook crack [1], [2]. MnS inclusions were observed in the vicinity of the crack. The overall MnS inclusion was high as shown in Table III. Microstructural analysis further revealed that the hook of the crack was turning toward upward surface. The originator of hook crack is non-metallic inclusion primarily MnS stringers. These flattened non-metallic inclusions are formed during hot rolling of plate. They reduce the ductile toughness of the steel even in their normal position but do not affect the yield or tensile strength of the steel [3]. So, the mechanical properties of the tube under investigation were also satisfactory. Near bondline, these weak layers reorient themselves in such a way that they become subjected to tensile hoop stress when the pipe is pressurized [4] and a small crack originates. The slight upset of the metal at the weld acted to turn the ends of this usually very small subsurface crack in the direction of the upset. Because the metal flow during the upset is toward the both surfaces. The hook of the hook crack may turn toward either the outside or inside surface, depending on which the

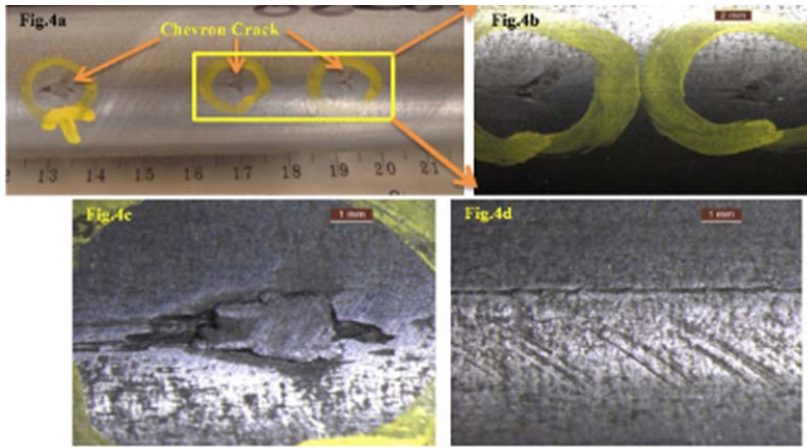
Sample #2: General view of the tube sample with defect is shown in Fig. 4 (a). Multiple chevron marks were observed on the surface of the tube. These chevron marks were found to form a single line (Figs. 4 (a) and (b)). Similar marks with less severity and a line mark running through centre of these defects were observed at 180-degree location (Fig. 4 (a)).

Fig. 4 (a)-(c) Chevron cracks on the surface of the tube, (d) Less severity defects were observed at 180-degree location of the chevron crack

Sample #2: Repeating chevron marks were observed to form a single line at certain interval on the tube surface. Similar marks with less severity and a line mark running through centre of these defects were observed at 180-degree location. Closer observation of the chevron marks in stereo microscope shows accumulation of material at centre of the chevron. Optical microscopy shows grain deformation at the defect contour indicating cold stage deformation. Based on the repetitive nature of the defect, it appears to be originating from the drawing stage itself and that too at exactly diametrically opposite locations of the tube. Decarburised grains along with internal oxidation associated with dark brown entrapment were observed along the cracks. Presence of mould powder entrapment inside the material indicates origin of the defect from slab stage. The morphology and location on the tube suggests that the steel defect got aggravated during drawing forming the chevron mark. Mold powder entrapment mainly occurs in the so-called “transient casting” periods, e.g. the time of casting start, casting end, ladle exchange, mold width change, SEN change, etc. During the unsteady casting periods, usually, the casting speed is largely varied, which disturbs the flow of the liquid steel in the mold and results in severe level fluctuation. Hence, mold powders are easy to be carried into the liquid steel, and some are entrapped by the solidified shell

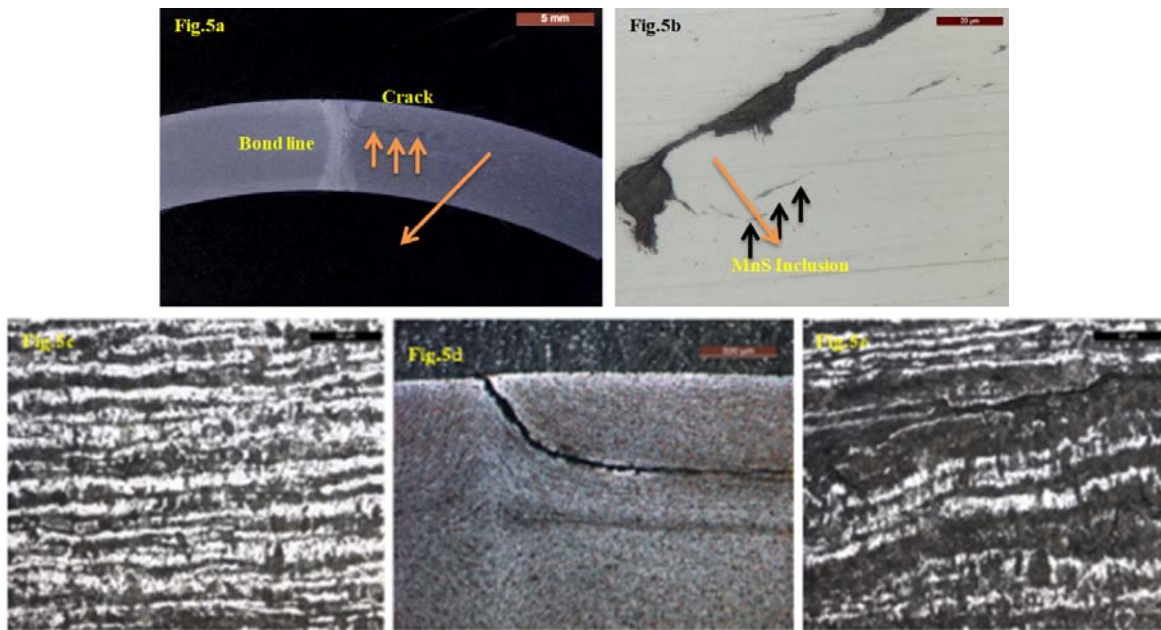
Fig. 5 (a) Chevron cracks on the surface of the tube, (b) Un-etched micro image of the defect location, (c)-(e): Etched micro image of the defect location at different magnifications

Sample #1: The un-etched microstructure showed a crack, 'J' type in shape and of 0.5 mm in depth (Fig. 5 (a)), typical to hook cracking [1]. Further the crack was found to be associated with some non-metallic manganese sulfide (MnS) inclusions (Fig. 5 (b)) which were further confirmed through EDS analysis. The macro dual zoom photograph of the micro sample revealed white bond line associated with the crack (Fig. 5 (c)). The 3% nital etched microstructure showed that the crack was slightly offset from the bond line of the Cold drawn Electric resistance Welding (CEW) seam (Fig. 5 (a)), but following the weld flow lines and opened up at the circumference. The hook of the crack turned toward upward, as shown in Fig. 5 (d). The weld flowline of the tubes was compatible to the cold drawn structure (Fig. 5 (d)), and the matrix revealed banded ferrite pearlite structure (Figs. 5 (c) and (e)) common to such high manganese structural steel

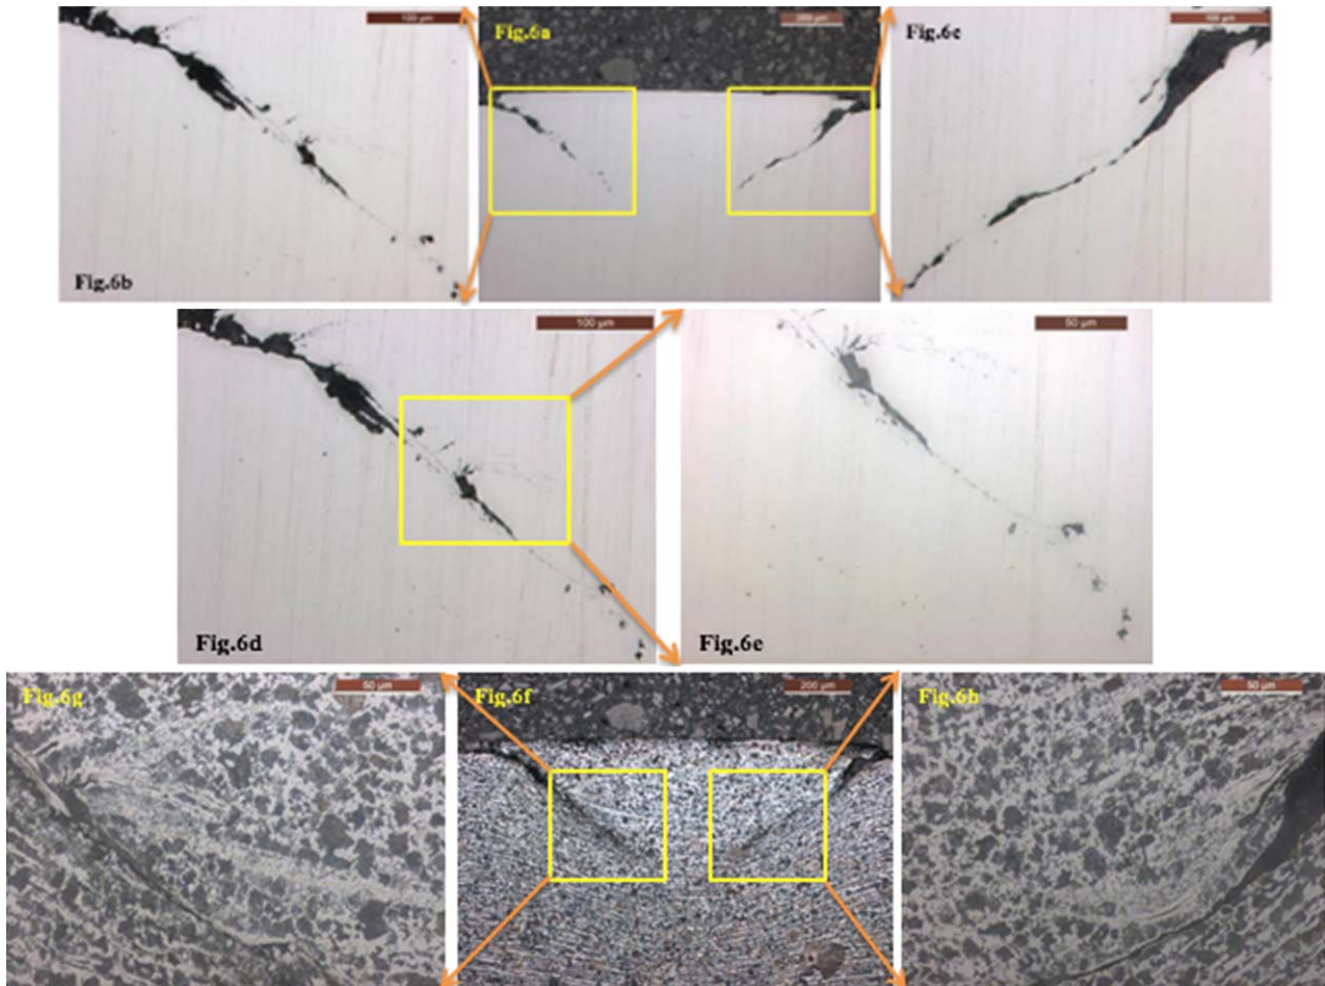
Sample #2: Un-etched micro image of the samples from defect area revealed bowl shaped defect. This was formed by chipped-off material as shown in Fig. 6 (a). Figs. 6 (b) and (c) show closer view of the cracks on both edges of the defect. It can be observed that the cracks contain some non-metallic entrappings in it. At higher magnification, as shown in Fig. 6 (e), suspected internal oxidation can be observed in chipped-off material.

The etched microstructure at the defect location is shown in Fig. 7 (a). Banded ferrite - pearlite structure was observed which followed the contours of the defect/chipped-off material. At higher magnification, decarburised grains were observed along the suspected internal oxidation. The chipped-off material does not show any banding or deformation. However, due to accumulation of this material, grains in the matrix below, it got deformed which is cold condition effect.

Fig. 6 (a)-(d) Un-etched micro image of the defect location at different magnifications, (e) Presence of dark brown entrainment along with internal oxidation (f)-(h) Etched micro image of the defect location at different magnifications

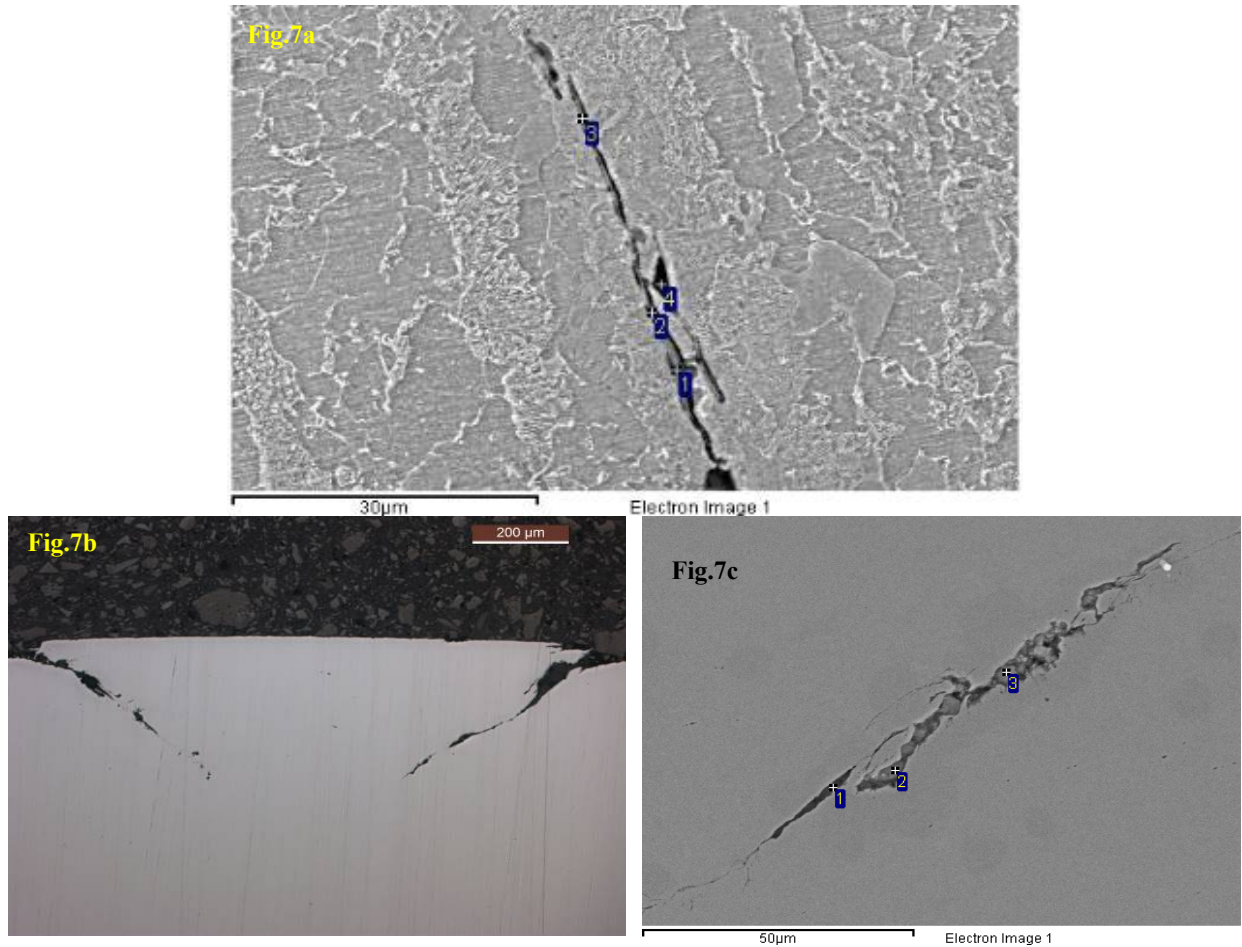
Sample #1: EDS analysis was carried out on non-metallic inclusion by Scanning Electron Microscope at an accelerating voltage of 15 kV. EDS analysis confirmed the inclusions as

MnS (Fig. 7 (a), Table II). Then, inclusion rating was also carried out by ASTM E 45 method to check overall cleanliness of the steel. The inclusion rating, shown in Table III, revealed higher MnS inclusions in steel.

Fig. 7 (a) EDS analysis of sample#1 at cracked location, (b) and (c) EDS analysis of sample#2 at defect location

Sample #2: EDS analysis of the dark brown entrapment revealed prominent peaks of Ca, Si, Al, Na, F and O which proves that crack has generated due to mould powder entrapment.

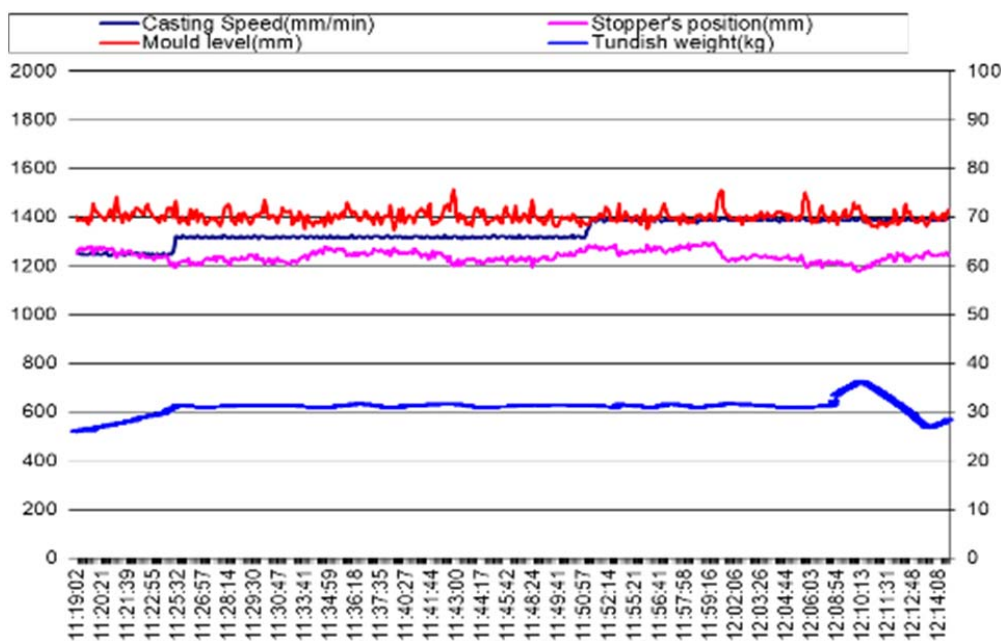
Fig. 8 Casting parameters for sample #2

and exist as non-metallic inclusions in slabs. If the interfacial velocity of steel melt which exceeds tear off velocity results in associated shear stress to become greater than the cohesion forces of the slag. Slag gets torn off and carried over in the form of droplets in the liquid metal. While a part of these droplets immediately floats back towards the meniscus, another part is transported by the metal flow and scattered in the liquid pool [7]. In case of sample #2, it has been observed that higher severity index in this coil is explained due to unstable stopper position shown in the caster (Fig. 8). As seen from the chart given for this slab, there are large fluctuations in casting speed along with large mold level fluctuations. Hence, changing stopper position causes unstable molten steel flow and so entrapment of mold powder.
