Diagnosis of Intermittent High Vibration Peaks in Industrial Gas Turbine Using Advanced Vibrations Analysis

Abubakar Rashid, Muhammad Saad, Faheem Ahmed

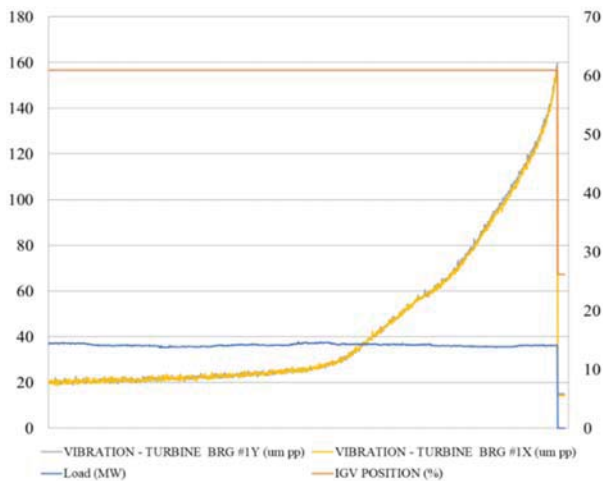
ambient conditions etc. were trended to find any irregularity or deviation from the normal baseline data (as shown in Fig 2). The only observation was the gradual increase in Bearing#02 vibrations to 76µm pp at the time when Bearing#01 cross the trip limit of 155µm pp. No other anomaly was found in any of the other parameter during the analysis. After necessary checks by machinery, instruments & electrical teams, GT was successfully started again on 30th October, 2018 at 1350 Hrs.

Fig. 2 (a) Bearing#01 vibrations trend against Load & IGW

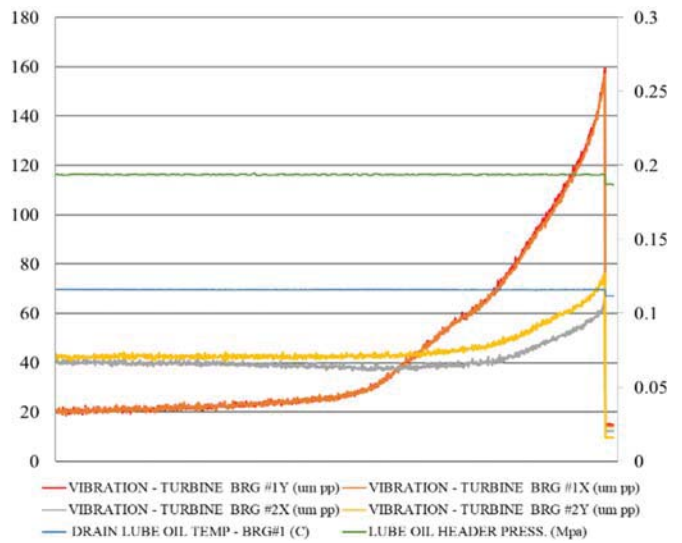
Fig. 2 (b) Turbine Bearings vibration trend against Lube oil drain temperature & header pressure

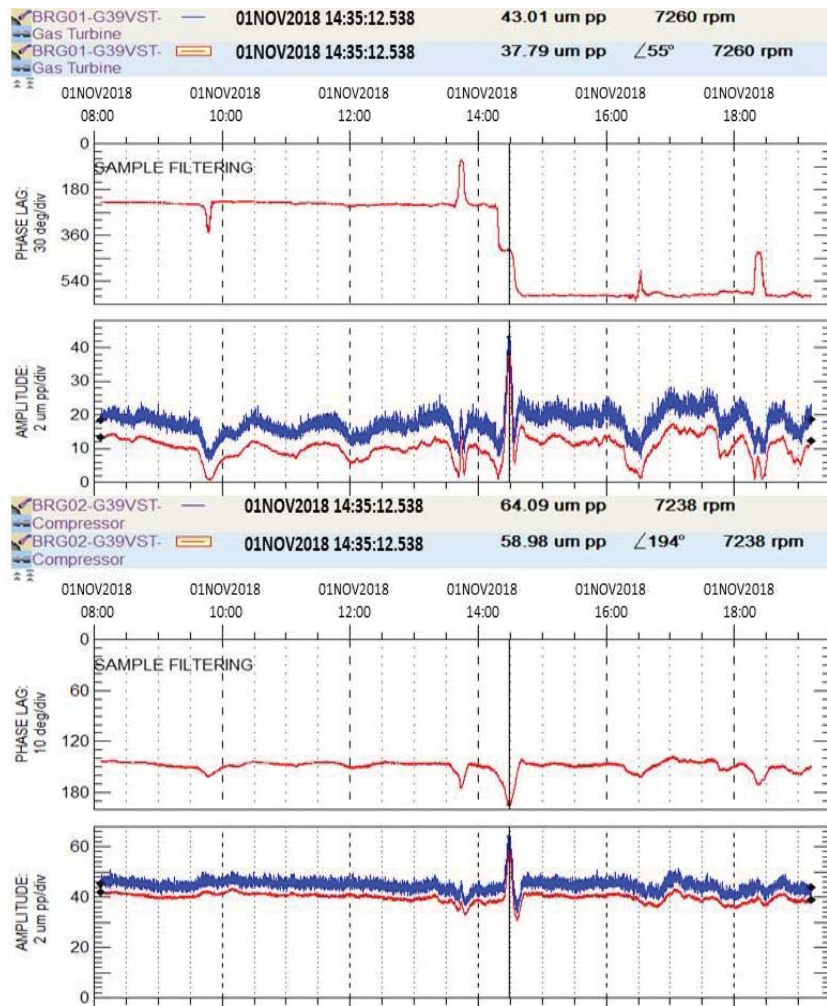
Vibration peaks was observed during steady state data recorded on 1st November 2018. Vibration peak was recorded at 1435hrs up to 40.09 & 35.54µm pp at Turbine Bearing#01 against normal vibrations of 22 & 24µm pp & at Turbine Bearing#02 up to 64.09 & 58.98µm pp against its normal trend of 43 & 45µm pp. As per vibration trend data, vibration peaks were observed to appear at different times & the peak lasted for duration of approximately 15 minutes (as shown in Fig. 3).

Fig. 4 (a) Time base trend of Bearing#01 & 02 with Phase angle

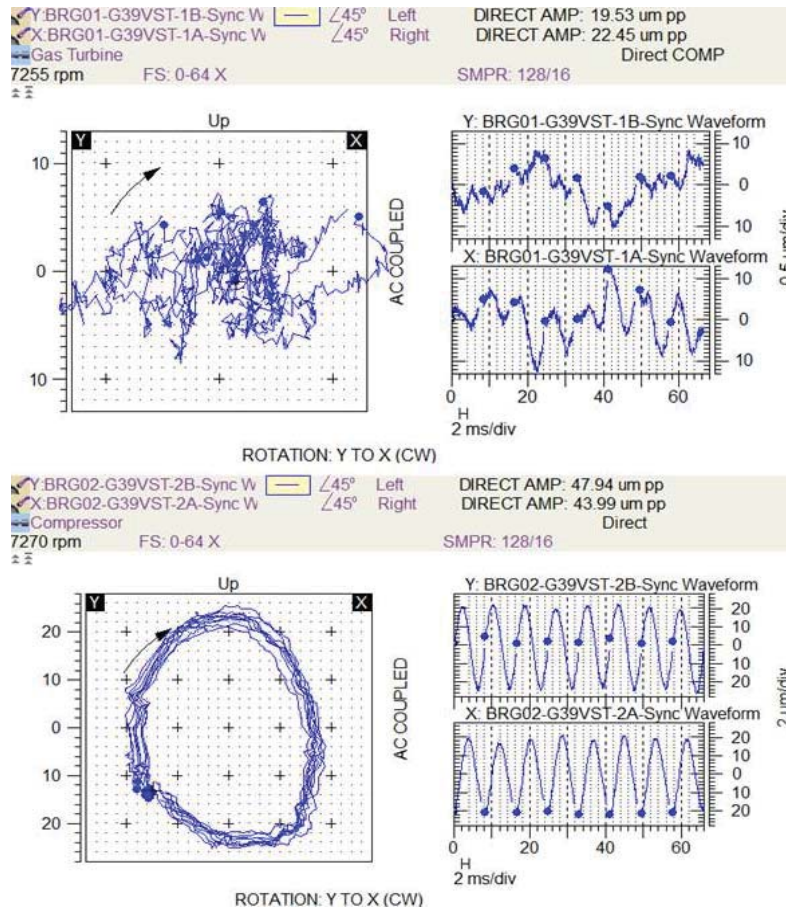
Based on the data gathered from ADRE SXP, there was a vibration increase with high 1X rpm response & 1X phase change [6], [7] is most probably suspected due to intermittent rubbing either in Turbine NDE bearing or bearing seals. Rubbing in the bearing oil (labyrinth) seal may be caused by

Fig. 4 (b) Orbit Plot of Turbine bearings showing rubbing symptoms at Bearing#01

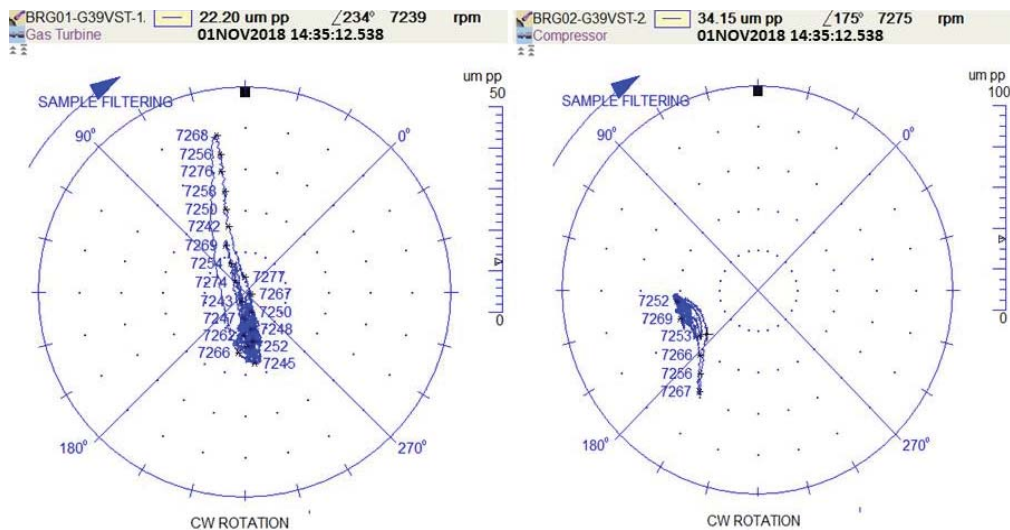
Basic rotor dynamic theory [3] states that when rotating at constant speed, rotor synchronous response remains constant, both in amplitude & phase. The occurrence of phase changes at constant speed could be caused by several different things, including rubs between stationary & rotating parts, angular shift of shrink fit components, a crack propagating through the rotor. In this case almost all vibration change was observed at frequency of 1X Turbine rpm while significant change in 1X phase (up to full 360° rotation) was also observed at Bearing#01 which most probably corresponds to symptoms of rubbing [4] (as shown in Fig 4). Also, as per shaft centerline plot, movement of rotor in horizontal plane was evident at Bearing#01 (as shown in Fig. 5)

Fig. 4 (c) Polar Plot of Turbine bearings showing phase change of almost 360° at Bearing#01

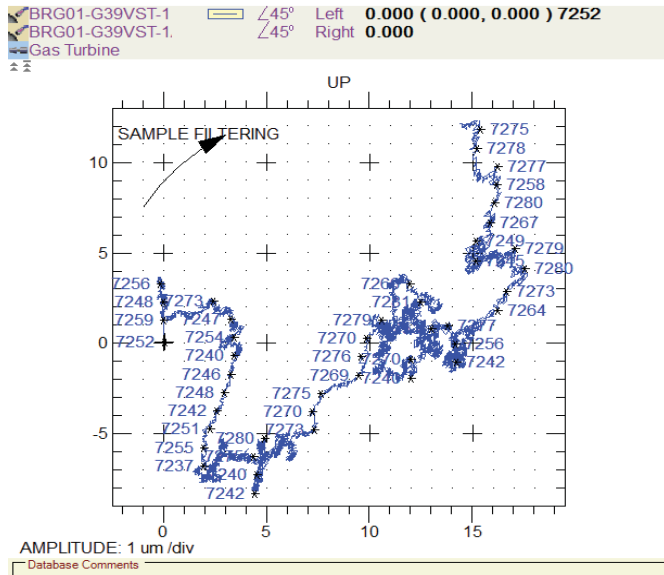
Fig. 5 Time base trend of Bearing#01 & 02 with Phase angle

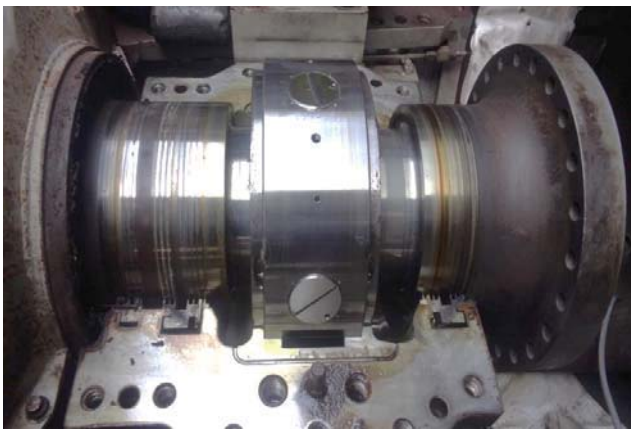
Fig. 6 Bearing#01 with housing upper half removed

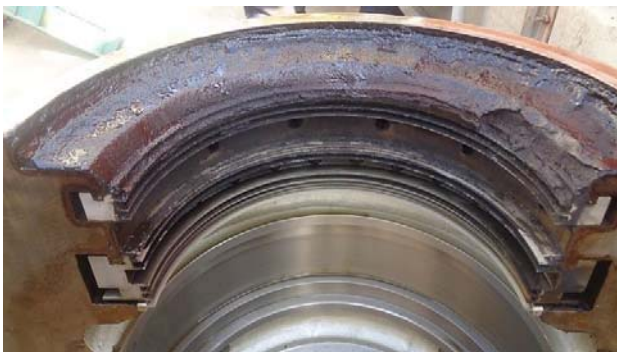
At Bearing#01, two labyrinth seal sets installed in the bearing housing each on forward & after side. In the forward side labyrinth seals clear rubbing marks were present, covering around 25 degrees in the inner radius of bearing housing. The bearing pedestal end & labyrinth seal close to turbine side had excessive coke deposition. A layer of coke varying in thickness from 5 mm on outer radius to 2 mm on inner radius was formed on the forward side bearing pedestal face. The cavities of the first set of labyrinths were completely choked because of heavy coke deposition. This coke was brownish black & was hard but not tough. There was a small area from that layer where coke was removed showing signs of an impact load (as shown in Fig. 7). Coke deposition was also observed on the after-side labyrinth seals, but the severity of deposition was comparatively less. However, the mechanical integrity & geometric profile of labyrinth seals were intact & they were installed back after thorough cleaning followed by inspection.

Fig. 7 Heavy coke deposition, rubbing marks on Bearing#01 housing

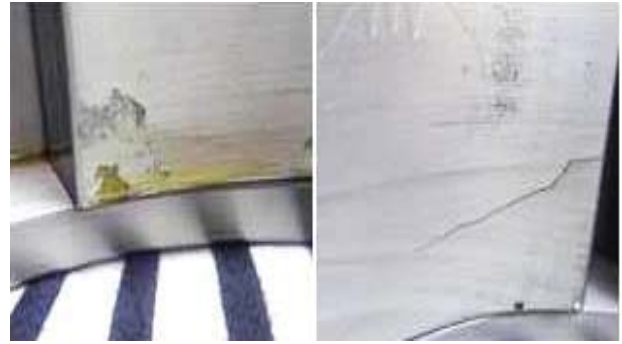
Two out of three shoes in the upper half of the bearing had symptoms of damage on the Babbitt layer. One shoe had a crack on the Babbitt while the other had pitting across its ends (as

shown in Fig. 8). The two shoes in lower half of the bearing had signs of rubbing, oil patches & Babbitt discoloration. The observations on the Bearing#01 pads were quite usual for a bearing with equivalent operating hours of more than eighty-

Fig. 8 Pitting and cracks on Babbitt layer of Bearing#01

After thorough cleaning & following the all quality hold points, new bearing was installed at location. Quality check measurements like semi height, bearing crush & radial clearance were also taken. The radial clearance of bearing was maintained at 0.45mm (shaft journal OD: 184mm). Bearing#02 was also inspected & did not have excessive coke formation like Bearing#01. The radial Bearing#02 at the driving end had minor signs of rubbing & oil marks. Its condition was comparatively better but replaced with new one with the top clearance of 0.40 mm. The thrust bearing was healthy & installed back after quality checks & inspection. Before final box-up, cooling & sealing air lines were thoroughly blown with instrument air to remove any suspected choking & installed back.

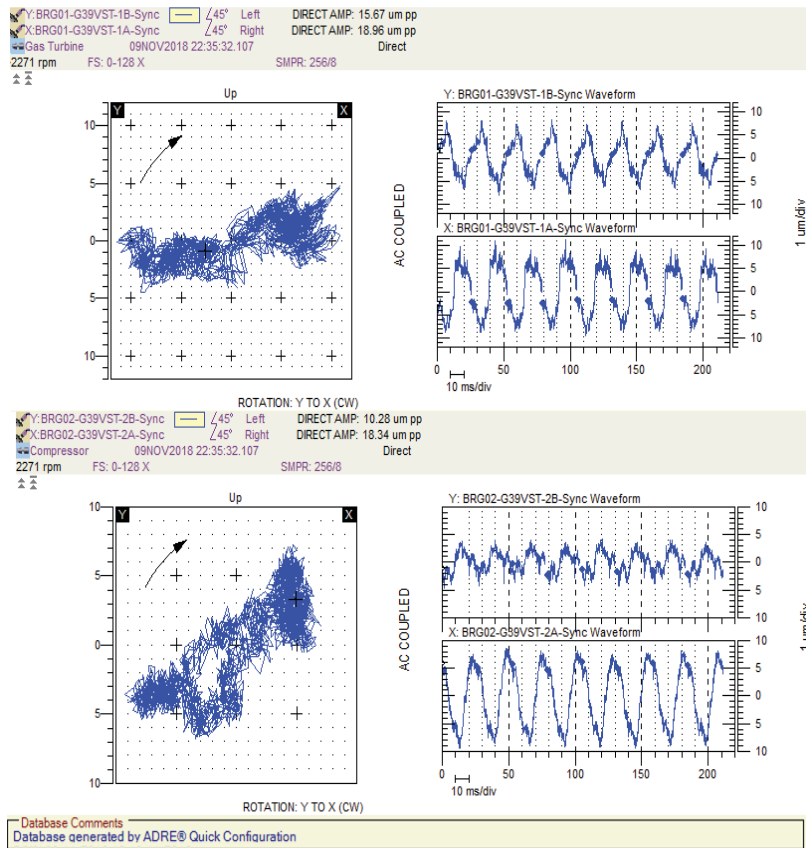
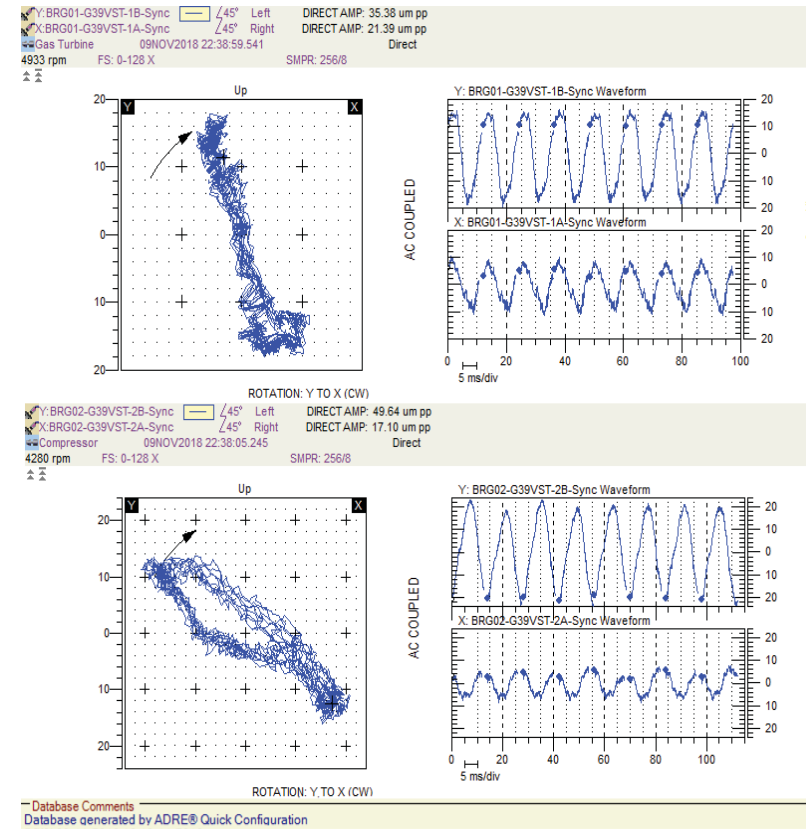
directly related to increasing machine speed, therefore unbalance was not suspected as the cause of vibration & the 1X vibration most probably was related to shaft bow condition during the machine start up. Orbit plots were found indicating 1X orbits & remained highly flat/elliptical throughout speed range from 2000 rpm to 5000 rpm (as shown in Fig. 9) suggesting possible rub during coast up. At operating speed i.e.

Fig. 9 (a) Orbit plot of turbine bearings at 2271 rpm

Fig. 9 (b) Orbit plot of turbine bearings at 4933 rpm

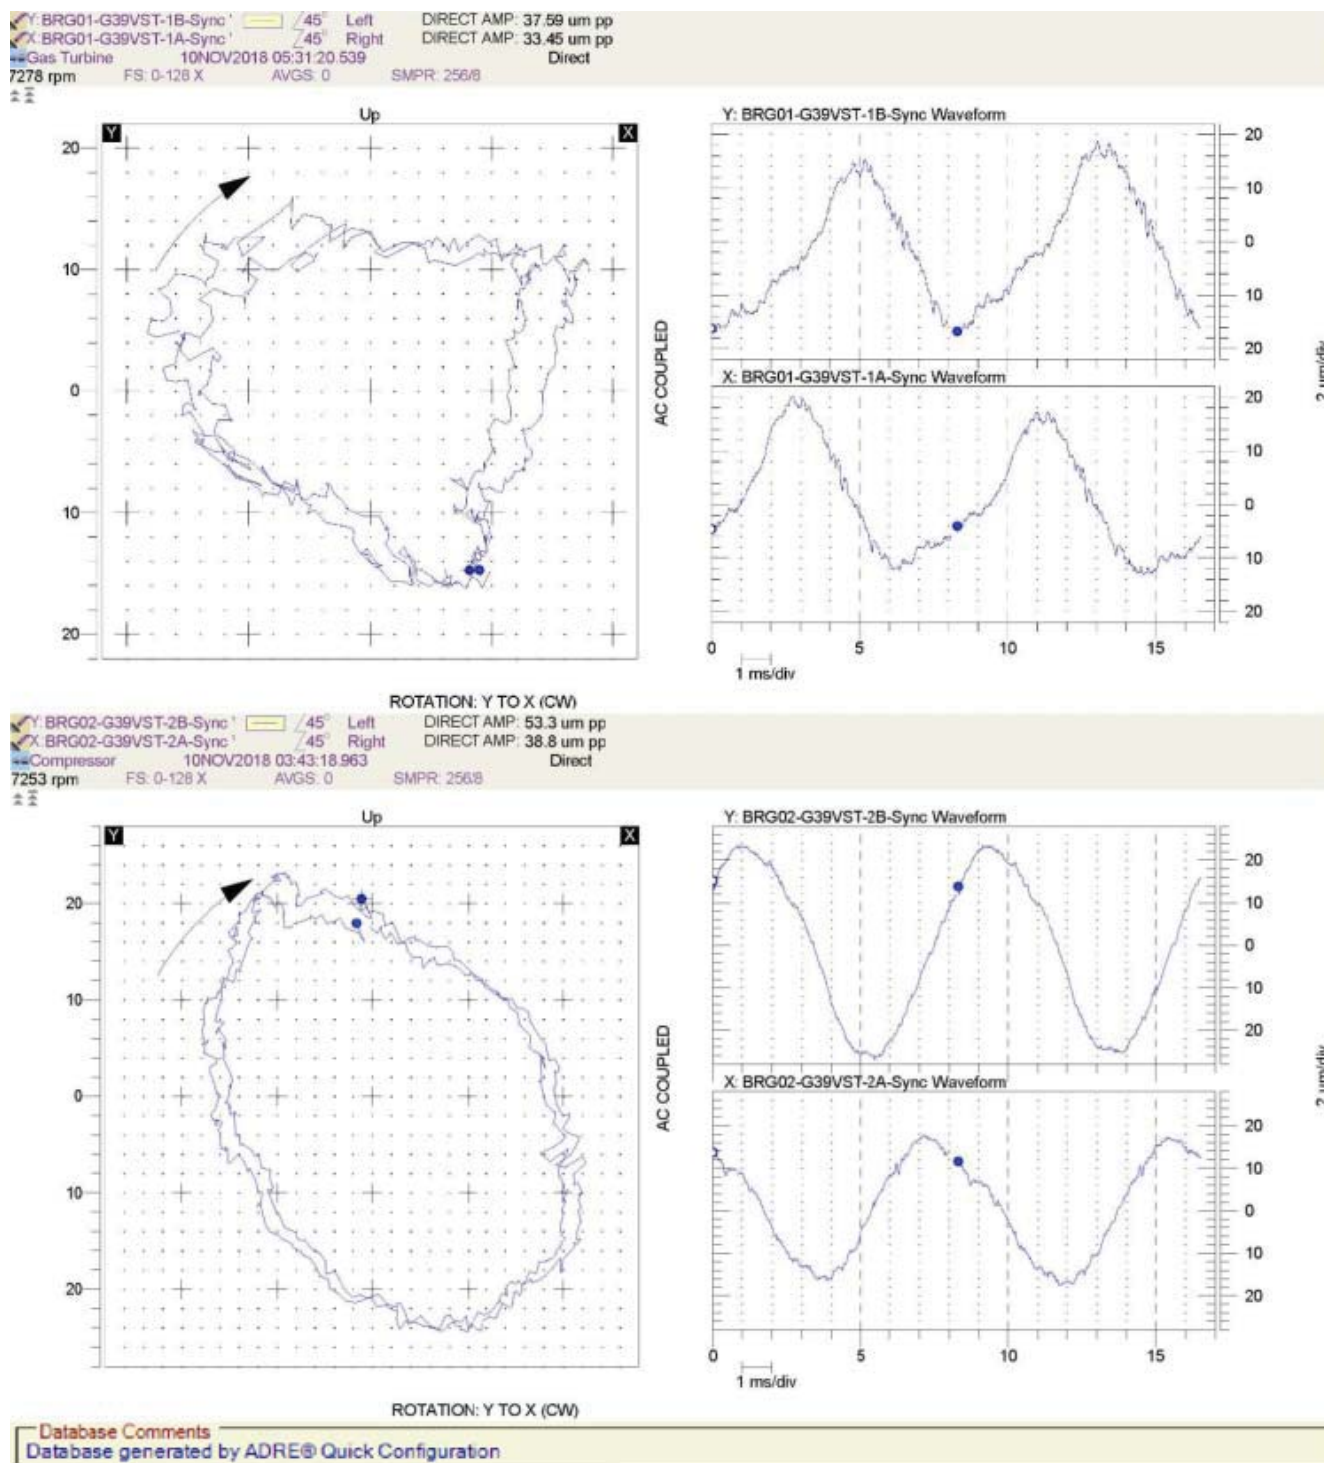
7272 rpm no such observation was found in 1x orbit plots (as shown in Fig. 10). As per Shaft center line plots, maximum shaft vertical upward movement of 134 microns was observed at Turbine NE Bearing#01 when machine was loaded from FSNL to 21 MW, which was within bearing clearance boundaries (as shown in Fig 11).

Fig. 10 Orbit plot of turbine bearings at 7278 rpms

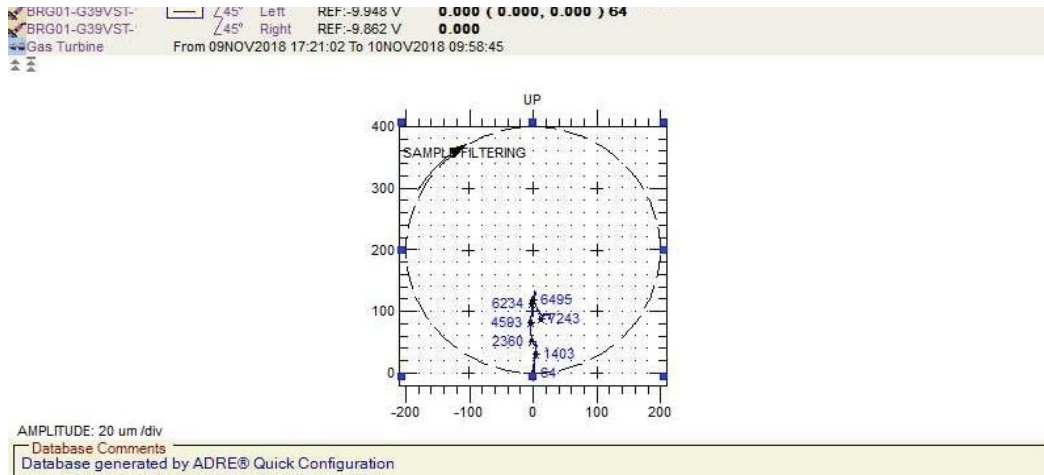
Fig. 11 Shaft Centre line of Bearing#01 after bearing replacement

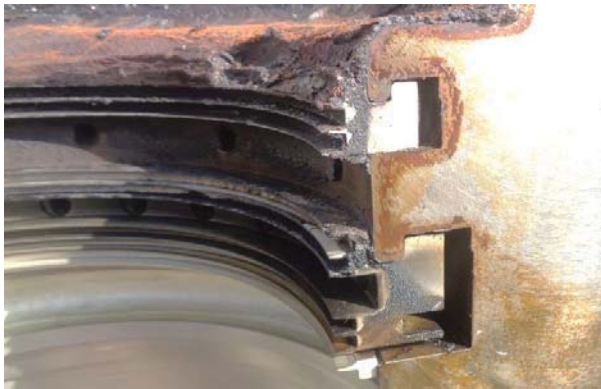
In the subject case puddle formation was observed in the labyrinth of the bearing housing (as shown in Fig. 12). Puddles form from high surface to volume ratio of lube oil layers & by long residence time of oil in a cavity. Physically it's in form of thick chunks of varying size & hardness depending on the age of coking. Its surface texture varies from shiny to matte like finish.

Fig. 12 Physical texture of Coke puddles

Although coke formation is more of an aging phenomenon and be addressed by timely planning the maintenance of components exposed to lube oil circuit, there are some design phase measures to prevent this from happening. One technique is to introduce scavenge or vent lines in the gas path, this can significantly reduce deposits. Secondly, some coking tests have demonstrated powerful predictive capability and are essential during oil formulation and development phases of lubrication

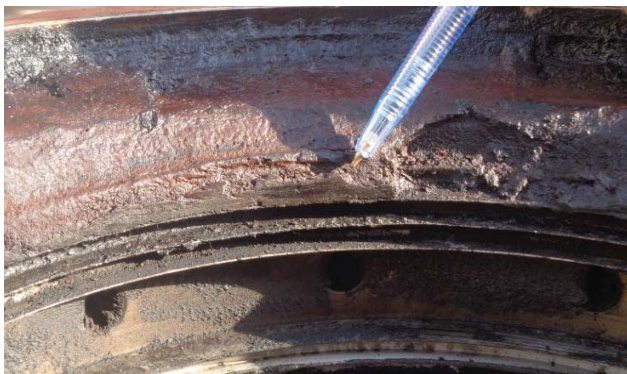
Fig. 13 Shedding of coke deposits after getting rubbed
