Failure Analysis of a Medium Duty Vehicle Leaf Spring

Gül Çevik

Abstract—This paper summarizes the work conducted to assess the root cause of the failure of a medium commercial vehicle leaf spring failed in service. Macro- and micro-fractographic analyses by scanning electron microscope as well as material verification tests were conducted in order to understand the failure mechanisms and root cause of the failure. Findings from the fractographic analyses indicated that failure mechanism is fatigue. Crack initiation was identified to have occurred from a point on the top surface near to the front face and to the left side. Two other crack initiation points were also observed, however, these cracks did not propagate. The propagation mode of the fatigue crack revealed that the cyclic loads resulting in crack initiation and propagation were unidirectional bending. Fractographic analyses have also showed that the root cause of the fatigue crack initiation and propagation was loading the part above design stress. Material properties of the part were also verified by chemical composition analysis, microstructural analysis by optical microscopy and hardness tests.

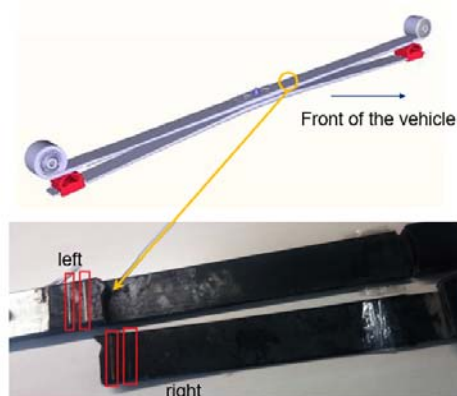
Location of failure is shown on Fig. 1. A complete separation of the upper leaf spring has occurred on vehicle due to fracture. Failure has occurred near to the center to the front side of the leaf. Red rectangles on the picture show the material verification test sample locations.

Fig. 1 Failure location

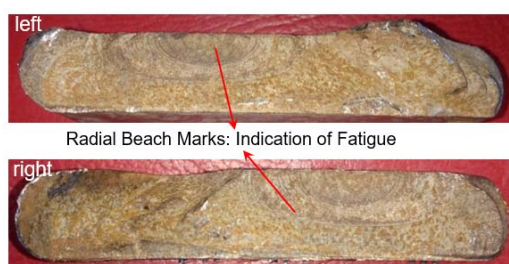
Fracture surface conditions are shown as-received on Fig. 2. Surfaces were corroded at field. However, radial beach marks which are indications of fatigue could still easily be detected.

Fig. 2 Fracture surfaces at as-received condition

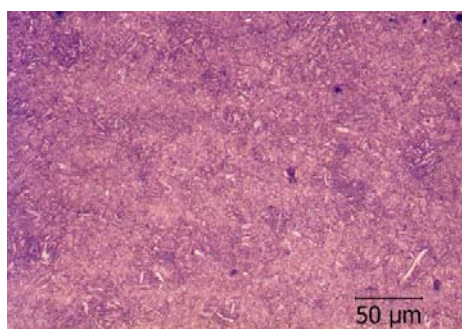
A microscopical analysis was carried out by optical microscope on samples from 5 mm and 50 mm to the failed section. Observed microstructure is tempered martensite as specified. No remarkable bainite or retained austenite phases were observed within the structure which may reduce mechanical strength and durability of the part under cyclic loading conditions.

Measured grain size is ASTM grade 8 as per ASTM E112 Method or finer which is as required. Fig. 3 shows a representative micrograph from the examined samples.

Fig. 3 Microstructure

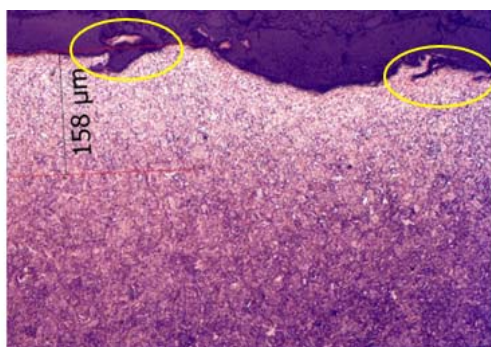
The specified level of decarburization depth of the part is 250 μm at maximum and partial type (Type 2). The observed decarburization type was partial and values of decarburization

depths from the examined region are within a range of 158 to 169 μm ; which describes no abnormal decarburization profile of the part surface.

During microstructural studies, small size of oxidized laps is potentially formed by subsequent oxidation of laps originated during hot rolling process. These surface irregularities were further searched for at the crack origin region whether there is a link to the failure mechanism, during fractographic examinations by SEM and will be discussed on the Micro-Fractography section. Fig. 4 shows a representative micrograph from the surface showing both the decarburization depth of 158 μm and oxidized laps.

Fig. 4 Decarburization extent and surface condition

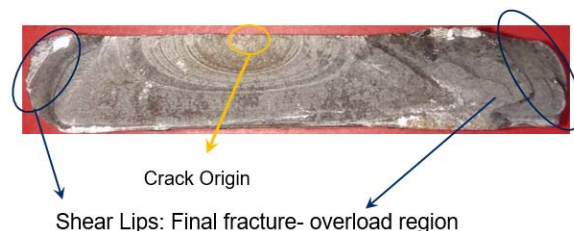
For microscopic examinations, the surfaces were cleaned by ultrasonic cleaning method with the usage of a special cleaning agent. Left-side fracture surface after cleaning is shown on Fig. 5. The thumbnail type of fatigue crack and shear lips at the final fracture region can be differentiated on this figure.

Macro examinations showed that a fatigue crack is present on the failed section. The shear lips and rough surface to the edges describe the final fracture region. Macroscopically observable size of the fatigue crack was found to be

approximately one-fourth of the total cross-sectional area. As the thumbnail shape of the crack is a possible indication of stress-corrosion cracking; further investigations were conducted on the micro-examinations and will be discussed in the micro-fractography section.

Fig. 5 Fracture surface (left-side) after ultrasonic cleaning

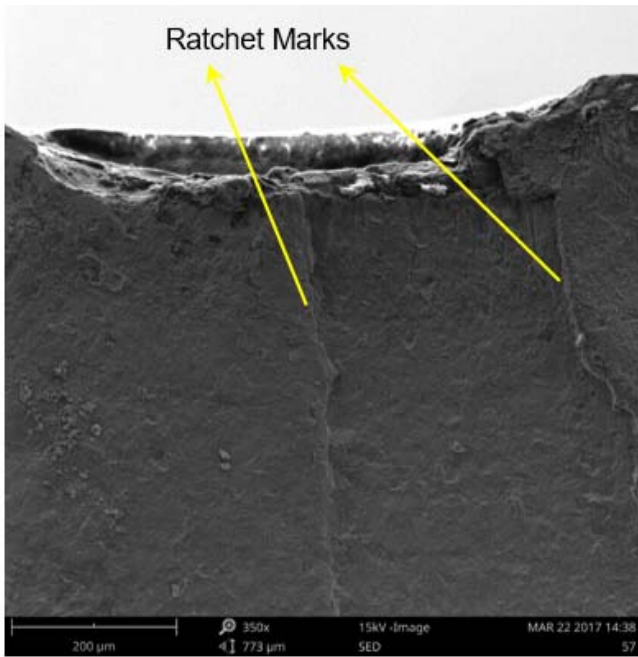
Fig. 7 shows the fatigue crack origin (point a) at X350 magnification. Ratchet marks which are indications of fatigue crack initiation mechanism were observed at the crack origin. Crack has emanated from a surface collapse of $\sim 500 \mu\text{m}$ which is possibly formed by plastic deformation of the surface during shot peening process. On the other hand, this is accepted as a natural phenomenon as these regions can act as local stress-raisers.

Examinations on crack origin showed that the crack initiation has occurred at single region. Singular crack initiation requires very low stress concentration. Examinations at crack origin region showed that this region is free of pre-existing cracks and metallurgical defects. These findings of low stress concentration and defect-free surface and singular type of crack propagation indicate that the reason of fatigue crack initiation and propagation is high magnitude of cyclic

Fig. 7 Crack origin

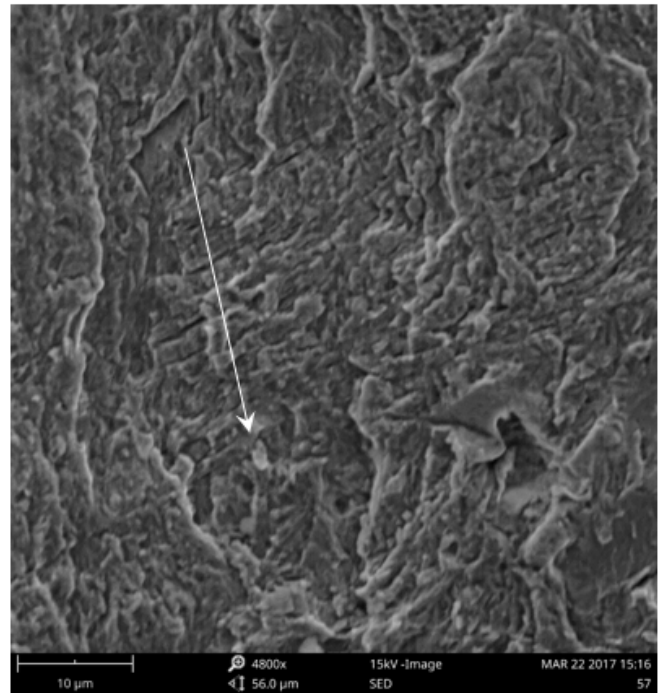
Fig. 9 Fatigue crack propagation direction and striations (point b)

Figs. 9 and 10 show the crack propagation directions. Fatigue striations can also be observed on Fig. 9 which are indications of stable crack propagation.

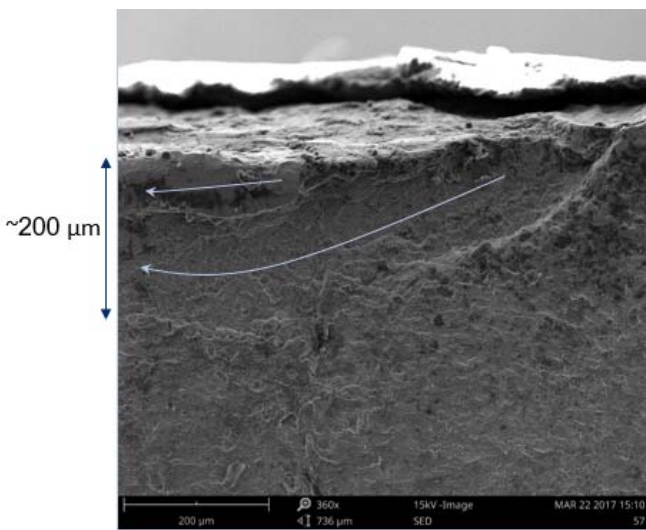
Fig. 8 shows the extension of crack initiations further beyond to the left (point b). However these cracks did not propagate and fatigue cracking continued with initial crack starting from point a.

Fig. 8 Extension of multiple crack initiation

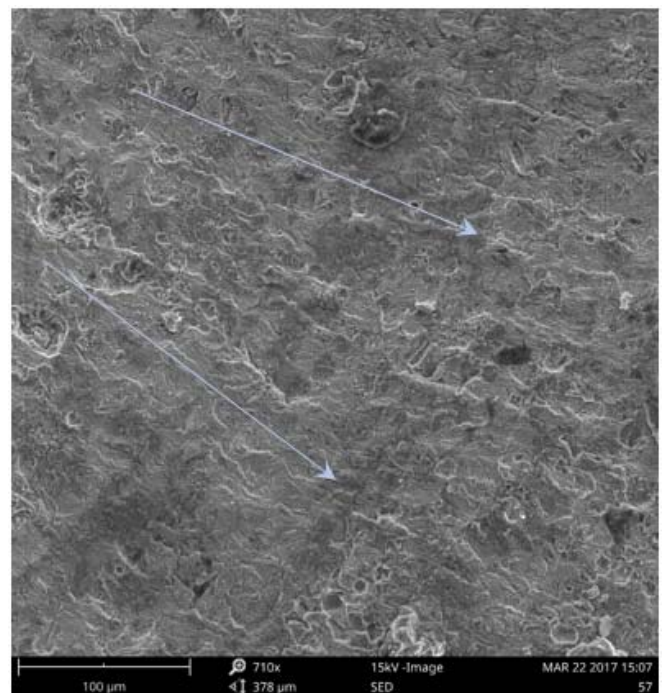
Fig. 10 Fatigue crack propagation directions (point c)

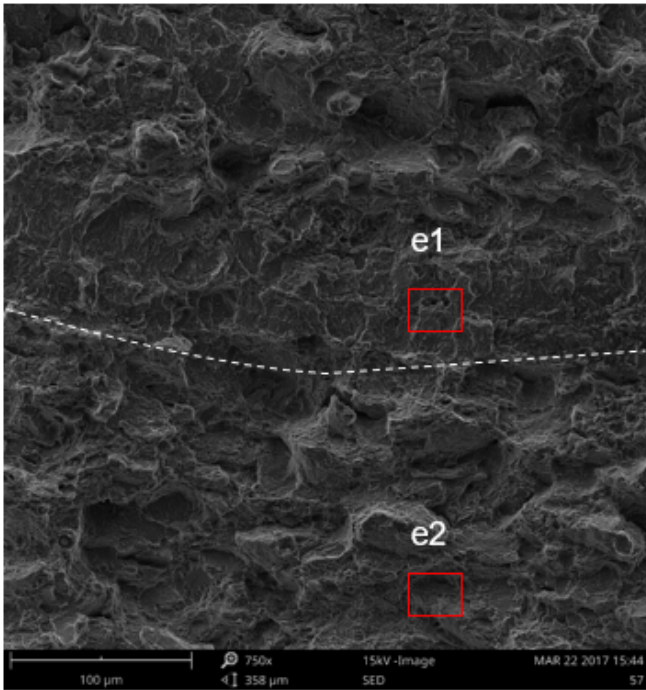
Micro examinations validated that the macroscopic transition from beach marks to rough and dull surface is the transition from fatigue to final overload fracture region. Figs. 11-13 describe the replication of fracture mechanism change from fatigue to ductile failure.

Fig. 11 Fatigue to overloading transition region (point e)

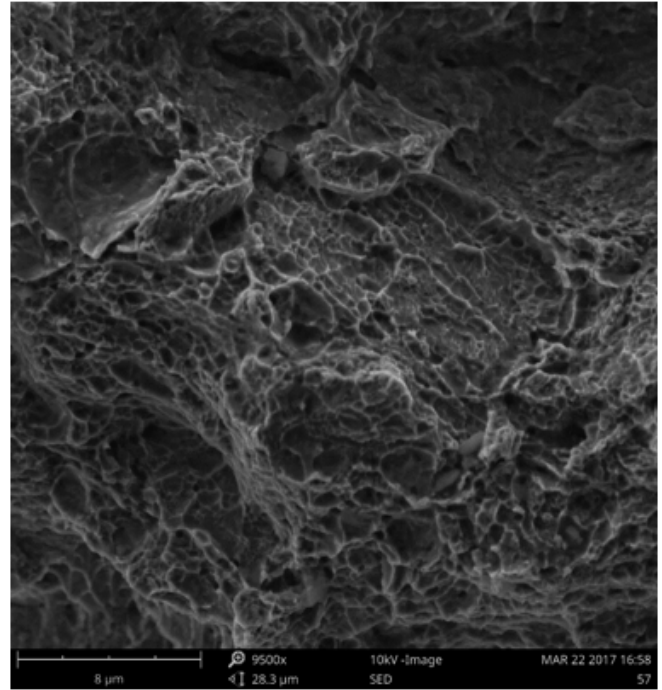
Striations and tear ridges were observed in fatigue region whereas dimples were observed on the overloading region.

Fig. 13 Ductile dimples due to overloading failure (e2)

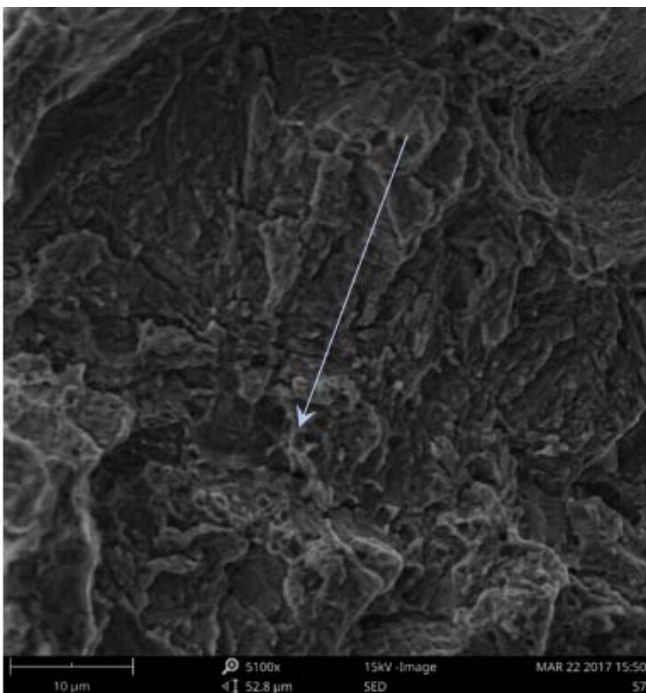
Fig. 12 Fatigue striations and tear ridges (e1)

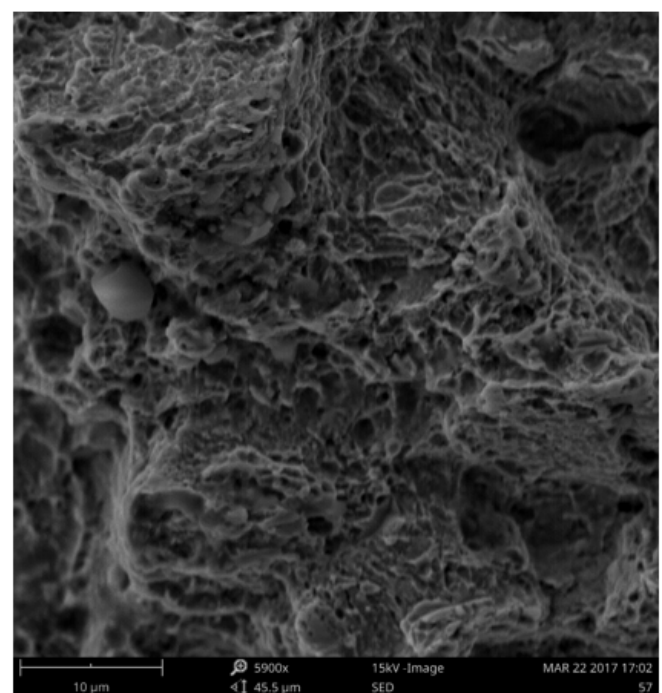
Fig. 14 Ductile dimples at final fracture (point f)

Figs. 14 and 15 show fractographs from the final failure regions. A complete ductile failure was observed near to the crack tip whereas both ductile and brittle features were observed near to the edge of the part. This may have occurred by more than one step of final overloading and increased strain rates at final stage resulting in cleavage plane formation due to brittle failure.

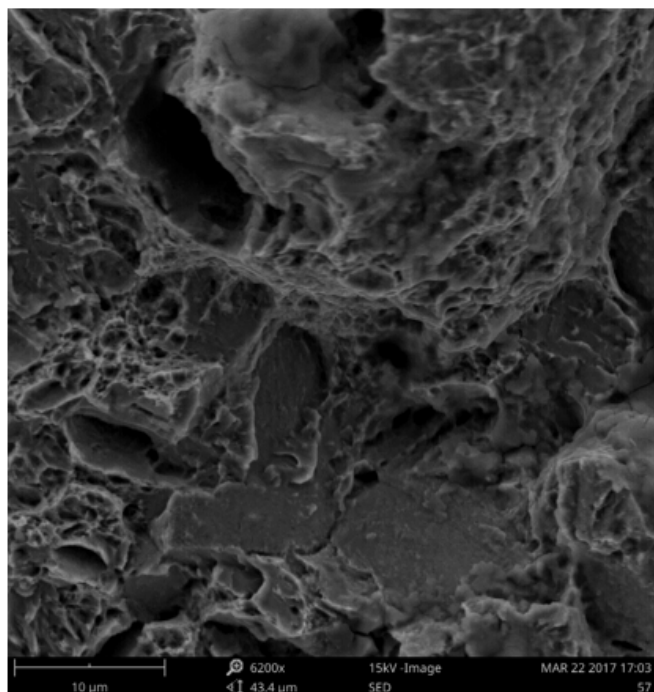
Fig. 15 Mixed type of overloading fracture (point g). Ductile dimples and brittle cleavage planes
