Ghost Frequency Noise Reduction through Displacement Deviation Analysis

Paua Ketan, Bhagate Rajkumar, Adiga Ganesh, M. Kiran

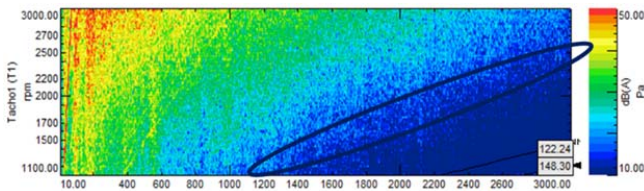
Figs. 1 (a) and (b) show Campbell plot of driver ear noise measurement in 5th gear in coast condition of good vehicle and problem vehicle identified during subjective assessment. From Campbell plot it was evident that in 5th gear coast condition problem vehicle had dominant 67.5 order whereas this order was absent in good vehicle. Vibration analysis of good and bad vehicle transmission indicated noise was originating from transmission.

Fig. 1 (a) Driver ear noise Campbell plot: 5th Gear coast: good vehicle

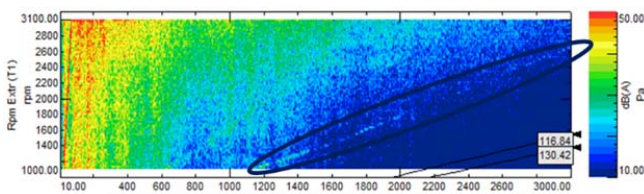
Fig. 1 (b) Driver ear noise Campbell plot: 5th Gear coast: bad vehicle

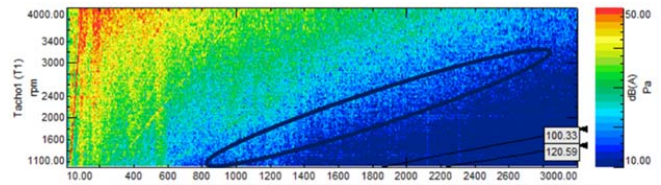
In-cab noise analysis of 4th gear coast condition highlighted the problem order at 51.75 as shown in Fig. 2 which is different from problem order identified in 5th gear condition. This meant that the problem order number changed with change in operating gear & the problem order relates to the component that was not rotating at same speed as engine speed.

Fig. 2 (a) Driver ear noise Campbell plot: 4th Gear coast: good vehicle

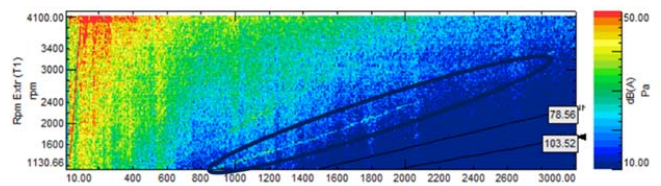
Fig. 2 (b) Driver ear noise Campbell plot: 4th Gear coast: bad vehicle

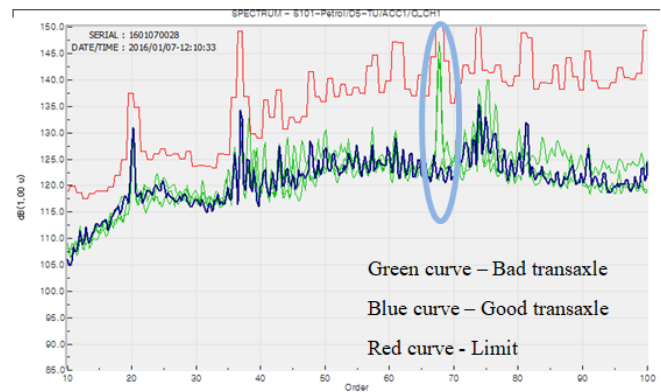
Based on vehicle level findings of whine noise problem, detailed vibration analysis of transmission End of Line (EOL) was conducted. Spectrum analysis of transmission EOL vibration demonstrated appreciable difference in amplitude of relevant ghost frequency of bad vehicle transaxle and good vehicle transaxle as shown in Fig. 3 which correlated with frequency from vehicle level noise and vibration measurements. Transaxle of bad vehicle showed significantly higher vibration of the ghost frequency relative to the good vehicle transaxle which had no whine noise. Also, it was

observed that drive flank EOL vibration response for ghost frequency amplitude of bad vehicle was higher than good vehicle even though the vehicle did not exhibit problem at vehicle level measurements in drive condition.

Fig. 3 (a) Transmission EOL vibration: Order plot: good transmission and bad transmission: 5th Gear drive condition

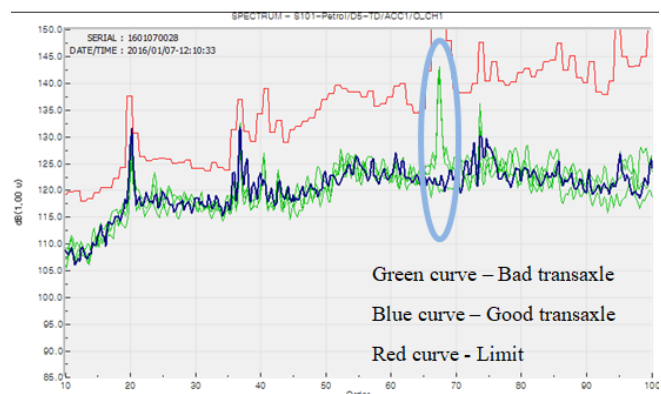
Fig. 3 (b) Transmission EOL vibration: Order plot: good transmission & bad transmission: 5th Gear coast condition

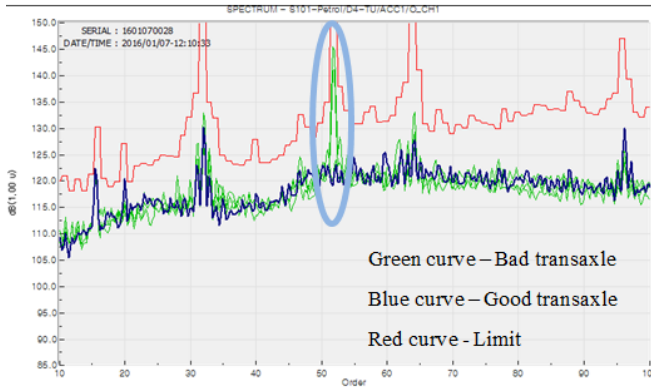
In 4th gear condition, transmission EOL vibration shown in Fig. 4 confirmed the problem order was 51.75 as identified in vehicle level noise and vibration measurements.

Fig. 4 Transmission EOL vibration: Order plot: good transmission & bad transmission: 4th Gear coast condition

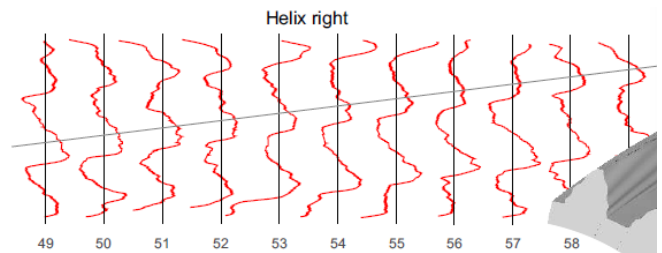
If a ghost frequency is present on gears, the tooth flanks show a ripple with varying phase position, and the form changes from tooth to tooth as shown in Fig. 5.

Fig. 5 Ghost frequency ripple

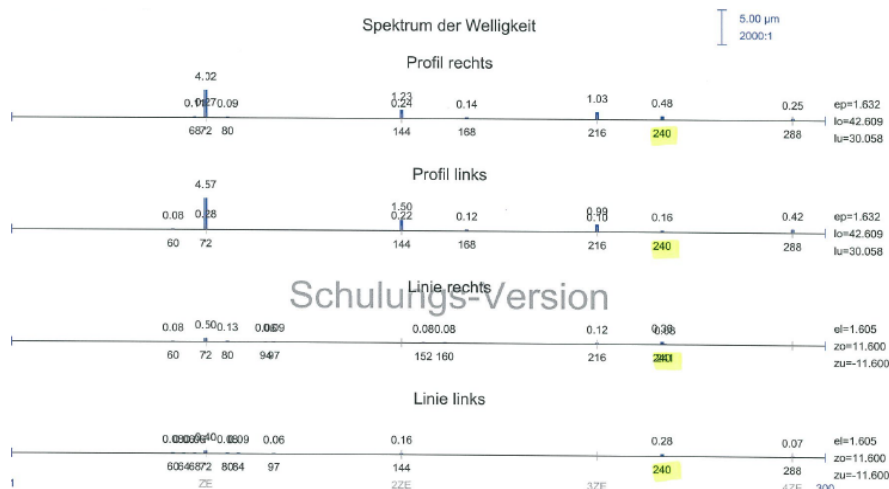
Fig. 6 (a) Deviation analysis: Ring gear: Bad transmission

Analysis of the measurement data shown in Fig. 6 (a) highlighted conspicuous 240 order deviation in bad ring gear which was absent in wave analysis of good gear as shown in Fig. 6 (b). This observation correlated with the problem order seen in EOL vibration measurement as well as in vehicle driver ear noise measurement. This measurement technique to assess gear quality was deployed in production line on batch wise random sampling basis leading to huge cost saving by avoiding repair and refitment cost of faulty gears in transmissions & vehicles.

Ring gear surface undulations were demonstrated to be the excitation forces causing ghost order noise generation at driver ear location in vehicle. Subsequently, gear quality control system was established for controlling the ghost order sensitive parameters at EOL machine. NVH measurements on vehicle level, EOL vibration diagnostics along with deviation measurement techniques helped to eliminate the ghost order noise from gear inside the vehicle.

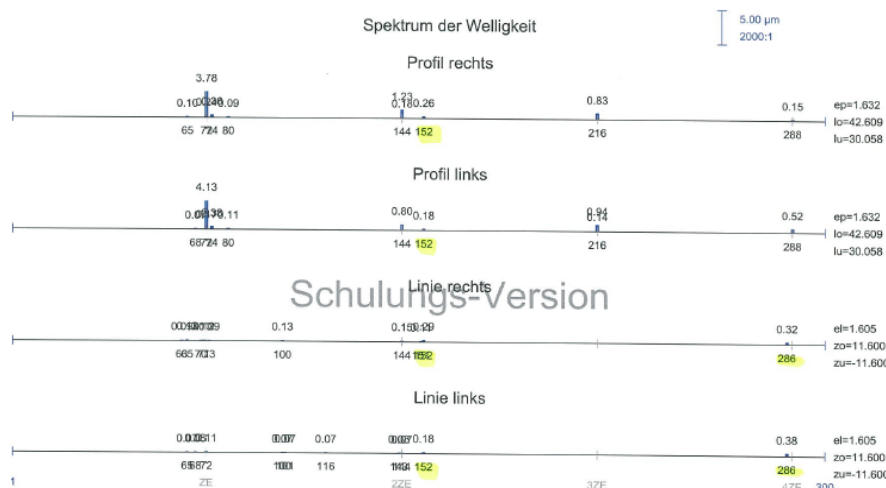
Fig. 6 (b) Deviation analysis: Ring gear: Good transmission
