# Railway Crane Accident: A Comparative Metallographic Test on Pins Fractured during Operation

Thiago Viana

Open Science Index, Mechanical and Mechatronics Engineering Vol:14, No:8, 2020 publications.waset.org/10011350.pdf

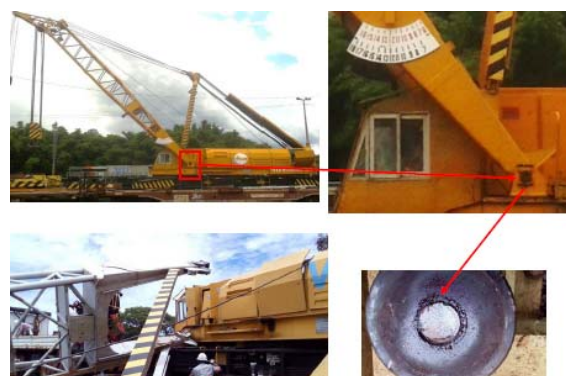
Fig. 1 The accident occurred with the railway crane due to the fall of the hoist by the fracture of the two support pins

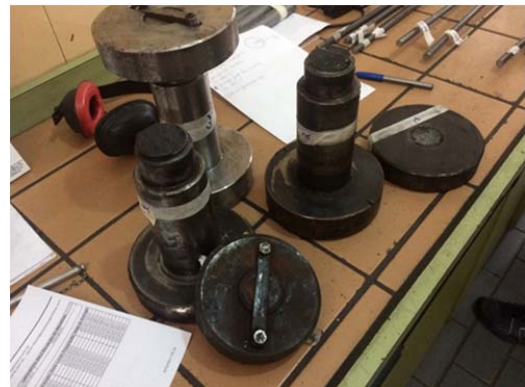
The types of analyzes performed and their results will be presented below. Three pins (Fig. 6), with about 400 mm and 50 mm of diameter, were analyzed being called:

- Fractured pin number 1 (right side crane).
- Fractured pin number 2 (left side of crane).
- New pin.

Fig. 6 Samples sent for analysis

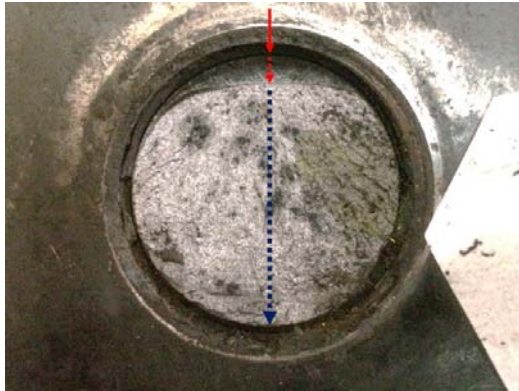
The fractured pin 1 (right side of crane), see Fig. 7, was fractured by fatigue through repeated efforts of unidirectional bending (presence of beach marks). The region of instantaneous and final fracture (about 90% of the cross section) was of the brittle fracture (radial marks).

Fig. 7 The visual inspection of the fracture shows: region of beginning of the fatigue crack (red arrow); beach marks: beginning and propagation of fatigue crack by unidirectional flexion (red dotted arrow); and radial marks: region of instantaneous fracture and final of brittle fracture (blue dotted arrow)

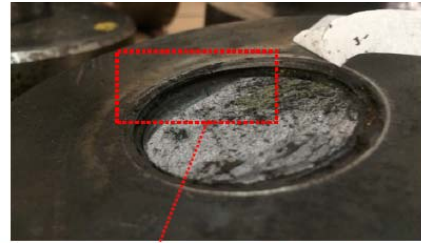
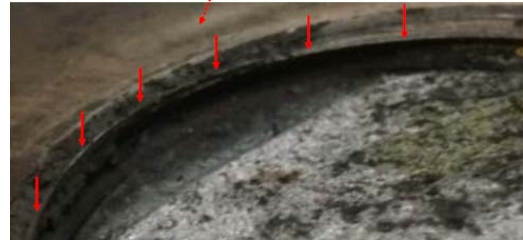
Further, Fig. 8 shows the detection that the screw peaks of the pin seat have no curvature, that is, they have sharp edges (sharp corners). This figure shows the presence of a sharp

corner in the first thread of the screw seat, and the same anomalies in the other threads are also shown.

Fig. 8 Presence of sharp edge (sharp corners) in the peaks of the threads of the seat of the fracture pin 1

The main cause of the failure was the notch caused in valley of pin 1 (right side of crane hoist) by the action/contact with the cutting edge contain in the peaks of the seat threads. From these grooves, the fatigue crack was started in pin 1.

- Perform visual tests with magnifying glass and/or non-destructive tests (dye penetrant, ultrasonic, etc.) on all the pins applied on the crane in order to detect notches and/or crack initiation.
- Calculate efforts to determine whether SAE 1045 steel (with or without heat treatment) and/or the entire crane is sufficient for the mechanical stresses imposed by the operation. Same for the seat.
- Elaborate technical drawing of the pin and seat, as well as elaborate technical specification containing various details including the design, material and type of heat treatment.
- Adapt the mechanical forming process of the seat and/or pin threads in order to eliminate sharp edges on the thread peaks.

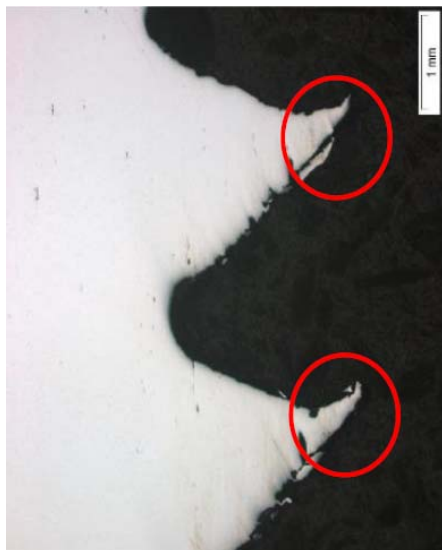
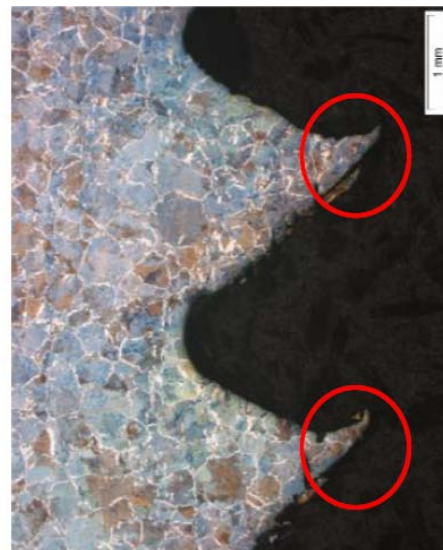
The metallographic examination of all three pins and of the three sites showed is formed by a perlite, as was already expected to be SAE 1045 steel. No irregularities were found in the microstructure. However, the anomaly in the peak of the threads of the seat of the fractured pin 1 was corroborated due to the presence of a cutting edge (Fig. 10). In addition, in the valleys of pin 1 threads several fatigue cracks were found in the beginning of propagation phase (Fig. 11).

Fig. 10 The presence of a sharp edge in the peaks of the threads of the seat of the fracture pin 1

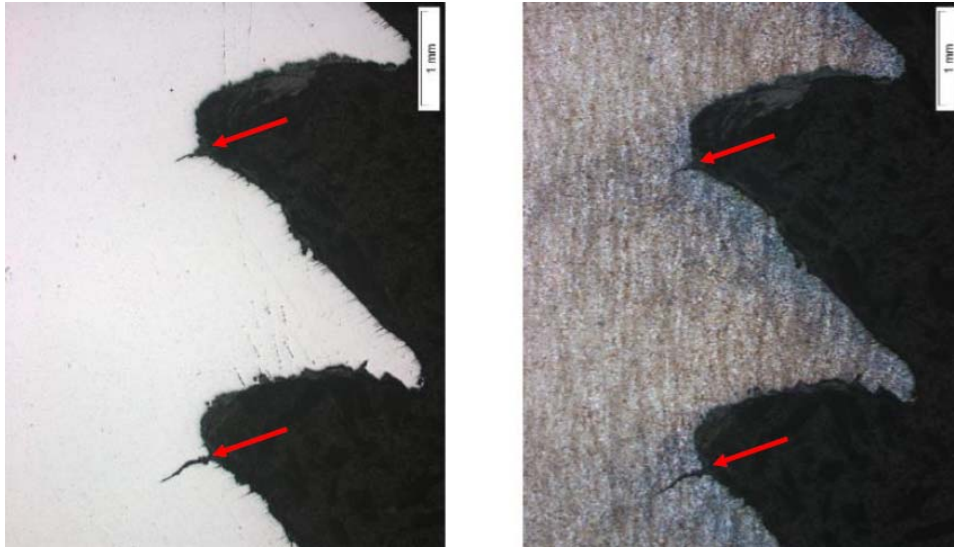
Fig. 11 Recording of several cracks found in some of the valleys of the threads of the fractured pin 1. The threads of pin 1, as well as that of its seat, were probably deformed plastically after the fracture occurred

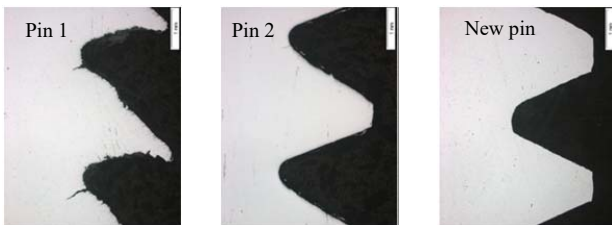
Fig. 12 Pin threads

The threads of the pin/seat 2 and the pin/new seat were shown with thread geometry to the satisfaction (without cutting edge) and without the presence of cracks and/or plastic deformations. An exception is that only a small crack was found in a valley of the pin 2 thread, most likely as a

consequence of the overload imposed after the fracture of pin 1. The comparative table in Fig. 12 shows the comparison

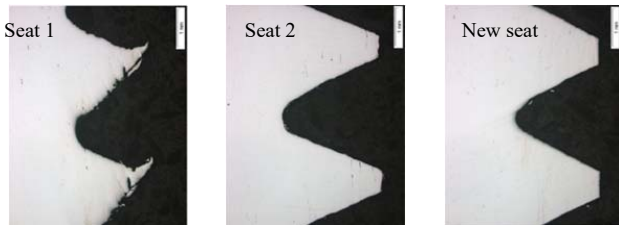
Fig. 13 Seat threads of pins

between the pin threads and Fig. 13 shows the comparison between the seat threads.

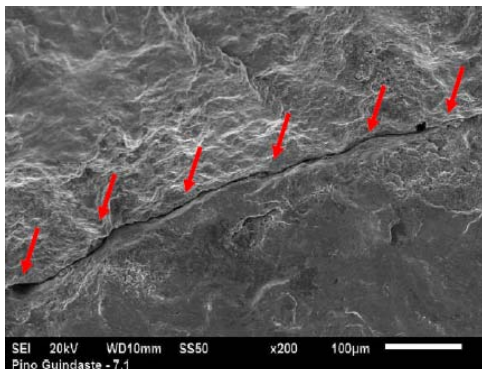
Aiming to verify the presence of notches, the fracture of pin 1 was analyzed in SEM (Scanning Electron Microscope). Fig. 14 shows the existence of notch in the valley of the thread of pin 1. This test was also performed for pin 2, with no notch in the thread.

Fig. 14 SEM analysis evidencing the presence of notch (risk) in the valley of the thread of the fractured pine 1
