# Railway Crane Accident: A Comparative Metallographic Test on Pins Fractured during Operation

Thiago Viana

Open Science Index, Mechanical and Mechatronics Engineering Vol:14, No:8, 2020 publications.waset.org/10011350/pdf

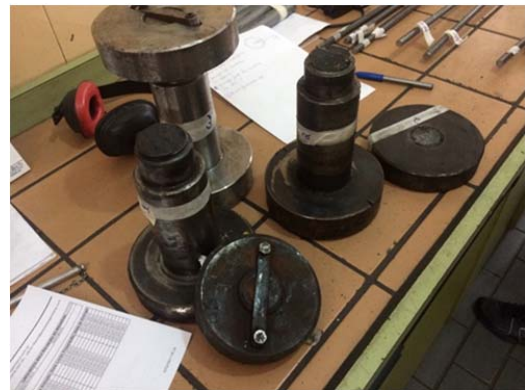
Fig. 6 Samples sent for analysis

The types of analyzes performed and their results will be presented below. Three pins (Fig. 6), with about 400 mm and 50 mm of diameter, were analyzed being called:

- Fractured pin number 1 (right side crane).
- Fractured pin number 2 (left side of crane).
- New pin.

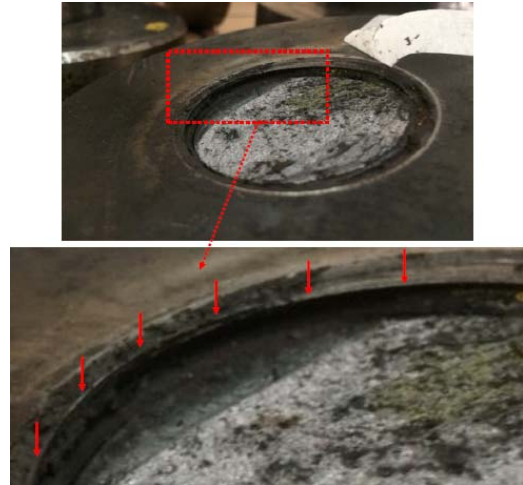
Further, Fig. 8 shows the detection that the screw peaks of the pin seat have no curvature, that is, they have sharp edges (sharp corners). This figure shows the presence of a sharp

corner in the first thread of the screw seat, and the same anomalies in the other threads are also shown.

Fig. 8 Presence of sharp edge (sharp corners) in the peaks of the threads of the seat of the fracture pin 1

- Perform visual tests with magnifying glass and/or non-destructive tests (dye penetrant, ultrasonic, etc.) on all the pins applied on the crane in order to detect notches and/or crack initiation.
- Calculate efforts to determine whether SAE 1045 steel (with or without heat treatment) and/or the entire crane is sufficient for the mechanical stresses imposed by the operation. Same for the seat.
- Elaborate technical drawing of the pin and seat, as well as elaborate technical specification containing various details including the design, material and type of heat treatment.
- Adapt the mechanical forming process of the seat and/or pin threads in order to eliminate sharp edges on the thread peaks.

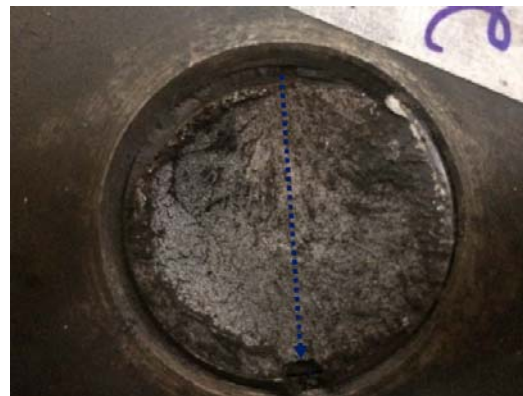
The fracture of pin 2 was of the brittle bending type through a single overload stress (fracture occurred almost instantaneously). Fig. 9 shows the radial marks proving to be a brittle fracture. The results of the chemical composition showed that the steels of the three pins are similar to those specified for the steel SAE 1045.

Fig. 9 Fracture of pin 2 due to bending overload stress generating brittle fracture (radial marks). The blue dotted arrow indicates the direction of instantaneous propagation

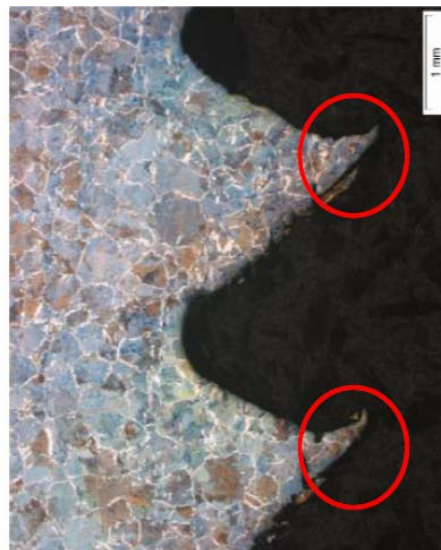
The metallographic examination of all three pins and of the three sites showed is formed by a perlite, as was already expected to be SAE 1045 steel. No irregularities were found in the microstructure. However, the anomaly in the peak of the threads of the seat of the fractured pin 1 was corroborated due to the presence of a cutting edge (Fig. 10). In addition, in the valleys of pin 1 threads several fatigue cracks were found in the beginning of propagation phase (Fig. 11).

Fig. 10 The presence of a sharp edge in the peaks of the threads of the seat of the fracture pin 1

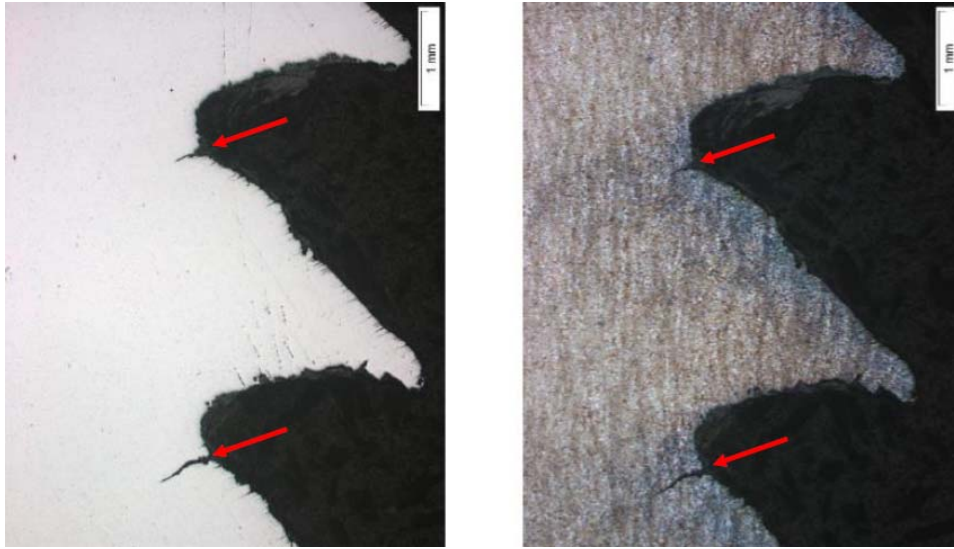
Fig. 11 Recording of several cracks found in some of the valleys of the threads of the fractured pin 1. The threads of pin 1, as well as that of its seat, were probably deformed plastically after the fracture occurred
