The Collapse of a Crane on Site: A Case Study

T. Teruzzi, S. Antonietti, C. Mosca, C. Paglia

Abstract—This paper discusses the causes of the structural failure in a tower crane. The structural collapse occurred at the upper joints of the extension element used to increase the height of the crane. The extension element consists of a steel lattice structure made with angular profiles and plates joined to the tower element by arc welding. Macroscopic inspection of the sections showed that the break was always observed on the angular profiles at the weld bead edge. The case study shows how, using mechanical characterization, chemical analysis of the steel and macroscopic and microscopic metallographic examinations, it was possible to obtain significant evidence that identified the mechanism causing the breakage. The analyses identified the causes of the structural failure as the use of materials that were not suitable for welding and poor performance in the welding joints.

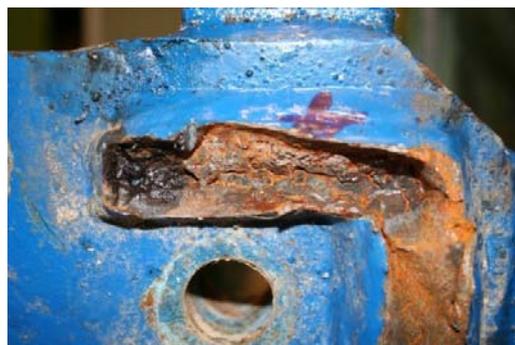
The problem addressed concerns on the analysis of the collapse of a tower crane used on a construction site. The structural collapse of the tower occurred at the upper joints of the extension element used to increase the height of the crane. This element consists of a steel lattice structure; the joints were prepared by arc welding of corner profiles with connecting plates to the adjacent tower element. The joints are of T-type. In the vicinity of the upper joints, the corner profiles have tapering which reduces the side from 140 to 90 mm (nominal dimensions). The breakage of the joints is always observed at the corner profiles at the height of the weld seam edge. Immediately after the collapse of the tower, the fracture surfaces were partially covered with rust (Fig. 1, joint

2). This may indicated that the opening of the joints did not occur instantly, but began before the accident. Furthermore, the detachment of the weld seam from the wall of the corner profiles is observed locally.

Fig. 1 Joint n. 2. Fracture surfaces covered with rust

During the subsequent operating life of the element and under the influence of the connected service tensions, they gradually developed, bringing the structure to collapse. These findings are compatible with the presence of corrosion products on the broken surface of the joints observed on the samples immediately after the collapse, which support the hypothesis of the presence of pre-existing cracks.

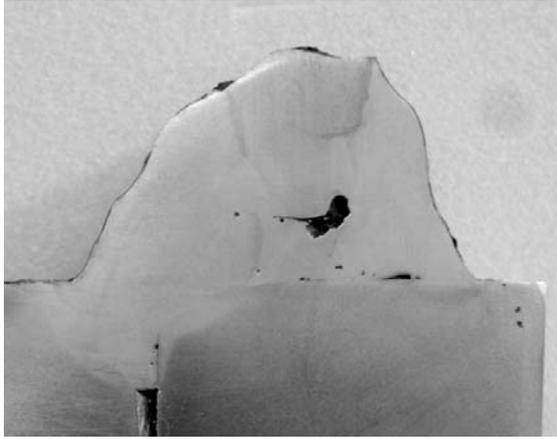
Fig. 2 Joint n. 1, Lack of penetration of the filler metal and pores

Some imperfections are visible in some joints, as defined in standard EN 6520-1 [5]: lack of penetration of the filler metal and lack of fusion. Both imperfections can be attributable to operational errors, therefore avoidable by applying adequate techniques and precautions during welding (e.g. adequate cleaning and preheating of the edges to be welded).

All four broken joints feature the presence of a millimeter-sized cavity between the corner profile and the plate due to incomplete penetration of the filler material. In the intact joints this characteristic is not found, in fact in these cases the

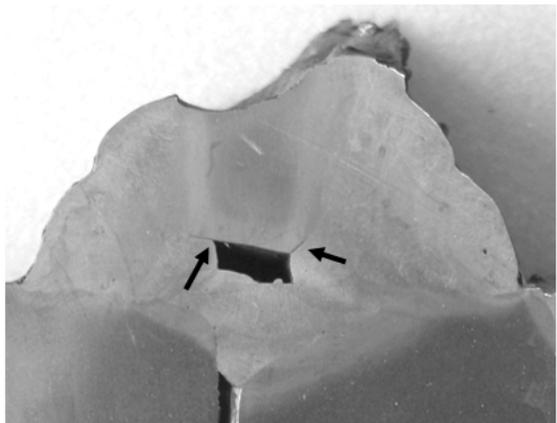
Fig. 3 Joint 2A, Lack of penetration of the filler metal and lack of fusion (arrows)

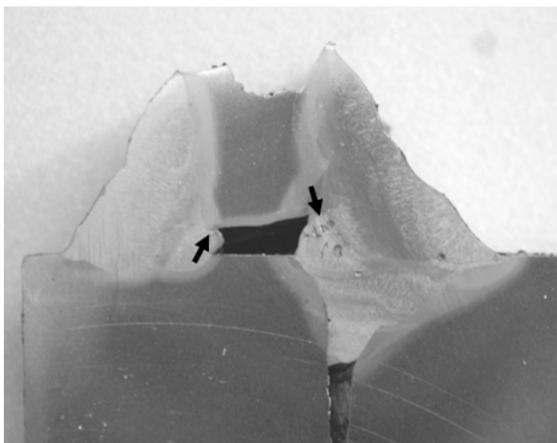
Fig. 4 Joint 3, Lack of penetration of the filler metal and lack of fusion (arrows)

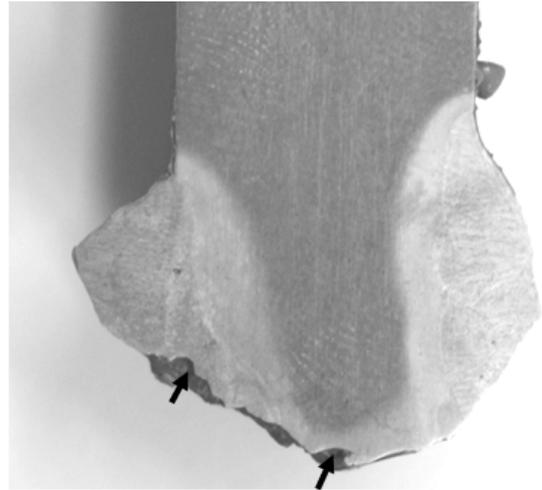
Fig. 5 Joint 2B, Presence of vacuoles along the fracture margin (arrows)

In joint 2, the fracture occurred partially in the filler material. In the specific case, the breakage surface is rich in pores and slags (Fig. 5).

Based on the results obtained from the analyses carried out, the hypothesis can also be made that the susceptibility of the steel of the corner profiles to the formation of cold cracks could have been increased by hydrogen embrittlement of the material, due to insufficient preparation of the edges to be welded (e.g. moisture in the coating of the electrodes or damp edges; insufficient cleaning of rust and other residues) [9]. In support of this hypothesis, in several joints (especially in joint n. 2), an abundant presence of vacuoles and pores in the filler material was found.

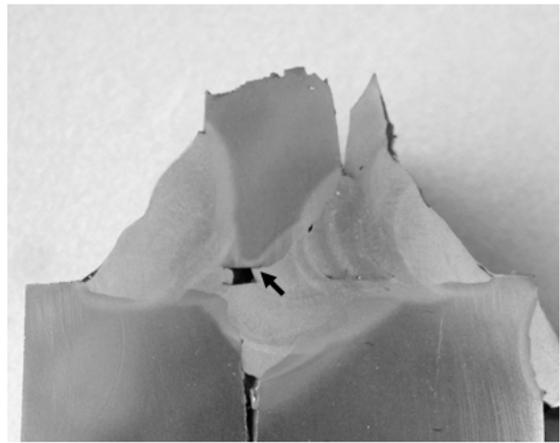
Fig. 6 Joint 4, Welding seam between the corner profile and the plate overlaps to the joint between the two elements making up the plates. Lack of penetration of the filler metal and lack of fusion (arrows)

The examination of the connection plates corresponding to the broken joints revealed that they are not monolithic, but they were obtained by joining two elements by welding. Locally, the welding seam between the corner profile and the plate overlaps the joint between the two elements making up the plates (Fig. 6). Welding on an existing welded joint is not in accordance with practice and is not recommended.

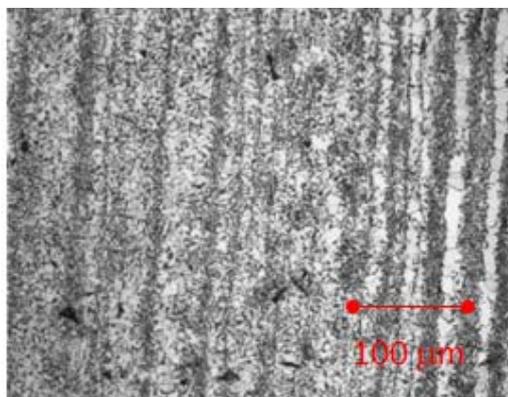
Fig. 8 Joint 1, corner profile, HAZ: micrograph #.2

The metallographic examination in the HAZs of the profiles allowed ascertaining the presence of phases with a bainitic structure, sometimes with enlarged grains. This confirms the tendency of the material to change into hardening structures, under the influence of thermal welding cycles. This trend is also confirmed by hardness measurements, which show a significant increase in the HAZ. The crack observed in the HAZ of joint n. 2 illustrates the initial stage of the mechanism that led to the collapse (Fig. 11). The shrinkage generated was probably due to too rapid cooling. The hardened base metal did not adapt to the dimensional change, thus causing cracks in the HAZ.

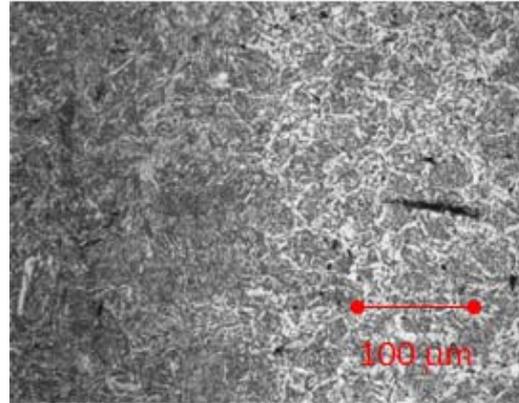
Fig. 9 Joint 1, corner profile, FZ: micrograph #.4

In the fusion welded joint there are three different areas: the fusion zone (FZ), the HAZ and the base material. The three areas have different microstructure. The conditions of the material can be clarified specifically, the implementation of surface treatments, any thermal treatments and therefore ascertaining the existence of probable deterioration phenomena (fatigue breakages, wear phenomena, surface corrosion, etc.) [6]. To highlight the microstructure of the samples, the glossy sections are subjected to an acid etching process (Nital 2%). The images are obtained with an optical microscope with reflected light in bright field mode. The microstructure of the corner profiles in the unaltered areas is characterized by the alternation of bands of ferrite and perlite oriented parallel to the axis of the profiles (Fig. 7). This is a typical structure of hot rolled products. The HAZ of the corner profiles has an approximate width of 2-3 mm and is characterized by the gradual dissolution of the perlite bands and by the formation of a globular ferritic-pearlitic structure with refined grain, similar to that obtainable by normalization treatment (Fig. 8). The structure of the corner profile in the area adjacent to the FZ is bainitic with enlarged grains (Fig. 9). The filler metal is characterized by a ferritic-bainitic structure.

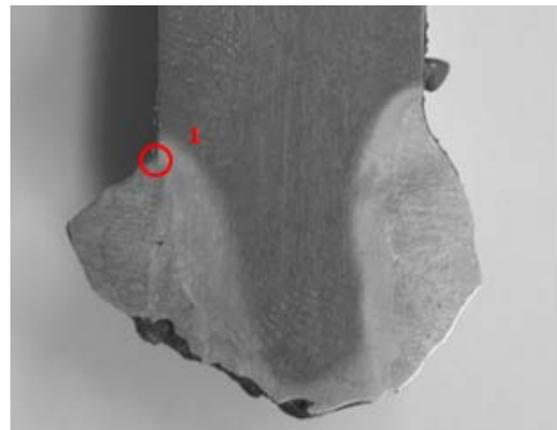
Fig. 10 Joint 2B, Corner profile, location micrograph #.1

At joint no. 2, in particular on specimen 2B, the presence of a marginal crack inside the HAZ of the corner profile is observed (Figs. 10, 11). It propagates from the upper edge of the weld seam and initially runs along the border line with the FZ, and then continues towards the core of the profile. It is a cold crack. This two-dimensional defect is unacceptable as it represents a discontinuity which, over time can lead to the failure of the joint, depending on the operating stress.

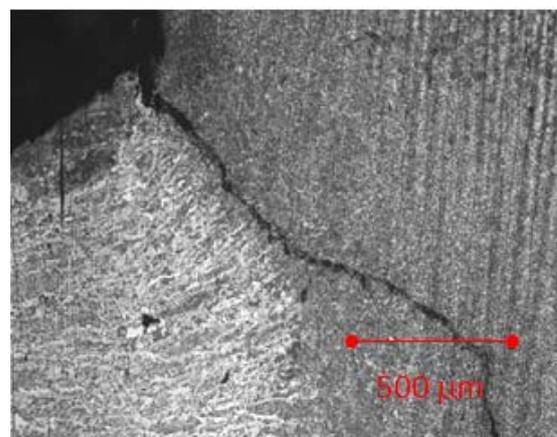
Fig. 11 Joint 2B, corner profile, HAZ: micrograph #.1. Cold cracking
