Modelling for Roof Failure Analysis in an Underground Cave

M. Belén Prendes-Gero, Celestino González-Nicieza, M. Inmaculada Alvarez-Fernández

Keywords—Forensic analysis, hypothesis modelling, roof failure, seismic monitoring.

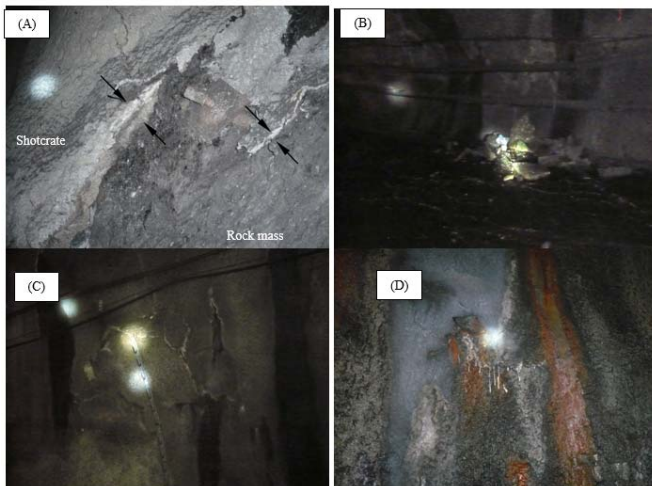
Along the ramp, when coal layers are crossed, the shotcrete support suffers a lot, because when this type of ground is deformed, it cracks and detaches the shotcrete. At some points it was found that the thickness of shotcrete was small and, in others, the shotcrete was not resting on the floor, if not "hung". These situations indicate that the shotcrete was not working properly as support. On the other hand, the infiltrating water produced oxidation problems in the bolts, as well as in the reinforcing fibbers of the shotcrete in the sections they were metallic. These problems are shown in Fig. 1. In some places, the support was reinforced by increasing the bolt density or installing new wood-clad metal frames (Fig. 2).

Fig. 1 Found problems in the shotcrete: (A) poor thickness, (B) detached blocks, (C) cracking, (D) leaks and oxidation

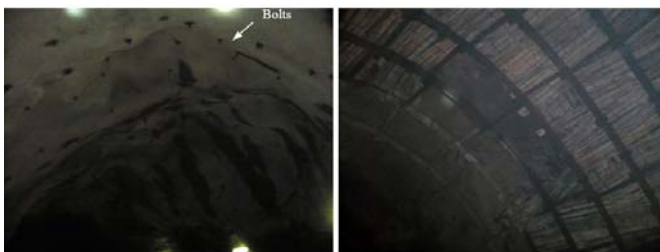
Fig. 2 Places with reinforced support in the ramp

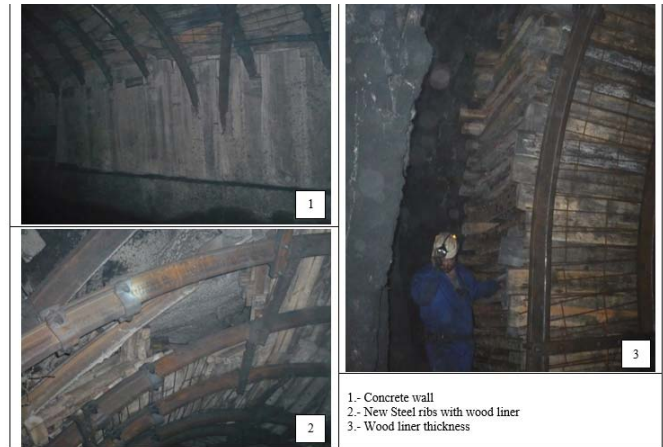
The area of the collapse was entirely reinforced after the incident, with new metallic frames (type Th29) and a coating of wood that in some areas exceeded one meter of thickness (see Fig. 3). The coating wood produces a reduction of the size of the section. On the right wall, where the detachment of

material happened, the metal frames were braced by embedding them in a concrete wall.

Fig. 3 Reinforced support after the accident

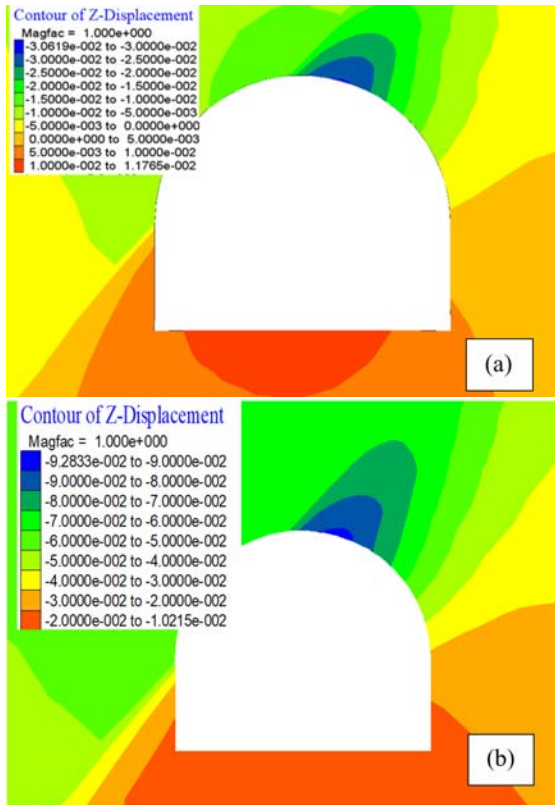
Fig. 7 shows the vertical displacements (in meters) of the model around the gallery. They are represented in the form of isovalues, so each colour is equivalent to an interval of displacements according to the legend that appears on each figure. They are negative when their direction is descending and positive when their direction is ascending (swellings).

The simulation shows displacements of 3 cm in the roof and swellings of 1 cm in the floor. These displacements increase to 9 cm and 2 cm respectively after the longwall exploitation.

Fig. 7 Vertical displacements: (a) during tailgate opening;(b) during longwall exploitation

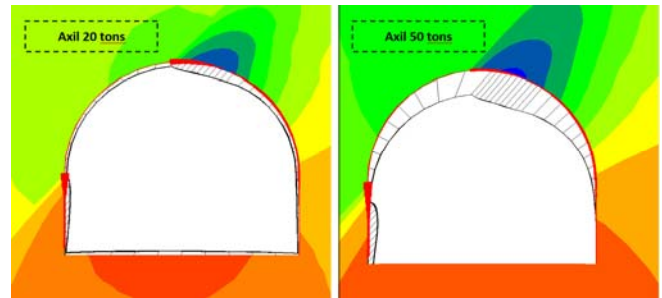
Fig. 8 shows the axial efforts over the support. The efforts go from 20 t before the exploitation until 50 t after the exploitation. In this figure, the geometric deformation of the gallery is represented in a magnified way. It can be noticed that in the intersection with the coal layer the deformation is bigger and this change in the deformation produces cracks in the shotcrete. In this case, less rigid and more flexible supports, as wood, have a better behaviour because they better absorb the deformations.

Fig. 8 Axial efforts over the support and tailgate deformation before and after the exploitation

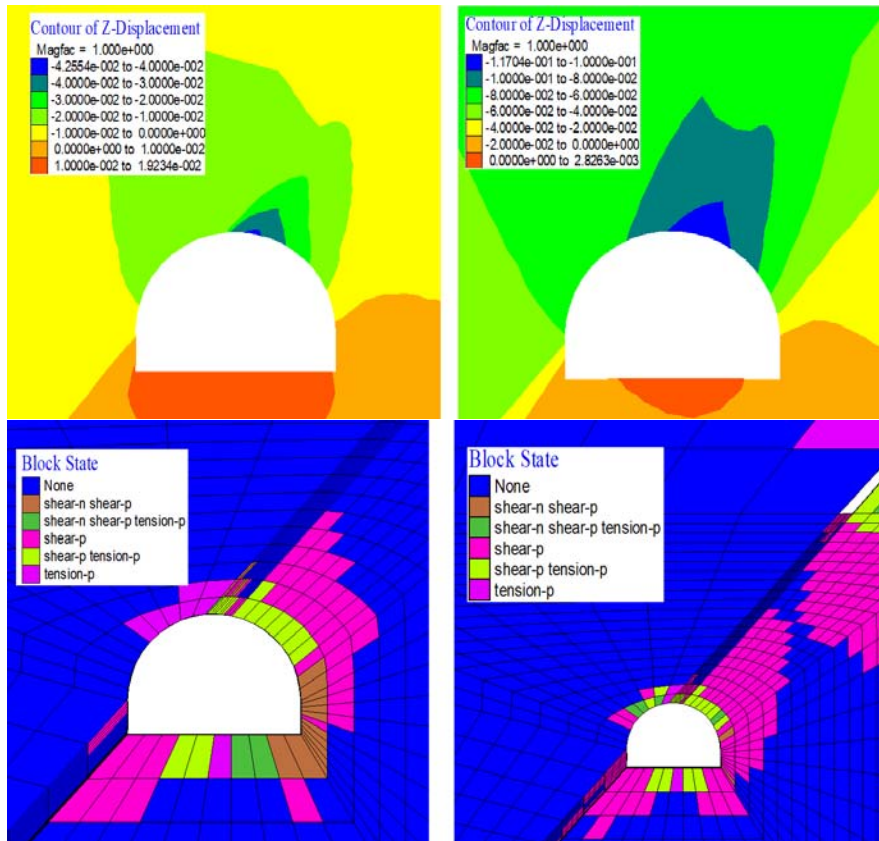
The bigger dimensions of the cross section produce an increase in the vertical displacements until 4 cm. Besides, a plasticized zone around the tailgate appears not only along the exploitation but also before it (Fig. 9).

Fig. 9 Vertical displacements and failure surrounding of the tailgate before and after the exploitation

Again, a change in the deformation appears in the intersection with the coal layer affecting the integrity of the shotcrete and producing cracks and detachments. The axial effort reaches the 24 t bigger than in the first case with one effort of 20 t.

After the exploitation, the displacements and the fractured surrounding increase in an important way and the support is overloaded until 60 t.

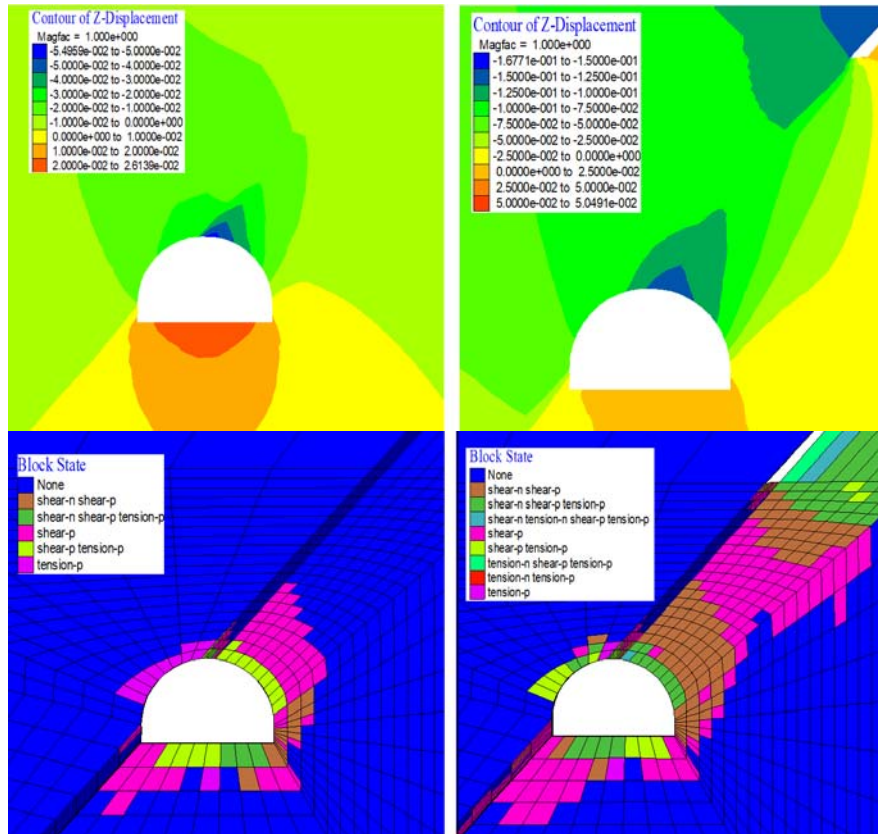
When the dimension of the tailgate is equivalent to the diagonal (14 m), the vertical displacements in the roof reach 5.5 cm and in the floor 2.5 cm. Again, is the wall of the layer the most affected placed with an increase in the fracturing and failure (Fig. 10).

Fig. 10 Vertical displacements and failure surrounding of the tailgate, before and after the exploitation for 14 m of diagonal

Once the workshop is exploited, the vertical displacements in the roof reach 15 cm, while the wall of the layer is totally plasticized between the tailgate and the workshop. There are very significant zones in the figure with a tendency to the break and/or landslide. This indicates that, if a landslide starts, it will take place in the wall of the layer and that the volume of involved material will be considerable, since the affected area has considerably grown compared to the previous situations.

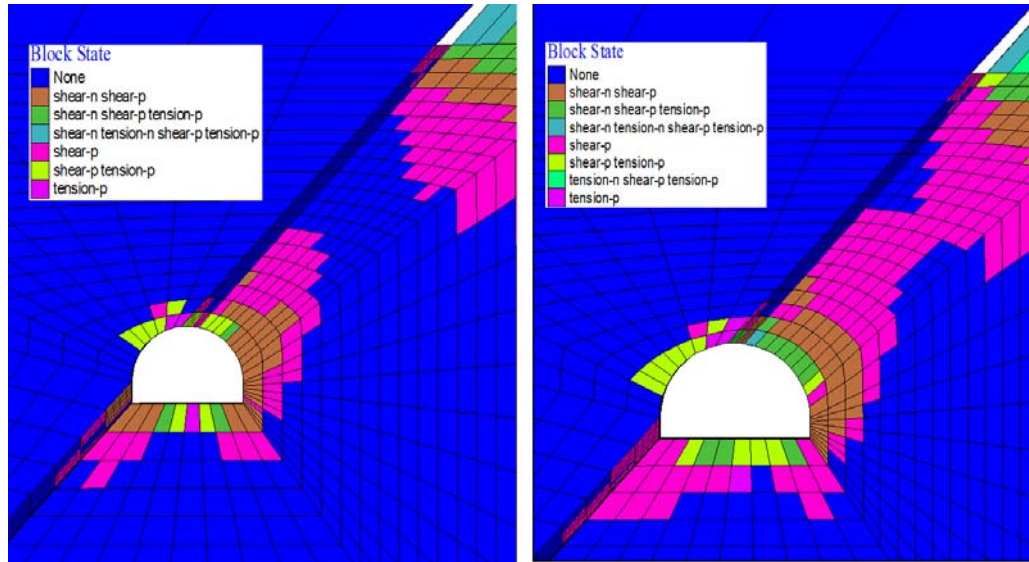
Protection pillars of 70 m could be suitable for gallery widths of up to 10 m (see Fig. 11), but they are insufficient when considering a gallery dimension equivalent to the

diagonal (14 m) because in this case, the plasticizing areas around the tailgate and the exploitation workshop appear again. On the other hand, with 80 m protection pillars, the plasticizing areas around the exploitation workshop and the tailgate are not connected (Fig. 12). Therefore, in case of one slide, it would be a local break in which the volume of material that can fall is much less and the support would

Fig. 11 Failure surrounding after the exploitation for 10 and 14 m and with protection pillar of 70 m

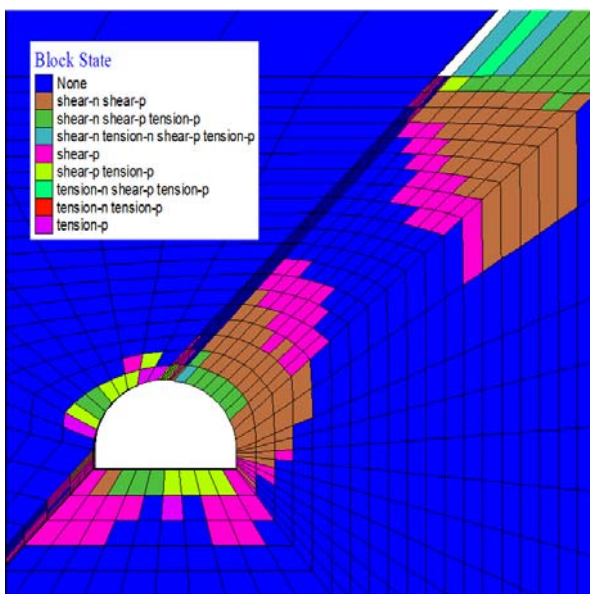
behave better. Based on these observations, it seems to be confirmed that the detachment was originated as a consequence of one sliding in the layer wall, due to the large roof span present in the place of the accident, and probably triggered as a consequence of the existence of a protection pillar insufficient.

Fig. 12 Failure surrounding after the exploitation for 14 m and with protection pillar of 80 m
