# Modelling for Roof Failure Analysis in an Underground Cave

This work is the failure analysis of a roof incident in a coal mine in northern Spain and its principal scope is to establish the causes of the accident to improve the security in other mining areas of this exploitation. The followed methodology begins with field works to recognize the area and to characterize geological materials. Then, different hypotheses were developed and a computational simulation was used to evaluate their viability.

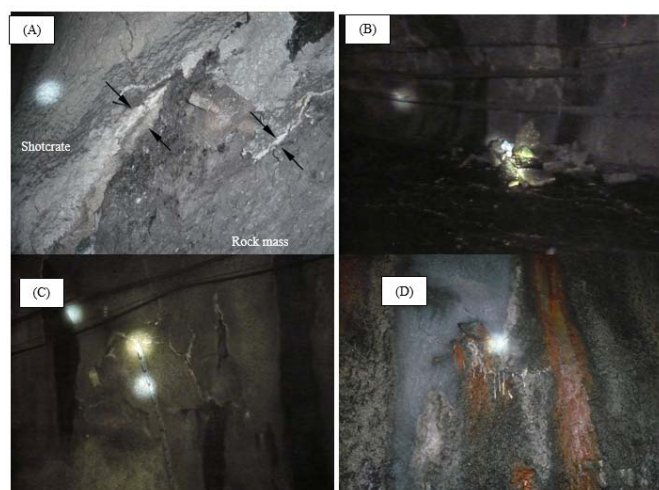
Along the ramp, when coal layers are crossed, the shotcrete support suffers a lot, because when this type of ground is deformed, it cracks and detaches the shotcrete. At some points it was found that the thickness of shotcrete was small and, in others, the shotcrete was not resting on the floor, if not "hung". These situations indicate that the shotcrete was not working properly as support. On the other hand, the infiltrating water produced oxidation problems in the bolts, as well as in the reinforcing fibers of the shotcrete in the sections they were metallic. These problems are shown in Fig. 1. In some places, the support was reinforced by increasing the bolt density or installing new wood-clad metal frames (Fig. 2).

Fig. 1 Found problems in the shotcrete: (A) poor thickness, (B) detached blocks, (C) cracking, (D) leaks and oxidation

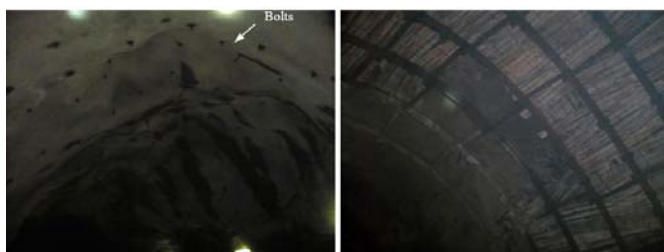
Fig. 2 Places with reinforced support in the ramp

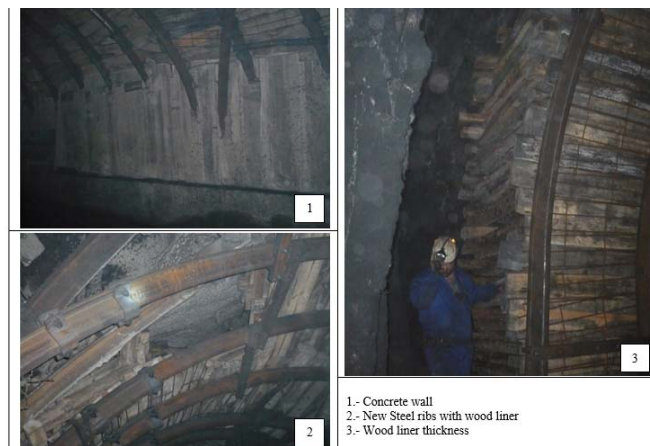
Fig. 3 Reinforced support after the accident

The area of the collapse was entirely reinforced after the incident, with new metallic frames (type Th29) and a coating of wood that in some areas exceeded one meter of thickness (see Fig. 3). The coating wood produces a reduction of the size of the section. On the right wall, where the detachment of

material happened, the metal frames were braced by embedding them in a concrete wall.

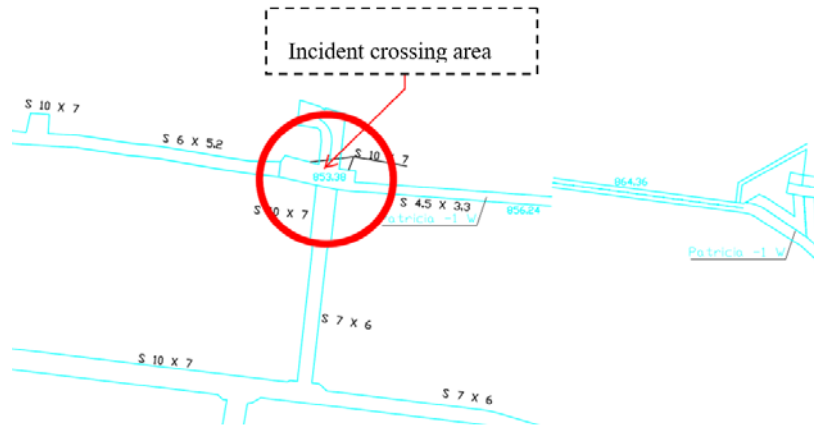
As indicated above, the accident occurred in the called "Morena Oeste". This gallery with a height of 853 m has a cross section of 6 m of width and 5.2 m of height, with the exception of the collapsed area where the section increases to 10 m of width and 7 m of height. This bigger size allows creating a transference place where the coal is loaded and evacuated to the outside.

Fig. 5 Dimensions of the galleries in the collapsed area

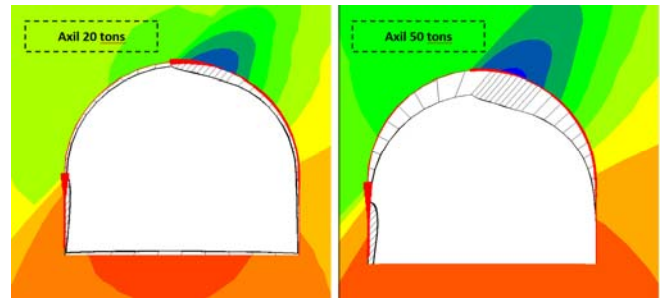
Fig. 8 shows the axial efforts over the support. The efforts go from 20 t before the exploitation until 50 t after the exploitation. In this figure, the geometric deformation of the gallery is represented in a magnified way. It can be noticed that in the intersection with the coal layer the deformation is bigger and this change in the deformation produces cracks in the shotcrete. In this case, less rigid and more flexible supports, as wood, have a better behaviour because they better absorb the deformations.

Fig. 8 Axial efforts over the support and tailgate deformation before and after the exploitation

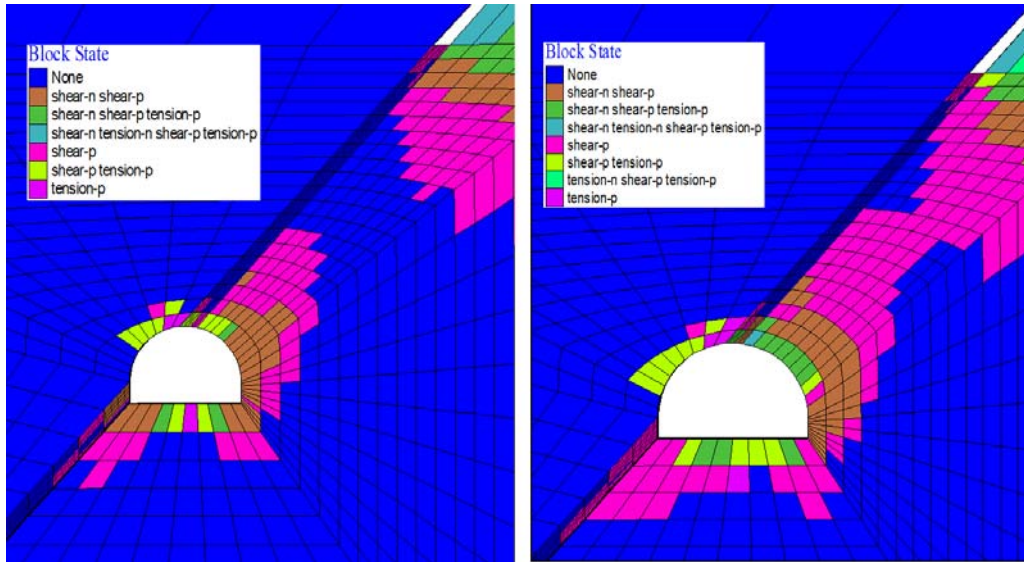
Protection pillars of 70 m could be suitable for gallery widths of up to 10 m (see Fig. 11), but they are insufficient when considering a gallery dimension equivalent to the

Fig. 11 Failure surrounding after the exploitation for 10 and 14 m and with protection pillar of 70 m
