Fatigue Failure Analysis in AISI 304 Stainless Wind Turbine Shafts

M. F. V. Montezuma, E. P. Deus, M. C. Carvalho

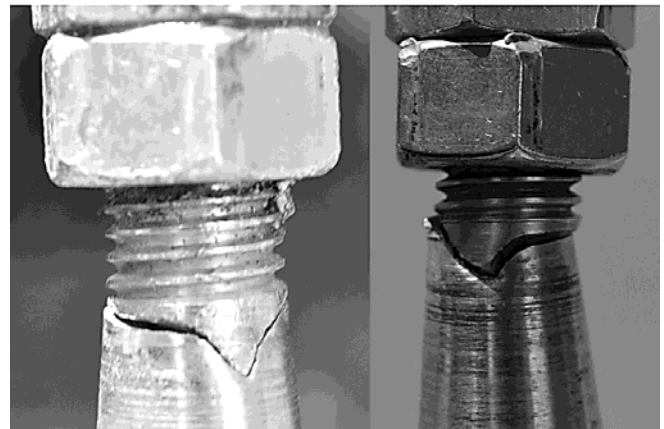
In the visual analysis, different failures morphologies were observed and compared with Metals Handbook [5]. The generator shafts A1700 - AP and RA broke at the beginning of the thread, Fig. 4, with fatigue break marks shown in detail in Figs. 5 and 6.

Fig. 4 AP and RA fractured shafts - Model A1700

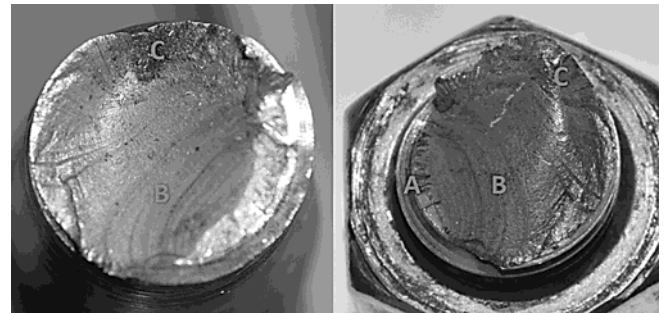
Fig. 5 View of the fatigue fracture region of the RA shaft: A - beginning of the fracture, B - beach marks, and C - final region of the fracture

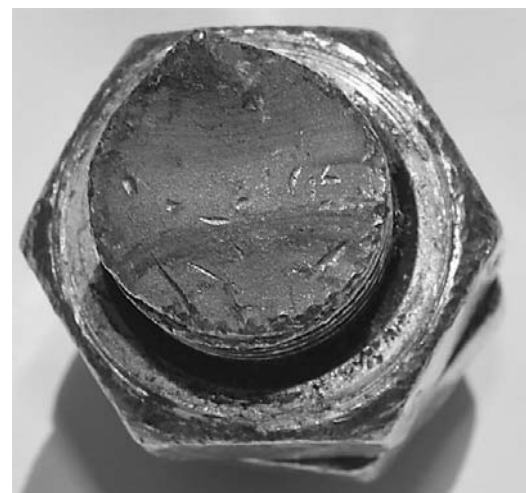
Fig. 6 View of the fatigue fracture region of the AP shaft – verification of beach marks

The visual inspection of the fracture on the AP shaft was compromised due to the numerous tool marks in the fracture regions, Fig. 6. However, it was possible to observe the "beach marks" characteristic of fatigue fracture.

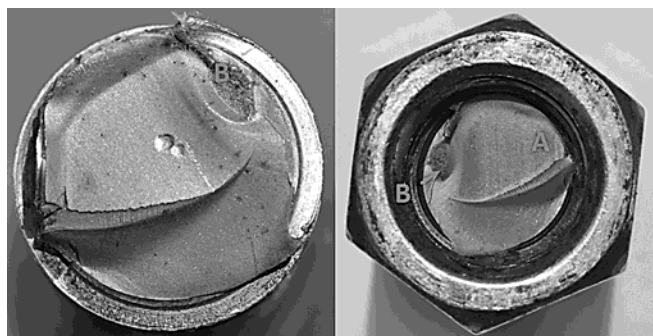
Fig. 7 View of the fatigue fracture region of the shaft I - Model A3300

The shaft I surface observed in Fig. 7 presented a region with a smooth aspect (A), corresponding to the area over which the crack spread slowly, and the smaller area (B) with a fibrous texture corresponds to the region the failure occurred. Quickly (catastrophic), which characterizes a fatigue failure.

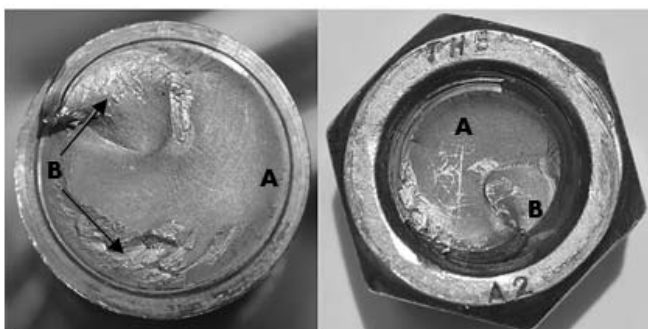
The B1 shaft, Fig. 8, presented two different types of fracture surface. On the right side, smooth surface (A), there is the fatigue zone, while on the other end, rough surface (B), the plastic zone is characterized by the appearance of tearing.

Fig. 8 View of the fatigue fracture region of the B1 shaft - Model A3300

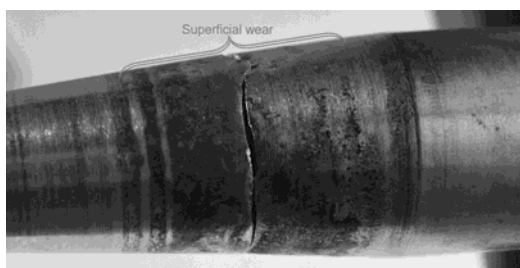
A superficial wear is visible on the PP axis of the A1700 wind turbine, where the part broke in the tapered transition region, favoring the initiation and propagation of cracks and fatigue failure, Fig. 9.

Fig. 9 View of the superficial wear on the fracture region of the PP axis - Model A1700

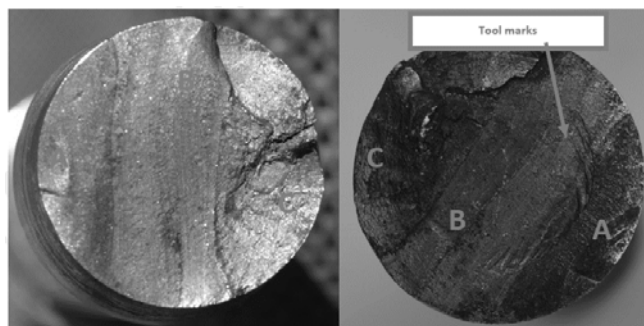
The fracture surface of the PP shaft can be seen in Fig. 10. Point A indicates the beginning of the crack that has spread, leaving "beach marks," indicated by point B and finally point C indicating the final region of the fracture. The fracture or rupture of the material usually occurs with the formation and propagation of a crack that begins at points where there is structural or compositional imperfection or a high-stress concentration, which generally occurs on the surface, as presented in the piece, where the wear marks and the consequent oxidation generated stress concentrating points. The darker coloration at point A shows oxidation and infiltration of contamination during the fracture's relatively long propagation stage.

Fig. 10 View of the fatigue fracture surface of the PP axis - Model A3300

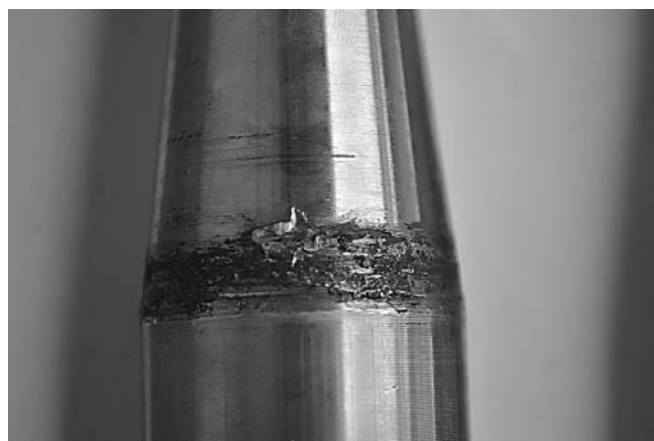
Similar wear was also observed in the B2 axis of the A3300 wind turbine, Fig. 11, and the other axes, however, with less intensity.

Fig. 11 Critical region of axis B2, due to loss of material due to wear (contact marks) and oxidation - Model A3300

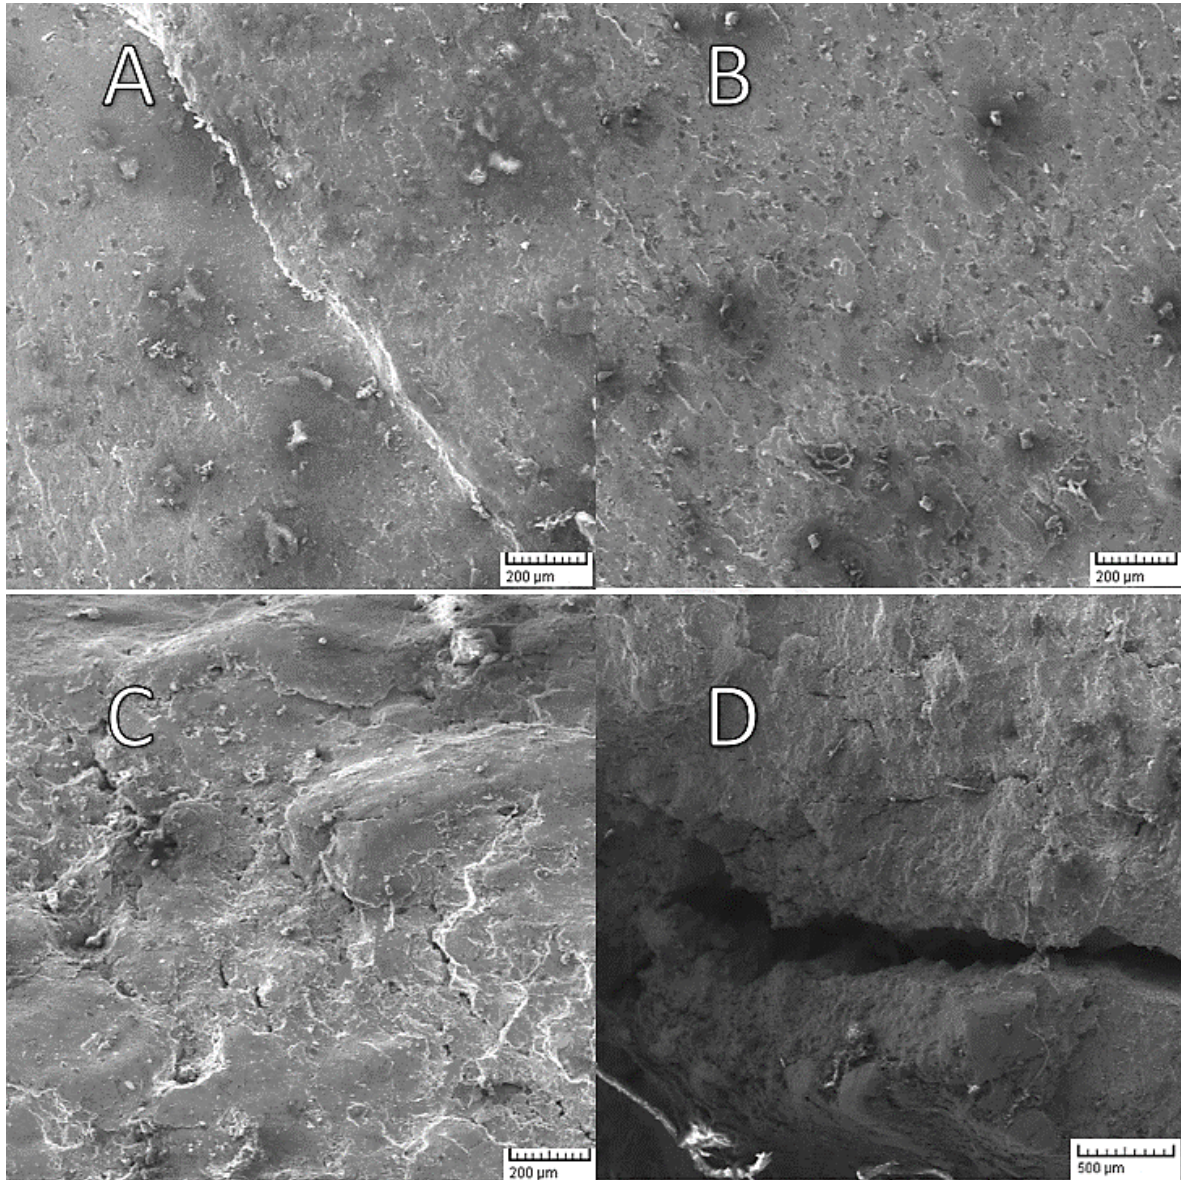
Fig. 12 SEM of the fractured region of the PP axis: A - region of the beginning of the failure, B - a region of the beach marks, C - a region of the catastrophic fracture with several secondary cracks, and D - secondary crack highlighted

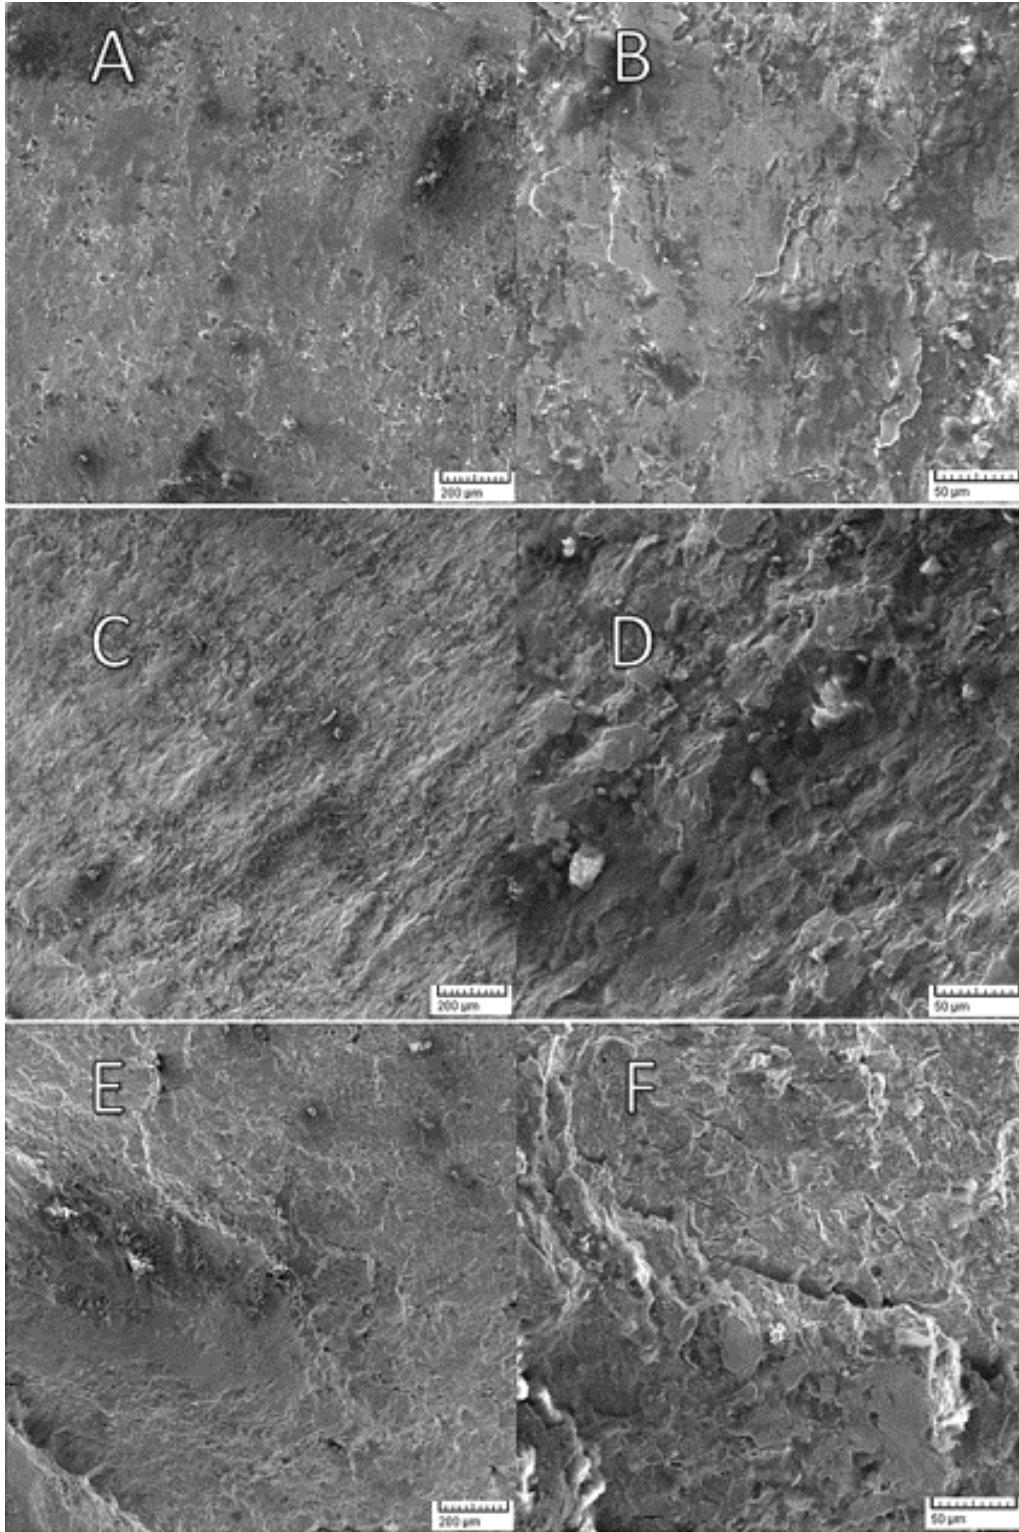
Fig. 13 SEM of the fractured region of the AP axis: A - a region of the beginning of the fatigue failure, B - detail of the region of fatigue in which the crack propagated slowly, C - a region of the beach marks, D - fatigue striation, high rate of deformation, E - catastrophic fracture region with secondary cracks and F - secondary crack highlighted

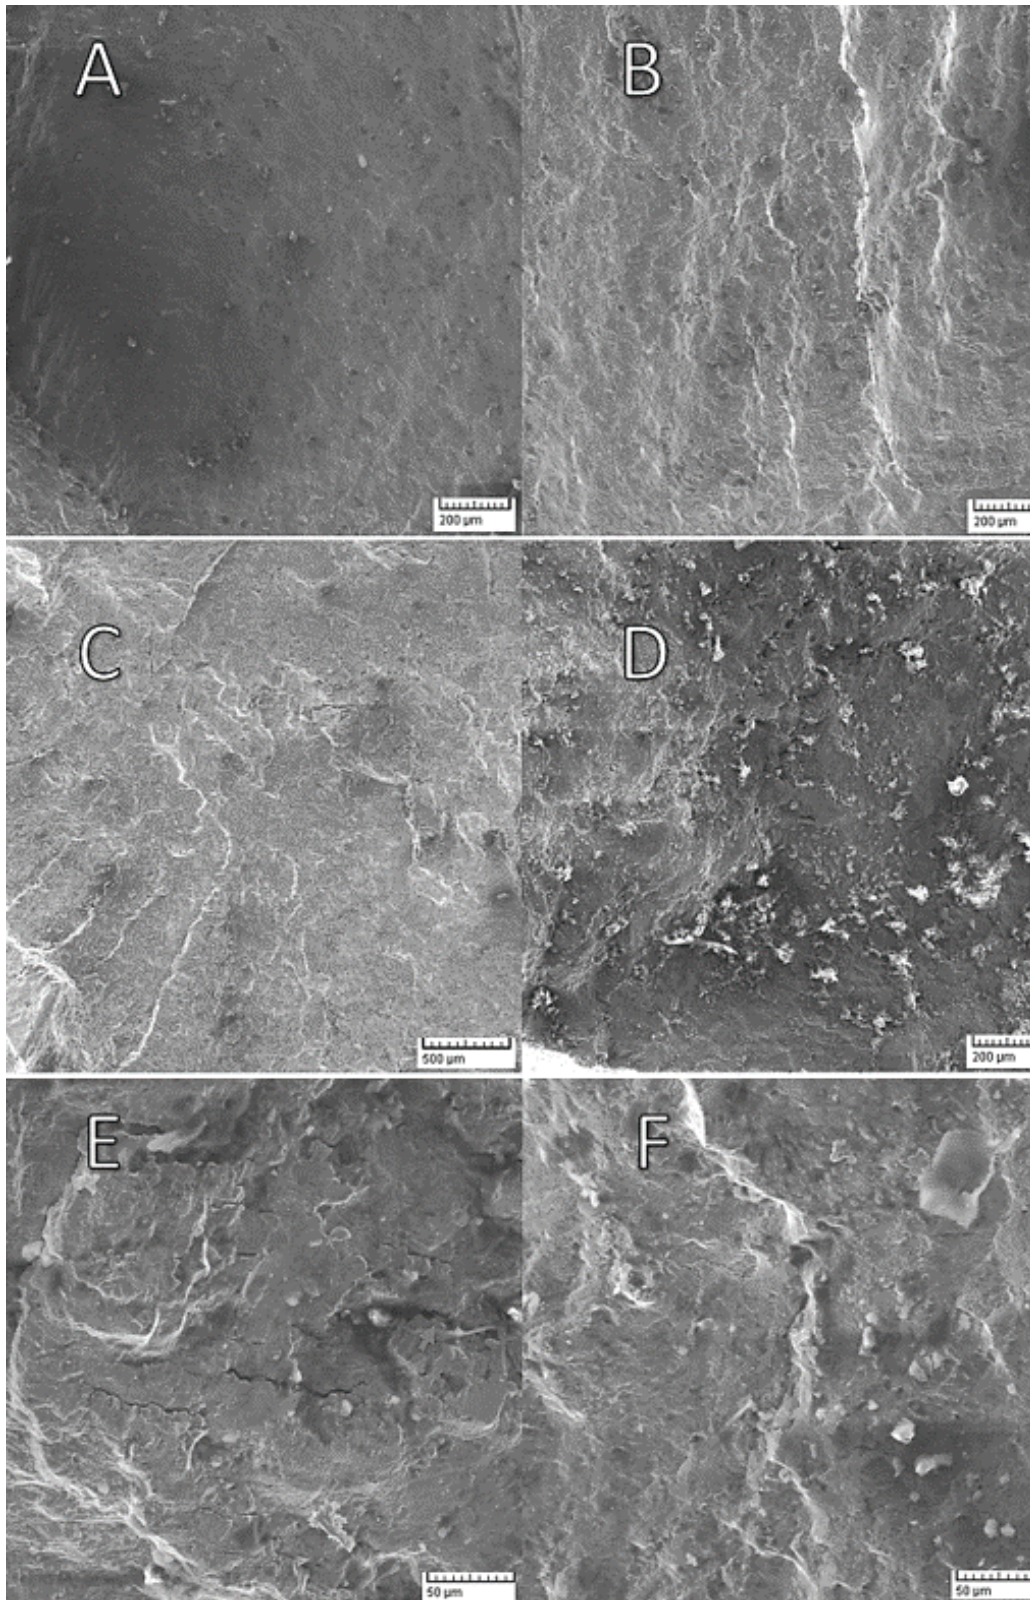
Fig. 14 SEM of the fractured region of the RA axis: A - region of the beginning of the fatigue failure, B - detail of the region of fatigue in which the crack spread slowly, the appearance of beach marks, C- a region of beach marks, D - region beginning of catastrophic fracture, the appearance of secondary cracks, E and F - regions of catastrophic fracture with secondary cracks

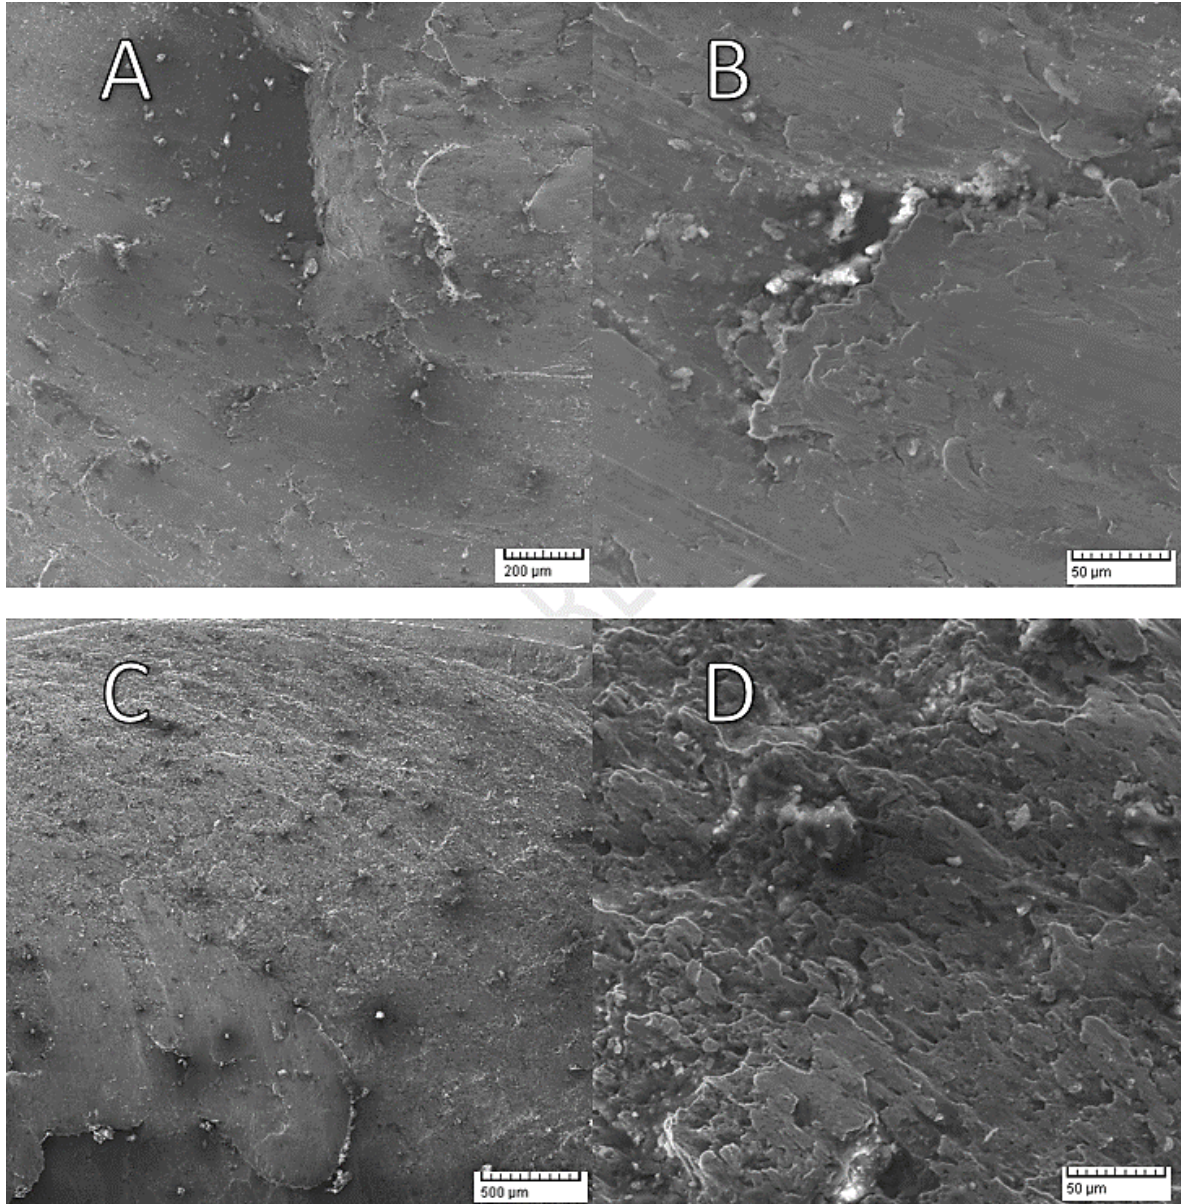
Fig. 15 SEM of the fractured region of axis I: A - region of the beginning of the fatigue failure, B - detail of the region of fatigue in which the crack propagated slowly, C - a region of slow/catastrophic failure transition D - a region of the catastrophic fracture

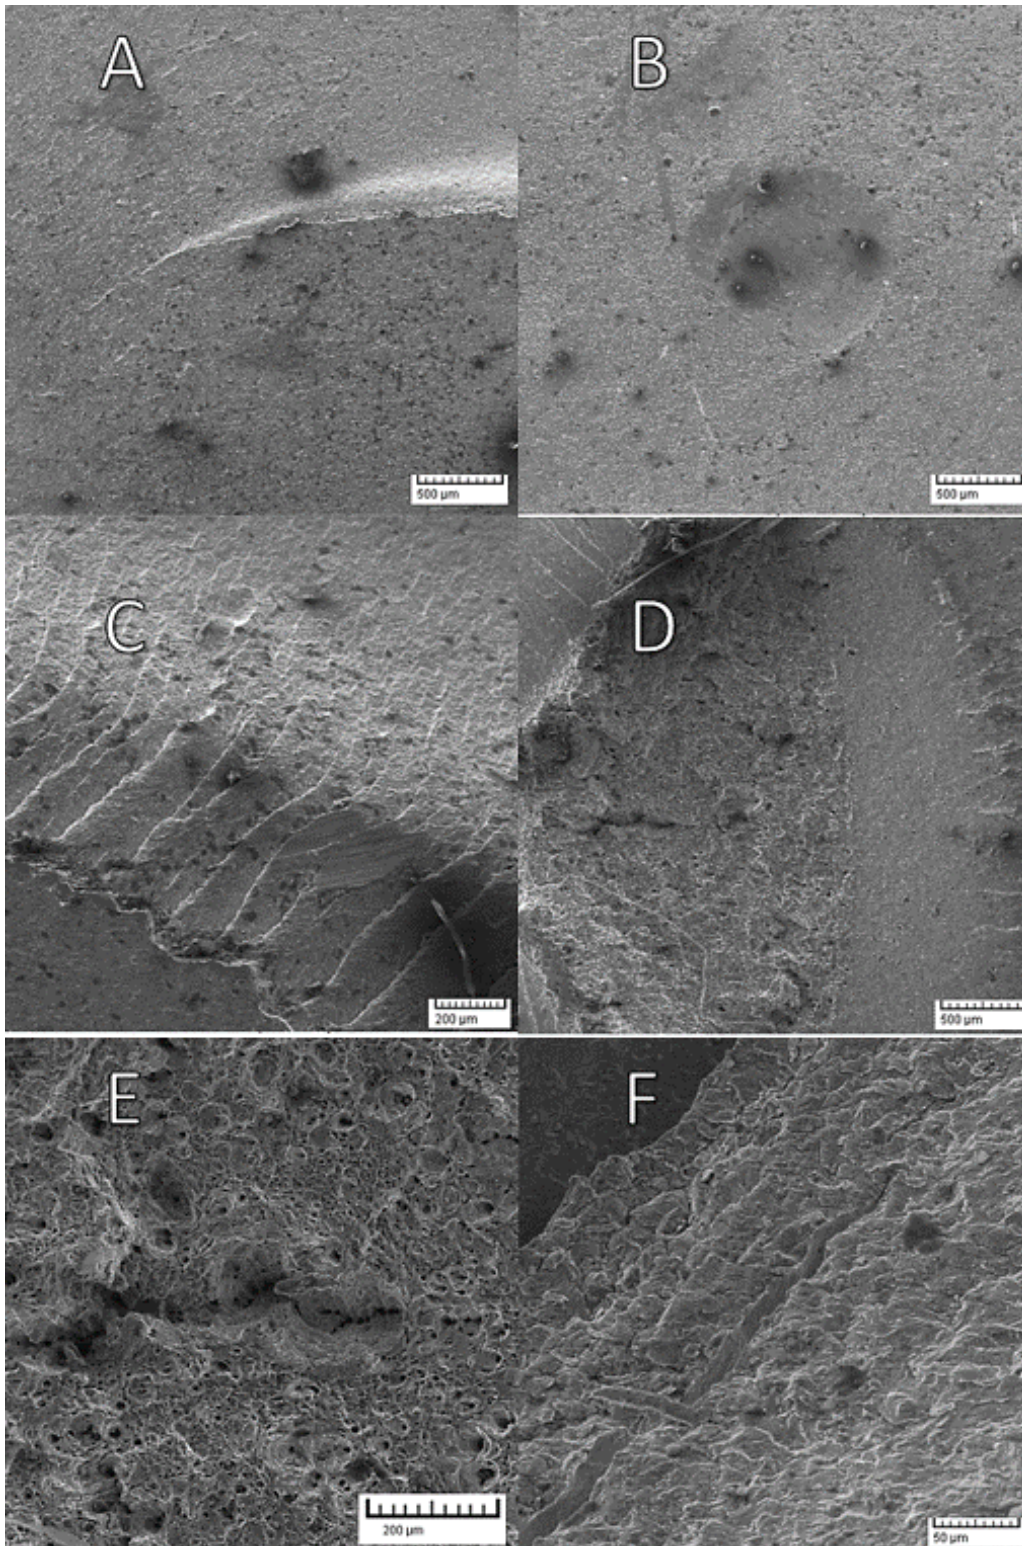
porosity found in the B1 axis demonstrates a possible manufacturing problem, since the presence of gases dissolved in the metal liquid can result both in the presence of various types of oxide inclusions, as well as in the formation of porosities of endogenous origin, that is, metallurgical causes, inherent to the quality of the metal cast in the molds. There are also exogenous origin defects originating from external causes, such as molds and leakage and feeding channel

Fig. 16 SEM of the fractured region of the B1 axis: A - region of the beginning of the fatigue failure, B - Inclusions, C - beach marks, D - a region of the beginning of the catastrophic fracture, the appearance of secondary cracks, E - secondary cracks and porosity and F - secondary crack
