Failure Analysis of a Fractured Control Pressure Tube from an Aircraft Engine

M. P. Valles-González, A. González Meije, A. Pastor Muro, M. García-Martínez, B. González Caballero

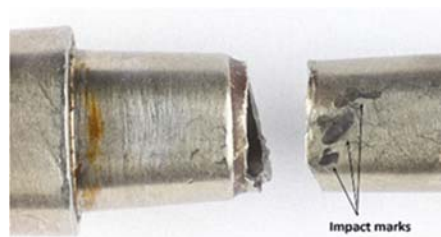
The fracture occurred in a plane of the cross-section that forms a 30° angle with the plane normal to the generatrix. It was located in the vicinity of the connector terminal junction area with the pipe. It exhibited some plastic deformation in diameter and most of the fracture surfaces showed a shiny and soft texture (Fig. 2).

Fig. 2 (a) Side view of the fracture area

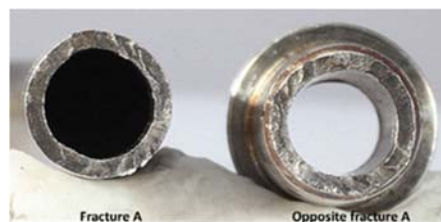
Fig. 2 (b) The fracture surface (A) and its opposite fracture surface

The fracture surface (A) shown in Fig. 2 (b) was inspected and six zones on this surface were selected for more detailed inspections, as shown in Fig. 3.

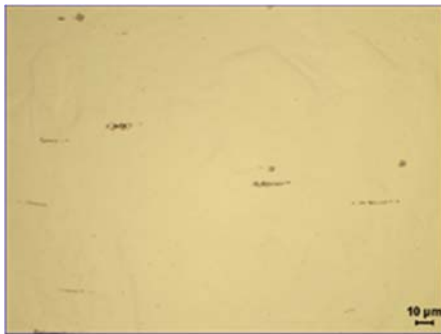
Fig. 4 (a) Carbides and carbonitrides chains aligned in the longitudinal direction of the tube

The tube material microstructure (Fig. 4) corresponded to equiaxed austenite grains with titanium carbides and carbonitrides and molybdenum carbides. All particles were analyzed by EDX resulting in the spectra shown in Fig. 5.

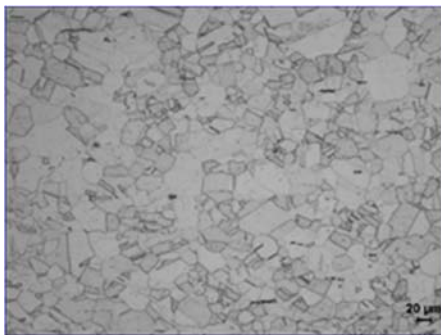
Fig. 4 (b) Austenitic microstructure

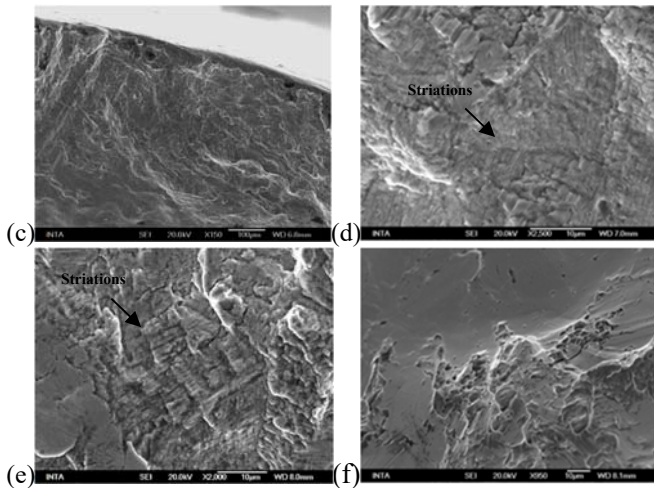
The fracture surface A was first inspected following the black observation line shown in Fig. 3, between zones 1 and 2. The fracture origin was located in zone 1, also showing in this area propagation lines and fatigue striations (Figs. 6 (a)-(d)) also present in zone 2 (Fig. 6 (e)). Some crushed microvoids were identified, indicating an overload fracture, Fig. 6 (f). Subsequently, another observation line was followed between zones 3 and 5, verifying the existence of another crack whose origin was located in zone 5, although it could not be identified because in this zone there were multiple crushes and it was highly oxidized. Fatigue striations were observed in zone 4 and some crushed microvoids in zone 3, Fig. 7. Due to the multiple crushing in zone 6, no microfractographic features could be identified. A surface with multiple defects and marks was observed on the outer wall surface of the tube near zone 1 (Fig. 8).

In this study, at least two crack origins were located. In both cases, fatigue striations, typical of a progressive fracture, were observed, leading to a final fracture by static overload.

Fig. 6 (a) Zone 1. Overview of the crack origin in fracture A, (b) Fracture origin, (c) Fracture propagation zone, (d) Fatigue striations, (e) Zone 2. Fatigue striations, (f) Crushed microvoids

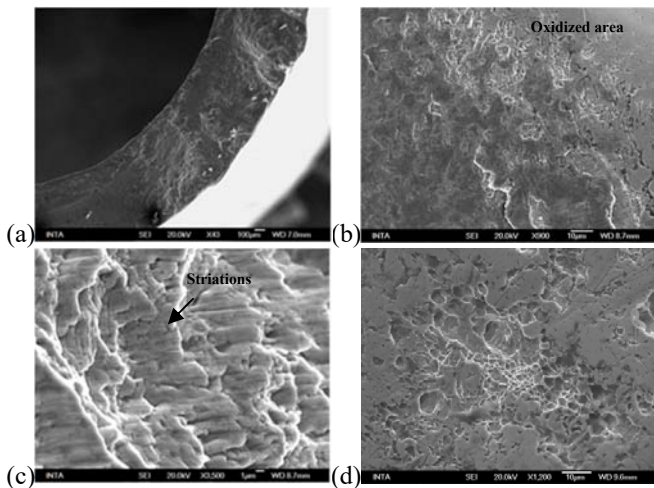
Fig. 7 (a) Zone 5. Overview of the crack origin in fracture A, (b) Oxidized zone, (c) Zone 4. Fatigue striations, (d) Zone 3. Crushed microvoids

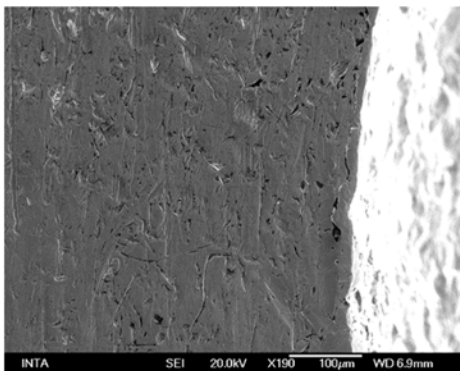
Fig. 8 Zone 1. Multiple defects on the surface

The fracture mechanism was fatigue, which could have originated from the multiple defects observed on the external surface of the pipe and where the cracks could have progressed due to the vibrations to which the pipe was

Regarding the stresses introduced during the tube assembly, it was recommended that the tightening of the tube end nuts should be done at the same time, to avoid misalignment of the tube ends with their housings, which could lead stresses. Considering the handling of tube as a critical stage, the tightening sequence of the tube ends should be established in the maintenance manual of the engine aircraft. And, in the event that this maintenance manual does not establish any type of inspection of the tube assembly, it would be advisable to perform different visual inspections and penetrate testing.

To absorb vibrations, it was recommended to install clamping flanges surrounding the tube with some type of elastomeric material.

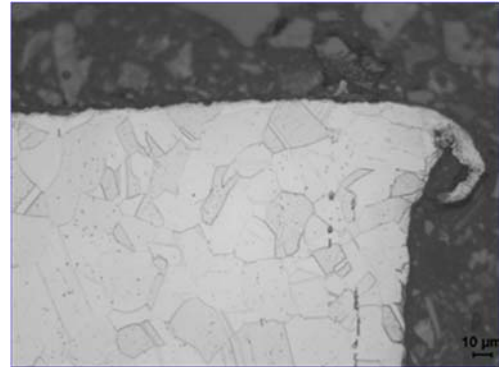
In order to analyze the fracture surface grains in the zone 1, a longitudinal section of the opposite fracture surface was mounted and etched to reveal the grain crystallinity. Fig. 9 shows that the fracture exhibited a transgranular profile.

Fig. 9 Transgranular profile of the opposite fracture surface. Zone 1
