Monitoring and Analysis of Bridge Crossing Ground Fissures

Zhiqing Zhang, Xiangong Zhou, Zihan Zhou

Keywords—Bridge monitoring, ground fissures, typical disease, structural displacement.

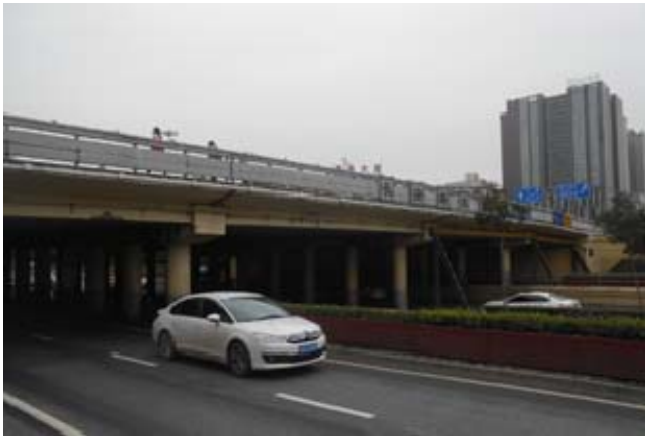
Fig. 1 Outside view of Chang'an Road Interchange

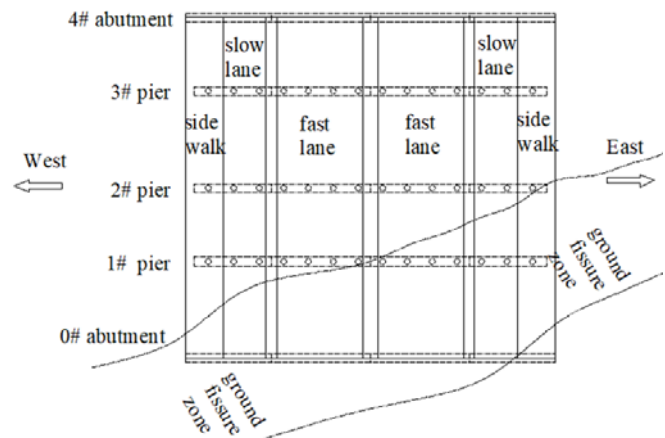
There is an F6 ground fissure under Chang'an Road Interchange; see Fig. 3 for the distribution of ground fissures around the bridge. The fissure has a long extension distance and a curved plane distribution. After crossing the interchange in

the east, it extends along the direction of NE 55 ~ 65° and enters the Caochangpo village. There are obvious staggered deformations on the kerb near the interchange and the pier column under the bridge. From 1990 to 1999, the average activity rate of F6 ground fracture is 41 mm/a, and the maximum is 49.42 mm/a. The average activity rate from 2002 to 2005 is 3.1 mm/a. From the geological exploration results, there are obvious differences in the physical and mechanical properties of the rock and soil on both sides of the ground fracture: the water content on the north side of the ground fracture is 19.2%, and that in the south side is 26.1%. The compression coefficient of the north plate is 0.22 MPa⁻¹, that of the south plate is 0.35 MPa⁻¹, and the dry density is 14.9 kN/m³. The shear strength C value has little difference, and the φ value is increased by about 10°.

Fig. 3 Distribution of ground fissures around the bridge

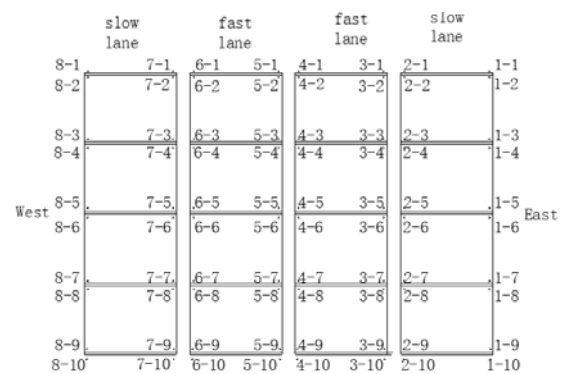
Fig. 4 Map of bridge deck elevation measuring point

According to Table I, during the monitoring period, the elevation of the bridge deck at the northwest side has an overall upward trend, with an upward range of 1-6 mm. The elevation of the bridge deck at the southeast side of the ground fissure also has a rising trend, with a rise of 1-5 mm. In the ground fissure area, the southwest corner of the bridge deck is in a state of decline, with a maximum decline of 4 mm. The deck in the northeast corner rises a little.

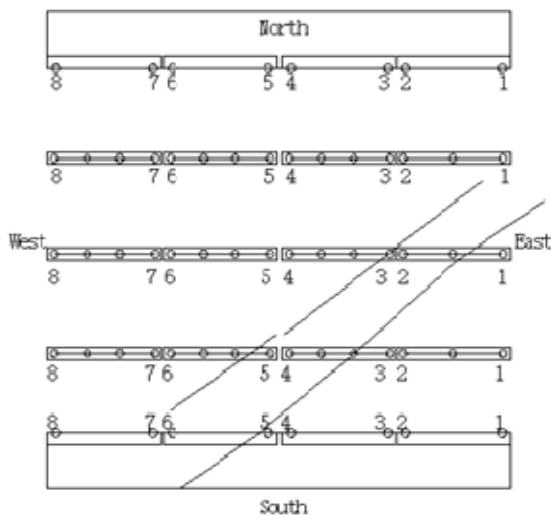
Fig. 5 Abutment and pier elevation monitoring

given in Table II. According to Table II, during the monitoring period, the change rule of the pier's elevation is that the pier (abutment) in the southwest corner is in a descending state. The maximum decline range is 4.5 mm (the maximum change value is at No. 6 measuring point of 1# pier). The pier in the northeast corner rises a little. Outside the ground fissure area, the pier (abutment) is in the rising state, and the maximum rising range is up to 7.5 mm.

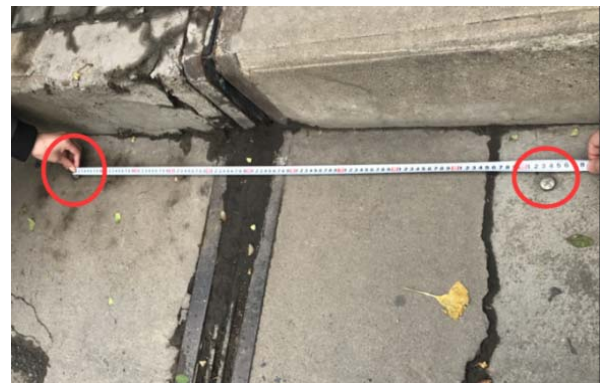
Due to the influence of ground fissures and uneven settlement, the pier and abutment settlement of Chang'an Road Interchange is staggered. This causes the bearing void, displacement, and inclination of the beam structure. These typical diseases reflect in the vertical dislocation, the horizontal tension, and extrusion of the expansion joint. Part of the expansion joint is squeezed, which loses the deformation function of the expansion joint and affects the working state of the bridge. To further understand the deformation trend of the expansion joint, we measure and analyzed the expansion joint width once a month. We use the measurement of the distance of the cross screw on both sides of the expansion joint to monitor the width change of the expansion joint (Fig. 6).

Fig. 6 Measuring point of expansion joint width

According to Table III, the width of the first and second expansion joints from south to north tends to increase, with a maximum cumulative increase of 4 mm. The width of the third, the fourth, and the fifth expansion joints tends to decrease, with a maximum cumulative decrease of 5 mm.

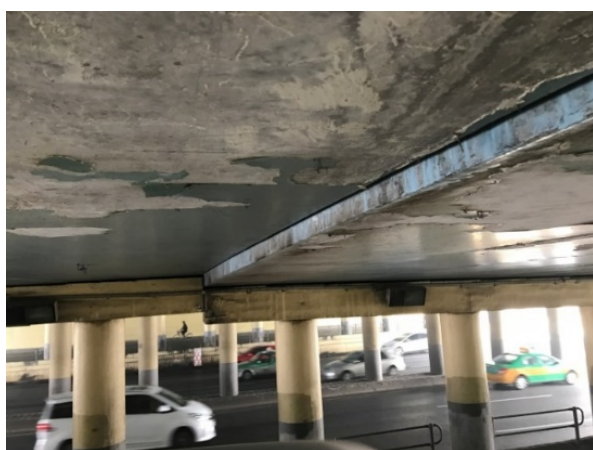
The second and third bridges built on 1# pier from the east are located in the ground fissures, and the height difference is greatly affected by the ground fissures as shown in Fig. 7. The observation point is the end of the cap beam on No. 7 and No. 8 columns of 1# pier. As a key monitoring object, the height difference of the capping beam is measured once a month. The layout plan of abutment and pier measuring points is shown in Fig. 5.

Fig. 7 Height difference of capping beam

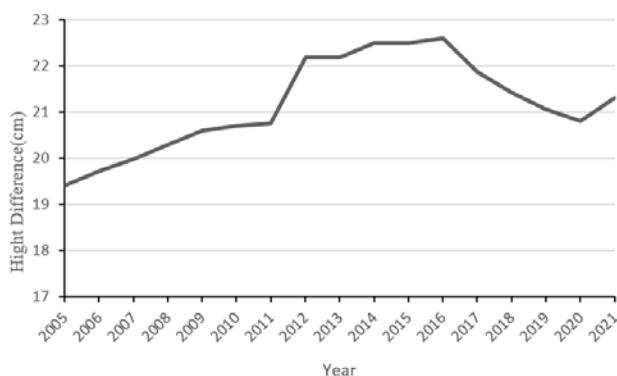
Fig. 8 Change of relative height difference of capping beam over years (cm)

The changing trend of the relative height difference between the West 2 and the West 3 capping beams of 1# pier over the years (from 2005 to 2021) is shown in Fig. 8. According to Fig. 8, the relative height difference of the capping beam tends to be smaller after 2016. At the end of the monitoring period (November 2021), the height difference reached 21.3 cm, which was increased compared with 20.8 cm at the beginning of the monitoring period (December 2020). During the 2020-2021 monitoring period, the relative height difference of the capping beam has a growth trend of 5 mm, and it is stable at 21.3 cm in the last three months. In addition, according to the monitoring data of 2# pier, the distance between the East 1 and the East 2 capping beams is stable at 19.3 cm during the monitoring period. It shows that the ground fissures increase but have little effect on the displacement of the piers in this observation period.

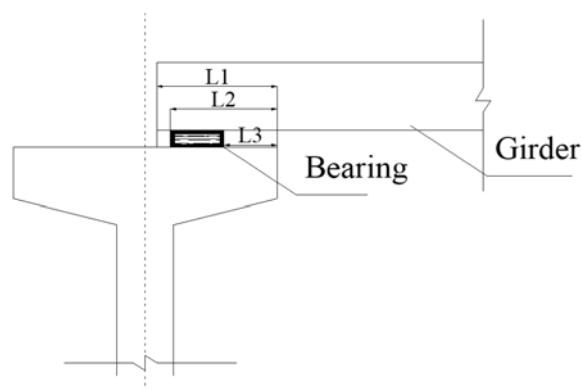
Fig. 9 Schematic diagram of bearing deflection measurement

From the measurement data (from December 2020 to November 2021), it can be concluded that most L1-L2 ≥ 5 cm, only six bearings L1-L2 < 5 cm, and the smallest is 1.0 cm. This is because the bearing is placed too close to the middle of the capping beam. Therefore, it can be seen that the cantilever length of the hollow slab on the upper part of the support is greater than 0, which has a certain amount of safety margin, and there is no risk of falling the beam under normal conditions. In addition, it is found that some bearings have obvious shear deformation in the process of monitoring.
