# Failure Analysis of a 304 Stainless Steel Flange Crack at Pipeline Transportation of Ethylene

**Abstract**—In the current research, a catastrophic failure of a 304 stainless steel flange at pipeline transportation of ethylene in a petrochemical refinery was studied. Cracking was found in the flange after about 78840h service. Through the chemical analysis and tensile tests, in addition to microstructural analysis such as optical microscopy and Scanning Electron Microscopy (SEM) on the failed part, it found that the fatigue was responsible for the fracture of the flange, which originated from bumps and depressions on the outer surface and propagated by vibration caused by the working condition.

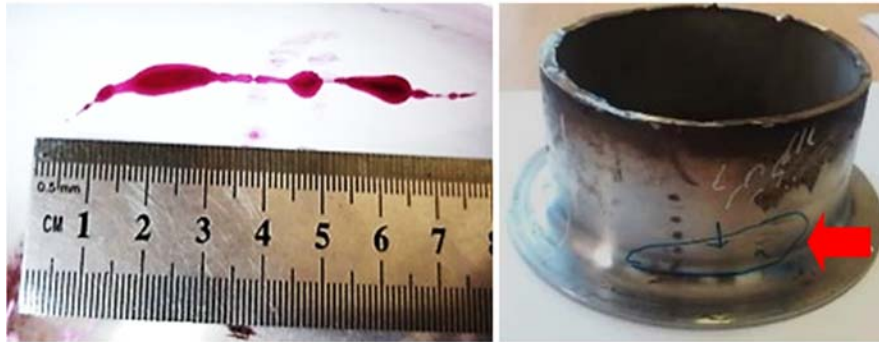
As shown in Fig. 1, the penetration testing result of the damaged flange reveals an 80 mm crack in the deformed part of the flange. Also, a closer visual examination shows that the cracking propagated from the internal surface through the wall. After crack initiation, the cracking has propagated through the thickness of the flange. Plus, in the outer surface of the part some circumferential bumps and depressions on the outer

surface were observed which seems they stemmed from the production (machinery) process.

Fig. 1 Detected crack in the damaged flange (arrow)

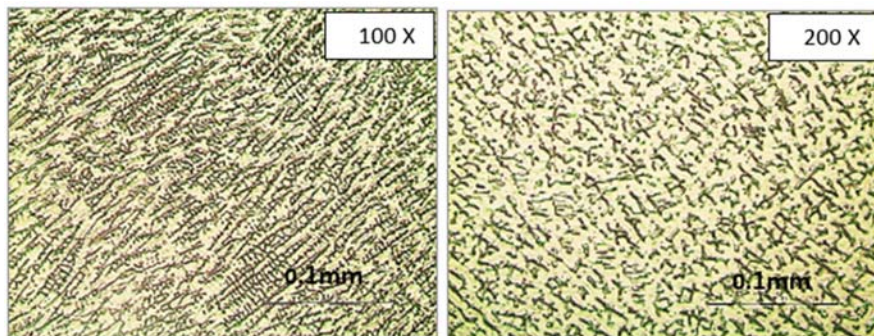
Fig. 2 The microstructure of the weld zone

To investigate the microstructure of the flange, specimens were cut from a section of the flange just near the premature crack by wire-cutting. The samples were mounted in Epoxy and polished to a mirror finish using emery papers up to 2400 grit followed by final polishing using 0.05  $\mu\text{m}$  alumina powder. Then, they immediately etched via concentrated nitric acid. Fig. 2 shows the metallographic images of the weld zone and Figs. 3 and 4 show the metallographic images of the fusion line and the base-metal, in turn. Microscopic examination revealed that the weld area has no welding defects and is composed of a combination of two phases of delta ferrite and austenite, while the base metal microstructure consists of austenite grains in which a large number of twins and strain lines resulting from the production process can be seen [16]. Besides, some impurities are observed in the microstructure.

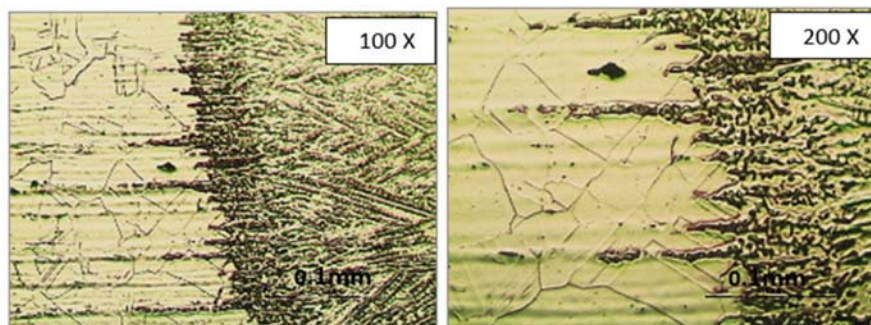
Fig. 3 The microstructure of fusion line

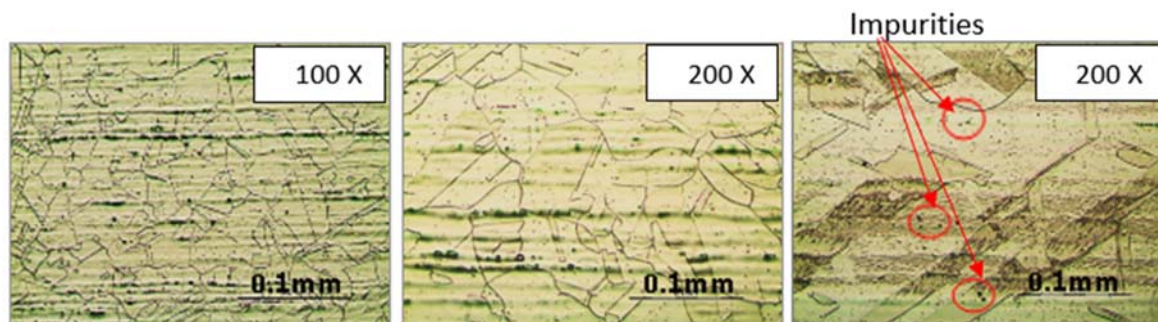
Fig. 4 The microstructure of base metal

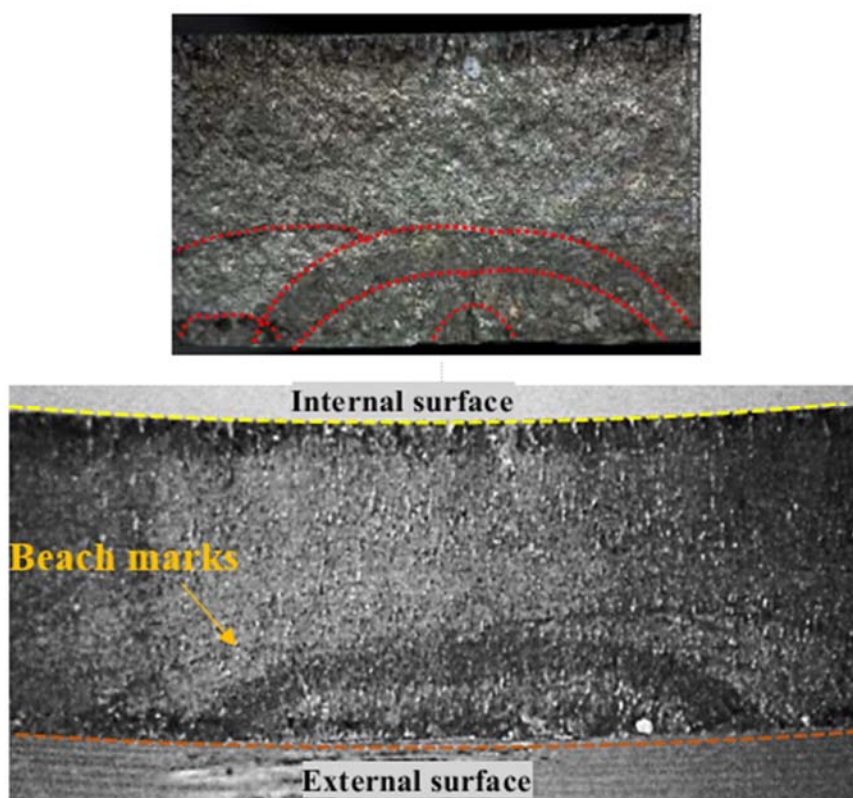
Fig. 5 The stereo microscopic images of the fracture surface

Taken images showed that the fracture surface was approximately smooth. Besides, as highlighted in Fig. 5 (the red dotted line), some arc features clarified that could be beach marks resulted from fatigue phenomenon [17]. Since the flange was operated in a situation in which nearly high vibration existed (Table I), occurrence of fatigue is predictable. Moreover, the different orientations of the arcs indicated the presence of various fatigue sources [18], [19]. Since the center of the beach marks depicts the crack origin [20], it should be noted that all of the fatigue cracks initiated from external surface. As mentioned earlier, on the outer surface of the flange, just close to crack, some bumps and depressions resulted from poor finishing were observed. These regions are capable of performing as fatigue crack origins because of stress concentration [21]. Researchers also reported that there is a direct relationship between surface smoothness and fatigue life.

Therefore, surface roughness can develop fatigue in a situation which cyclic stress are existed [21]-[23].

To prevent a similar failure, it is suggested that the applied stresses to the material should be decreased. Moreover, to

prevent and control the fatigue phenomenon, it is recommended to use more clean steel (with a low amount of impurities) and suitable surface finishing.

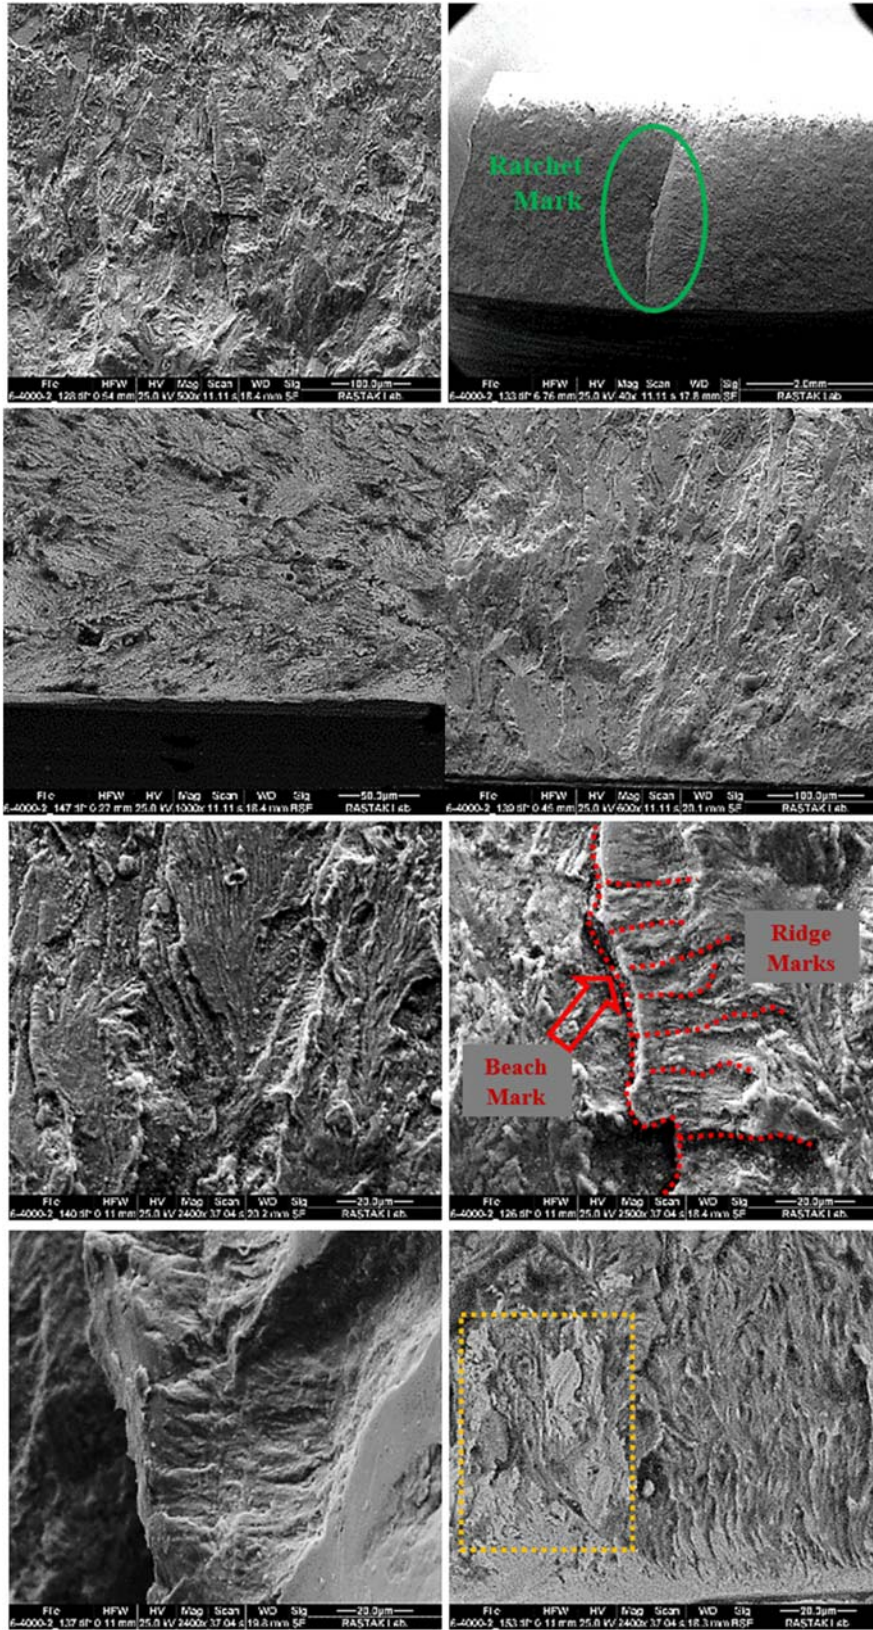
Fig. 6 The SEM images of the fracture surface

The fracture surface was studied by SEM, too. The beach and ridge marks in the SEM images in Fig. 6 revealed that the fatigue phenomenon was the main reason for the crack initiation. Furthermore, the micro-cracks observed showed that the fatigue phenomenon had been dynamic and progressive in the third dimension. It could be noted that the beach marks form as a curve around the crack source, whereas the ridge marks generate just along with the crack source [24]-[26].

When several fatigue sources exist in the specimen, not only do the ridge marks appear along with the crack source (perpendicular to beach marks), but also form between two beach marks produced by two different sources and result in the propagation of the integrated crack [18], [19]. The investigation of SEM images near the flange surface determined that the closer to the flange surface the wider cleavage surfaces (the orange rectangle in SEM image in Fig. 6) occur which is evidence for higher stress on the flange surface [27]. Thus, the stepwise surface (highlighted by the green oval in the SEM image in Fig. 6) which was named the Ratchet mark, was observed in the failed flange, because the stress concentration was high in the zone or thermal cycle was exerted on the specimen [18]. But in this case, the first scenario is more probable since, in the operation condition, temperature has been varied between 53-58 °C.

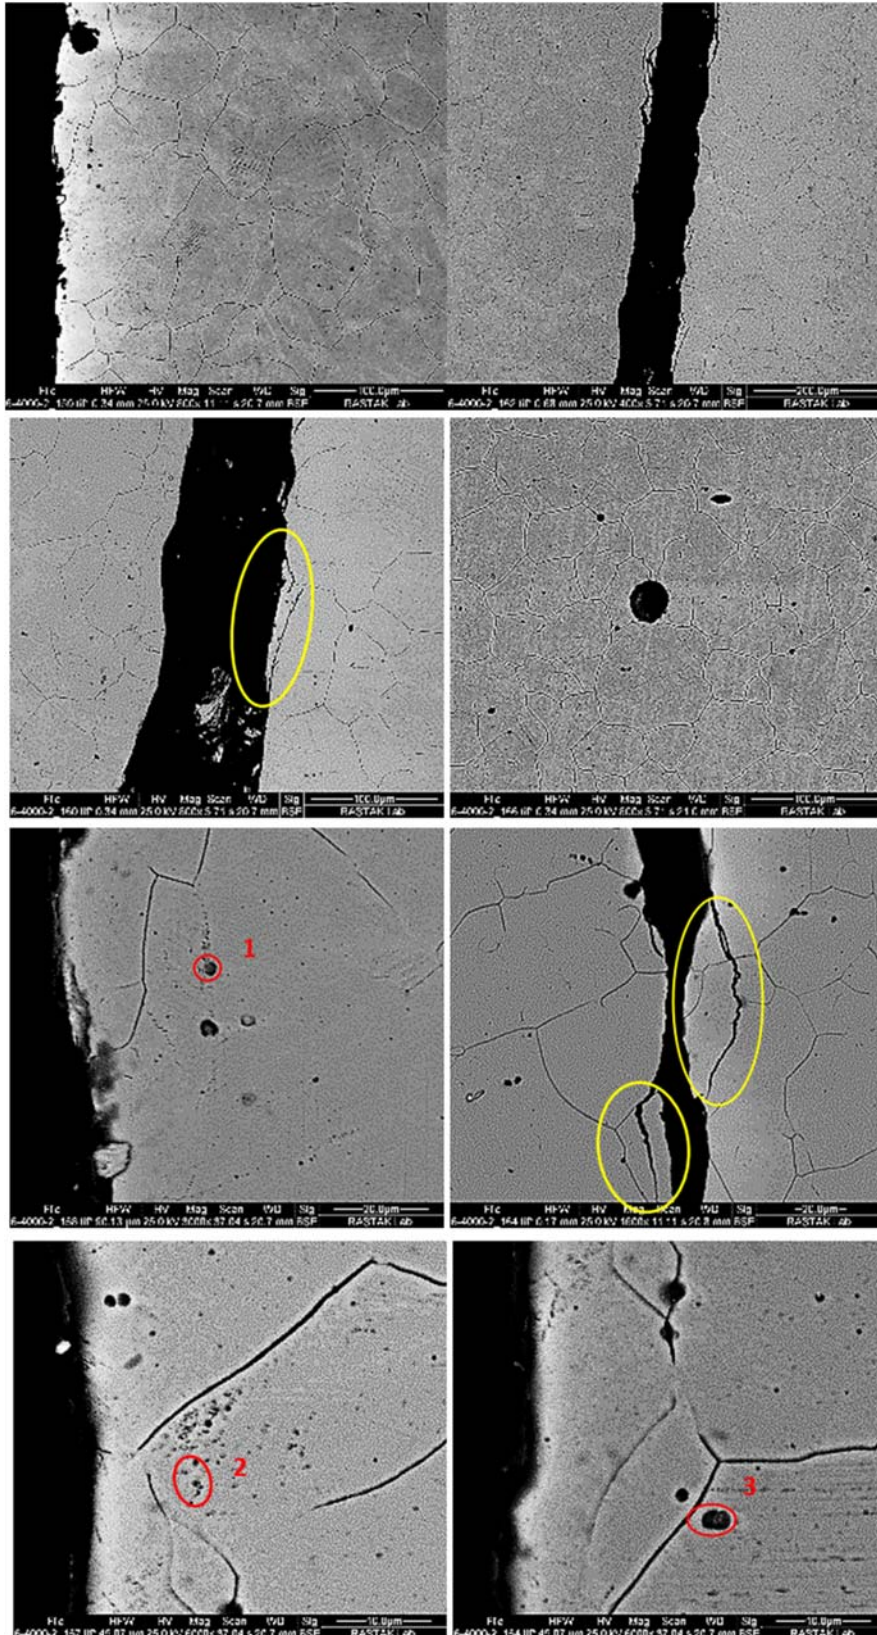
Fig. 7 SEM from the crack and the microstructure

Finally, to investigate the crack propagation in the base metal, a specimen such as the crack tip was chosen from the flange and microscopically studied. Fig. 7 represents the SEM images of the specimen along with the crack including microstructure and impurities. The images showed austenite microstructure with some impurities that the EDS results of these points shown in Figs. 8-10 and Tables IV-VI. These impurities include carbonitride, Si, alumina, and S, generally which are typical in stainless steels. As can be seen in SEM images, these impurities are small in size and sphere in shape and because of that, it seems that they were benign for the

specimen fatigue life [28]. The crack branches are shaped very thin and direct (denoted by yellow-ovals). They were also transgranular and did not propagate along with inclusions which proved the non-destructive nature of existence impurities.

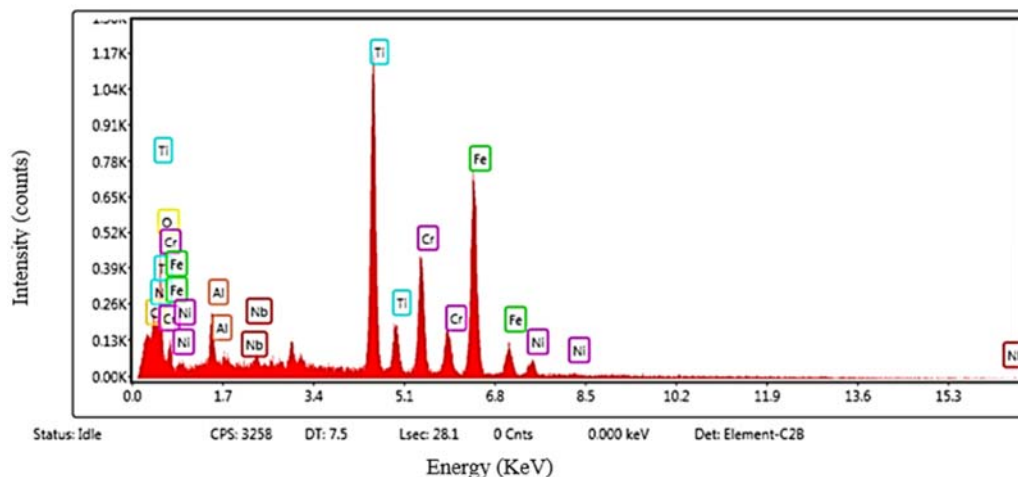
Fig. 8 EDS from point 1

TABLE IV  
 EDS ANALYSIS RESULTS OF POINT NO.1 IN FIG. 8

Element	Atomic (%)	wt%
C K	18.95	8.09
N K	9.75	4.85
O K	32.46	18.46
AlK	4.07	3.91
NbL	0.02	0.05
TiK	12.6	21.45
CrK	6.46	11.94
FeK	14.41	28.6
NiK	1.27	2.65

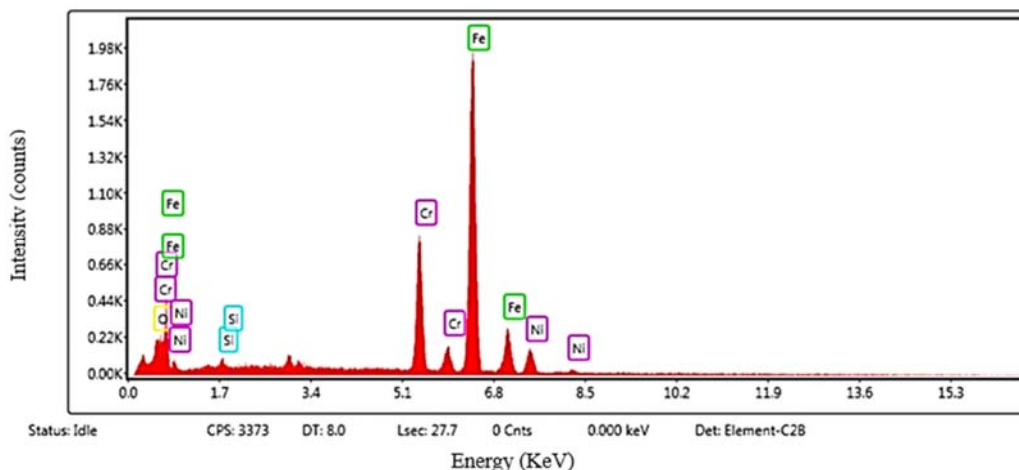
TABLE V  
 EDS ANALYSIS RESULTS OF POINT NO.2 IN FIG. 9

Element.	Atomic (%)	Wt%.
O K	5.63	1.71
SiK	1.34	0.71
CrK	18.5	18.25
FeK	67.55	71.55
NiK	6.99	7.78

Fig. 9 EDS from point 2

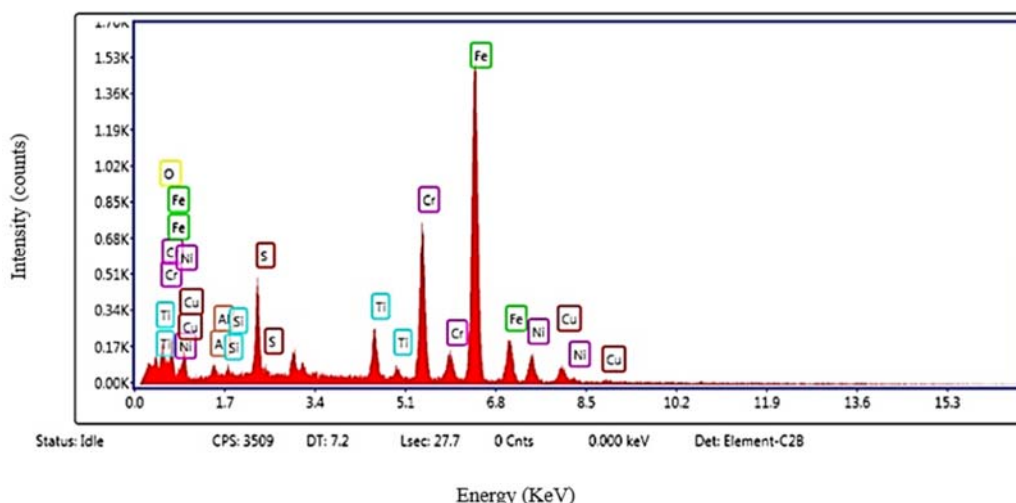
TABLE VI  
 EDS ANALYSIS RESULTS OF POINT NO.3 IN FIG. 10

Element.	Atomic (%)	Wt%.
O K	8.99	2.94
AlK	2.16	1.19
SiK	0.6	0.34
S K	8.34	5.46
TiK	4.1	4.01
CrK	15.74	16.7
FeK	50.95	58.08
NiK	5.46	6.55
CuK	3.66	4.74

Fig. 10 EDS from point 3
