# Analysis and Preservation of Lime-Kilns in Corsica

A. Papalou, K. Vozikis

*Keywords*—industrial heritage, lime kilns, post-tensioning, preservation

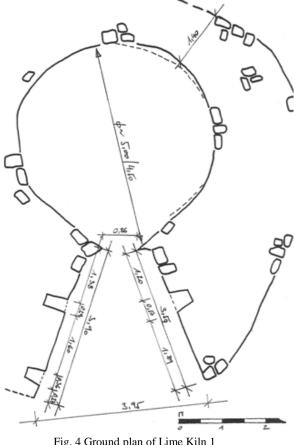
Fig. 4 Ground plan of Lime Kiln 1

This kiln has been partly built adherent to the hillside (almost two thirds of it). The rest of the kiln is constructed of stone walls with mortar. The thickness of the walls varies from 1.4 up to 3.6 m close to the entrance. The inside diameter of the chimney is around 5 m at the bottom (Fig. 4), narrowing gradually and reaching 4.5 m at the top. The entrance foyer of this lime kiln is almost 4 m long. The gate for entering the foyer is also almost 4 m wide, narrowing gradually until the door where the firing occurred. This firing door is today around 0.85 m wide. In this foyer, three 0.5 x 0.5 m niches still exist.

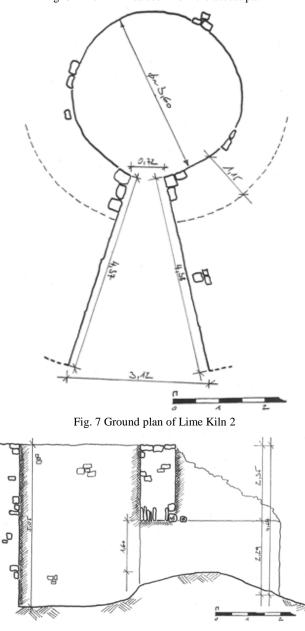
Fig. 8 Section of Lime Kiln 2

Lime kiln 2 (Fig. 6) also belongs to the Community of Rogliano and is located next to lime kiln 1. This lime kiln is much smaller than lime kiln 1. The inside diameter of the kiln's shaft measures only 3.6 m, and is constant from bottom to top (Fig. 7). This structure has also been partly built into the hillside. The rest of the kiln form walls built with mortar of 1.15 m wide. An entrance foyer is still visible, but not so well maintained. The entrance width is about 3 m and the distance from the corridor to the firing door almost 4.5 m. The firing door is 0.72 m wide and 1.60 m tall and is better preserved than the previous one (Fig. 8). The firing door dimensions of these two lime kilns are similar, although the shaft's dimensions vary considerably. The shaft of this kiln is in good condition in contrast to the outside part of the foyer. The kiln's height is today approximately 5 m. Two wooden beams still exist at the firing door opening. Lime kiln 2 was probably using the same quarry as lime kiln 1. This kiln is also visible and easily reachable from the custom footpath although its outside part is completely covered by maquis.

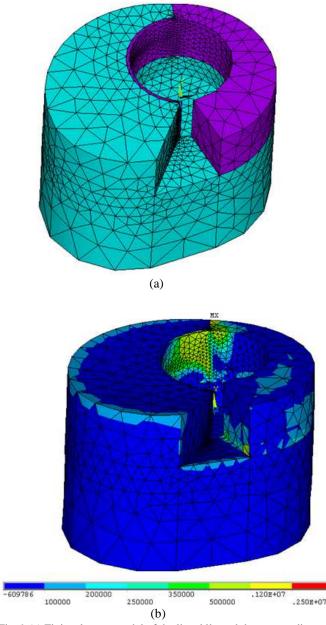
Structural analysis was performed on a typical limn kiln using the finite element method. The dimensions used for the model are representative of the dimensions of the lime kilns of Corsica and are based on the dimensions of lime kiln 1. In the finite element model the soil underneath the kiln was considered to extend up to 4 m. The thickness of the soil was 1.5 m at the junction of the thick stone wall with the soil, 10 m in the middle and 4 m next to the entrance (Fig. 9(a)). Extended dimensions of the soil were considered so that the kiln's existence had small influence on the soil at the end of the model where the boundary was considered fixed. A masonry wall of 0.20 m thickness was attached to the soil inside the shaft. Based on observations of the soil and masonry walls of the lime kilns in Corsica, the following properties were used to represent appropriately the materials that compose the lime kilns: the soil's density was  $1800 \text{ kg/m}^3$ , the modulus of elasticity 35 MPa, and the Poisson's ratio 0.24. The masonry's wall density was 2100 kg/m<sup>3</sup>, the modulus of elasticity 2500 MPa, the Poisson's ratio 0.24, the compressive strength 2.5 MPa, and the tensile strength 0.25 MPa. The materials were considered homogeneous and isotropic. Only dead load was considered. Static analysis was performed using the structural analysis software Ansys. The masonry and the soil were modeled using a 10 node, 3-D solid element. The results are presented in the form of contour plots of the first principal stress (in Pa). Fig. 9(b) shows that the masonry walls are the most stressed parts of the lime kiln. Most of these high stresses are due to the pressure that the existing soil exerts on the masonry structure. In particular, the most stressed areas are the area around the junction of the thick wall with the soil (extended to the thin wall inside the shaft), and the lower part of the thick masonry wall at the entrance. At these areas the stresses exceed the tensile strength of the wall. These results explain the damages appearing on the lime kilns not only in Corsica but elsewhere also (Fig. 6) where the stones have fallen inside the shaft and the entrance wall has been destroyed.

Fig. 9 (a) Finite element model of the lime kiln and the surrounding soil examined (light blue colour represents the soil and dark purple the masonry) (b) First principal stress (in Pa) of the lime kiln and the surrounding soil

Lime kilns are historical structures of every country's industrial heritage and an effort must be made for their restoration and preservation. This can be accomplished by removing any vegetation that has grown, replacing the mortar and stones that have been fallen or are in poor condition, and strengthening the areas of high stress. Several methods can be considered for increasing the strength of this structure and reducing the danger of future damage. One of these methods is the post-tensioning that has been used to strengthen several historical structures in the past [11]. A significant advantage of this method is its reversibility, keeping the structure in its original form something highly desirable for historical structures according to the directions of the Charter of Venice [12]. In this method stainless steel tendons are placed in any direction needed and are tensed with an initial stress that can

tie the structure and reduce the danger of failure. The tendons not only stabilize the structure but also apply compressive stresses to the walls they are tied on, reducing the tensile stresses that may exist. The post-tensioning system must be designed for the case in hand, selecting appropriately not only the properties of the tendons but also their location and the anchoring technique.

Post-tensioning can be applied to all the high stressed areas of the lime kiln considered, especially around the junction of the thick masonry wall with the soil. The usefulness of this method in reducing the high stresses was examined by performing finite element analysis on the same lime kiln model considered earlier. A few tendons were applied inside the shaft to tie the thin wall with the soil. The steel tendons used were modeled in Ansys using link elements and had the following properties: modulus of elasticity of 180 GPa, Poisson's ratio of 0.3, total area of 800 mm<sup>2</sup>, and initial strain of 0.00028. Fig. 10 shows the principal tensile stresses at the junction of the stone wall with the soil with the steel tendons. The existence of the tendons reduces drastically the stresses at the area around the tendons. All high tensile stresses will be reduced as more tendons will be applied to tie the stone wall to the soil securely.
