Behavior of RC Buildings to Tsunami Action

Carlos H. Cuadra

Abstract—The present report describes the characteristics of damages and behavior of reinforced concrete buildings during the tsunami action. The discussion is based on the field damage survey in selected cities located on the coast of the zone affected by the Great East Japan Earthquake on March 11, 2011. This earthquake is the most powerful know earthquake that has hit Japan with a magnitude 9.0 and with epicenter located at 129 km of Sendai city (off the coast). The earthquake triggered a destructive tsunami with run up height of up to 40 meters that mainly affect cities located on the Pacific Ocean coast of the Tohoku region (north-east region of Japan). Reinforced concrete buildings in general resist the tsunami without collapse however the non-structural elements like panels and ceilings were severely damaged. The analysis of damages has permitted to understand the behavior of RC buildings under tsunami attack, and has also permitted to establish recommendations for their use to take refuge from tsunami in places where natural topography makes impossible to reach hilltops or other safer places.

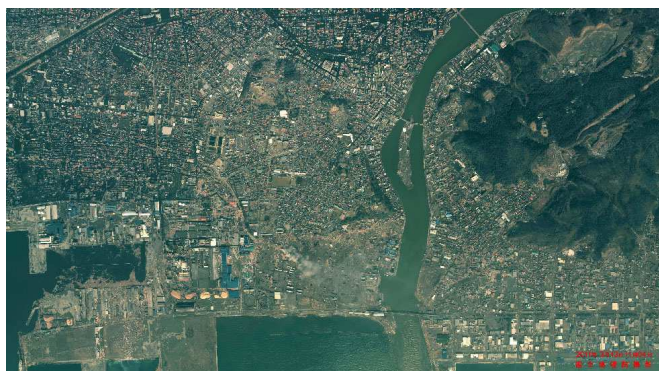
Fig. 2 Detail of Ishinomaki city port affected by the tsunami

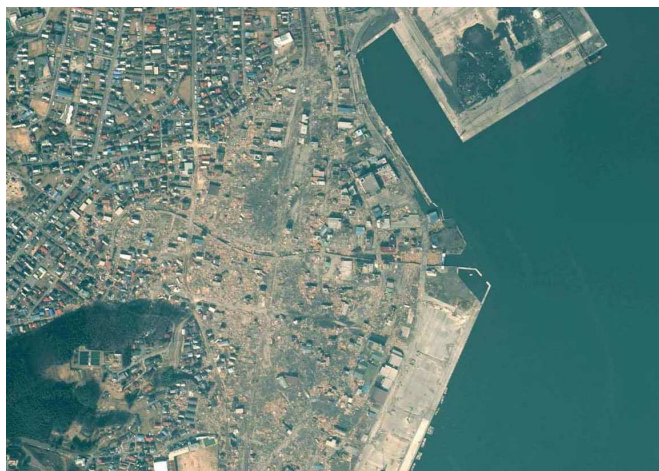
In Fig. 3 a portion of Ofunato city is shown. It is clear from the figure that only large building remains in the inundated zone while small building like wooden houses were washed up. These buildings were steel structures and reinforced concrete structures that resist the lateral forces originated by the inundation of the tsunami. In the left part of the Fig. 3, some intact constructions can be observed. These building are located on a high ground level that was not reached by the tsunami.

Fig. 3 Aerial photograph of Ofunato city after the Tsunami

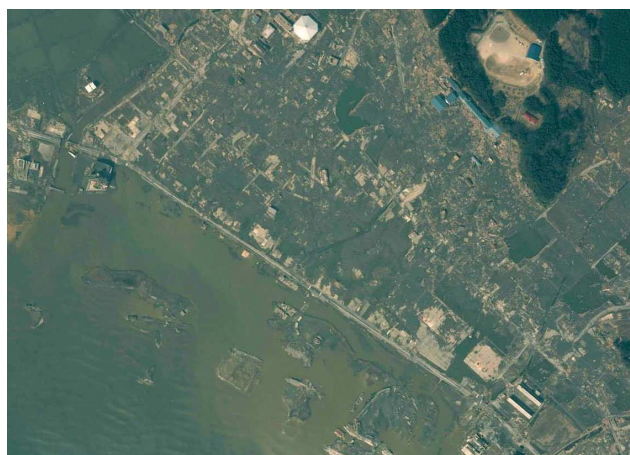
In Fig. 4 a portion of the aerial photograph of Rikuzentakata city can be observed. Near the coast line only few buildings remained after the tsunami attack. The behaviour of the buildings located in the left part that was a hotel and the buildings of the right lower side which correspond to apartment buildings is described in the next section. It can be observed that the tsunami destroyed first a sea wall and now the sea water reaches the road that can be observed as a straight line from the left to the right lower corner. On the right upper corner by observing the color of the vegetation the limit of the inundation area can be inferred. This place corresponds to a high ground level where a school building is located. These school facilities are now used as shelter zone.

Fig. 4 Aerial view of Rikuzentakata city after the tsunami

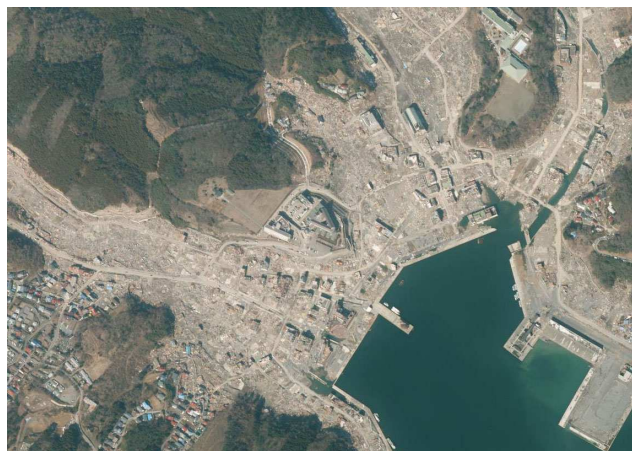
Fig. 5 shows the condition of Onagawa town after the tsunami damage. In this aerial view it is possible to identify clearly the zones of high ground level by observing the condition of the vegetation. As can be observed in the figure, the area between the sea line and high ground level is narrow, and therefore the tsunami reached high inundation depths. This high level of water and poor soil condition originated the overturning of some RC buildings which is described in the next section.

Fig. 5 Aerial view of Onagawa city after tsunami inundation

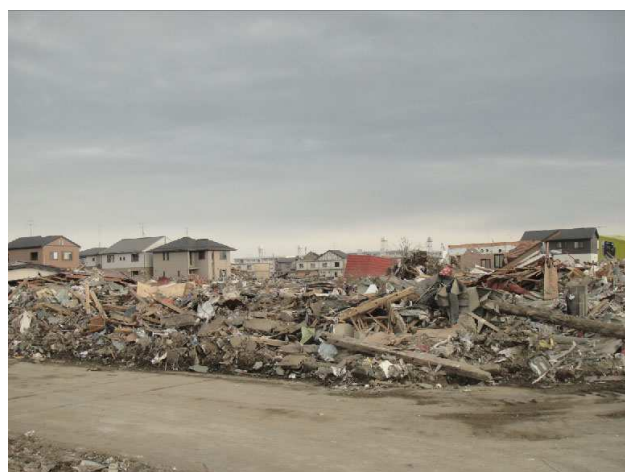
In Fig. 7 to Fig. 10 some typical damages on wooden houses that were produced by the tsunami are shown. In Fig. 7 it can be observed that wooden houses were completely destroyed by the tsunami action. It can be also observed that houses located on high sites are not affected.

Fig. 7 General damages of wooden houses

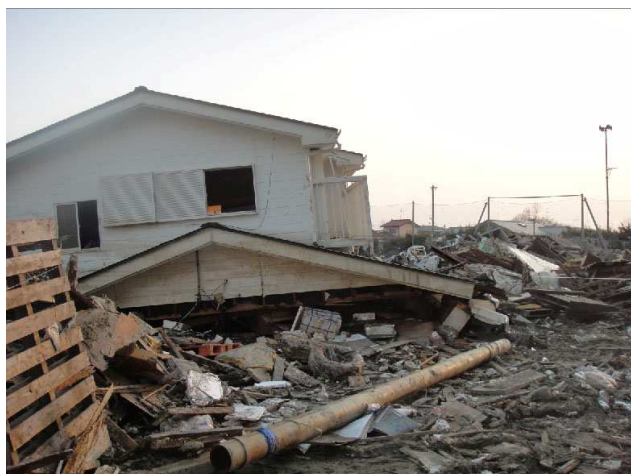
Fig. 8 Failure of the first floor

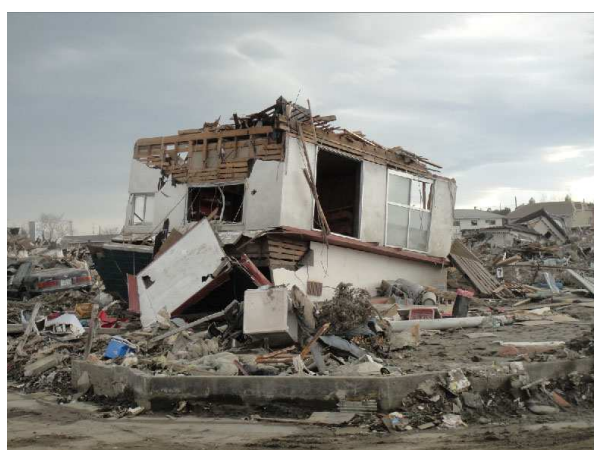
location. In the case of Figure 10(d) the tsunami destroyed the first floor and also produced the overturning of the remaining upper floor.

Fig. 10 Over turning of upper floors

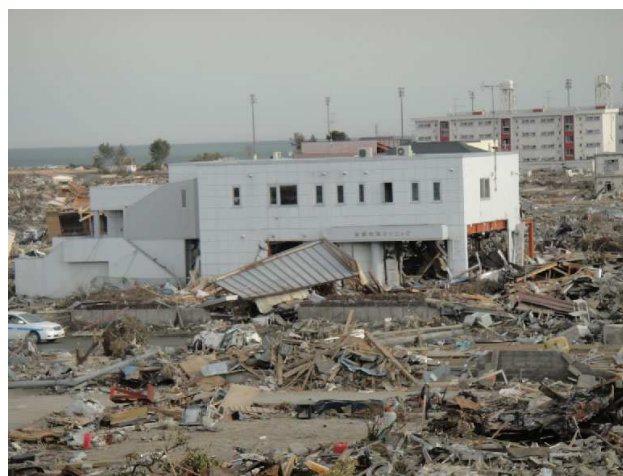
Damages on Steel structures can be observed in Figures 11 to 14. When the inundation depth reaches only the first floor the structure remains almost intact however the wall panels of the first floor suffer some damages as can be observed in Fig. 11. In Fig. 12 and Fig. 13 the inundation depth reached the second floor and wall panels and ceiling are destroyed. In this case the structures remain stand up however some local failure of the structural elements were observed. Fig. 14 shows a total collapse of steel structures. In this case the building was completely covered by the water.

Fig. 11 Steel structure almost intact

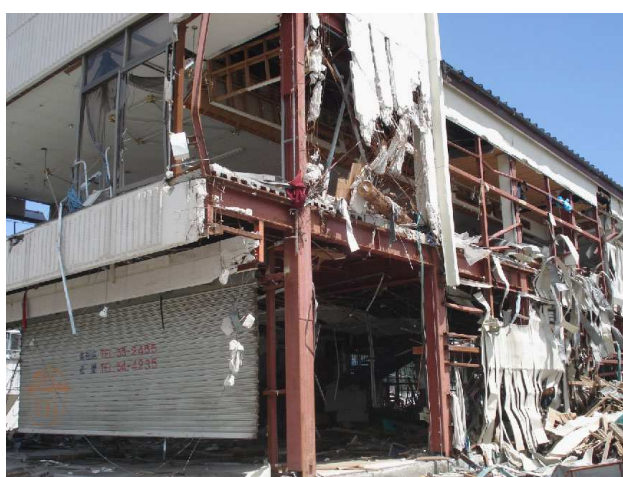
Fig. 12 Destruction of panels

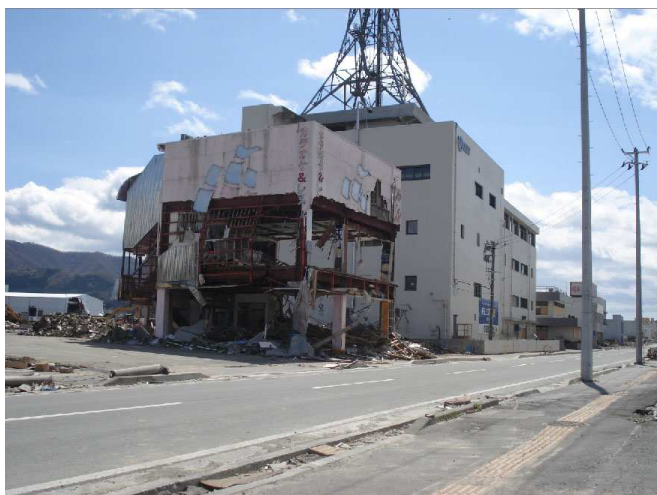
Fig. 13 Destruction of wall panels

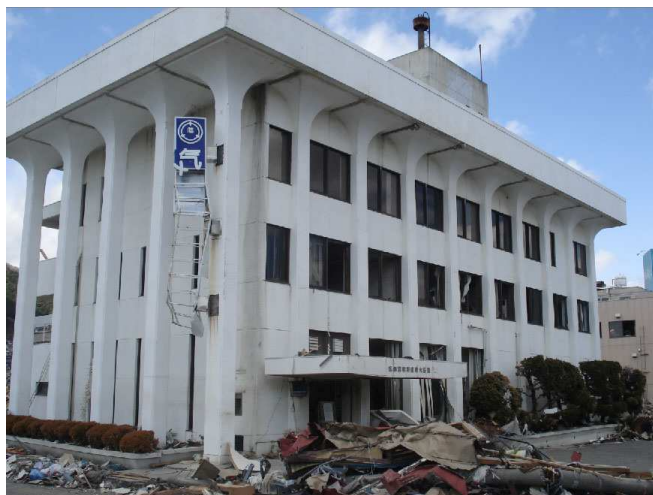
Fig. 15 RC building (Ofunato city)

Many reinforced concrete structures resisted the tsunami action without collapse as can be observed in Figures 15 to 20. Fig. 15 shows the building of a local bank located at Funato city. It can be observed from the damages of the windows and the damage of the advertisement panel of the left corner of the building that the tsunami reaches the third floor.

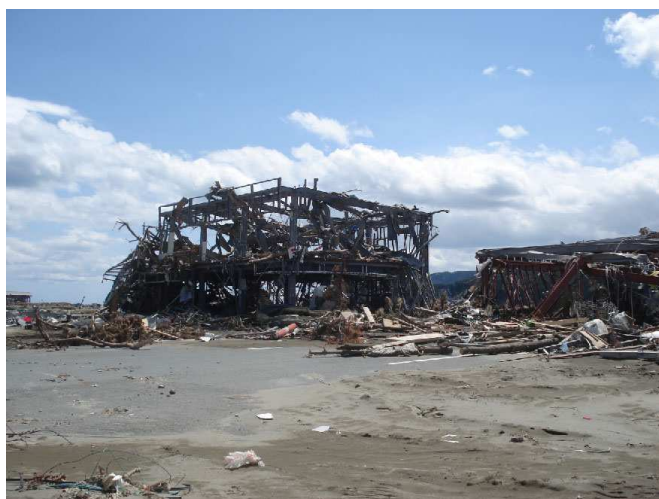
Fig. 14 Collapse of steel structure

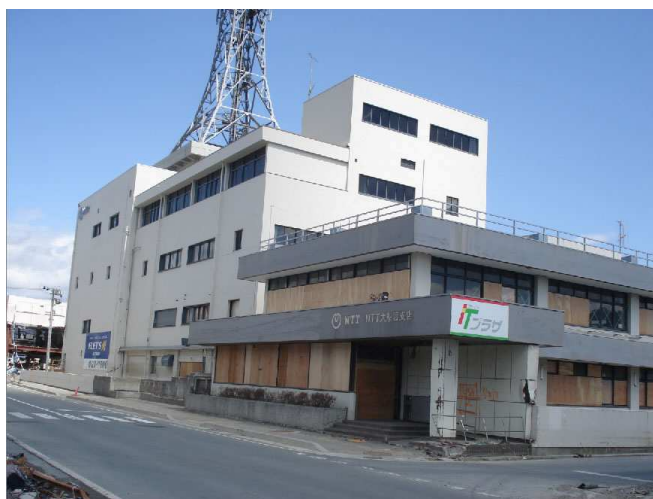
Fig. 16 Two story RC building

In Fig. 16 it is also inferred that the tsunami covered the second story of the building by observing that the window glasses were destroyed and now are replaced by wood panels.

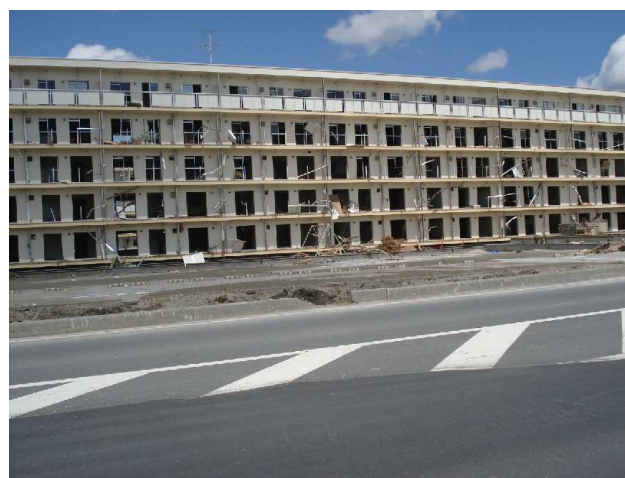
Fig. 17 shows an apartment building located at Rikuzentakata city and from the damages of the balconies it is inferred that the tsunami reaches the fourth floor. Detailed of the damages of the balconies can be observed in Fig. 18, where the panels of the balconies of the fifth floor are intact while the panels of the lower floors are completely destroyed.

Fig. 17 Building at Rikuzentakata city

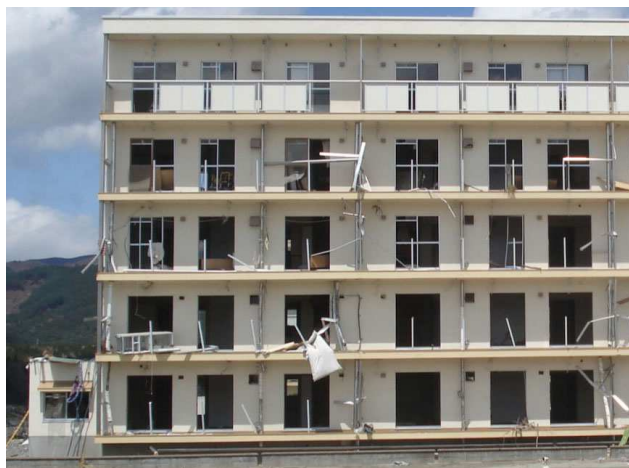
Fig. 18 Detail of damages on balconies

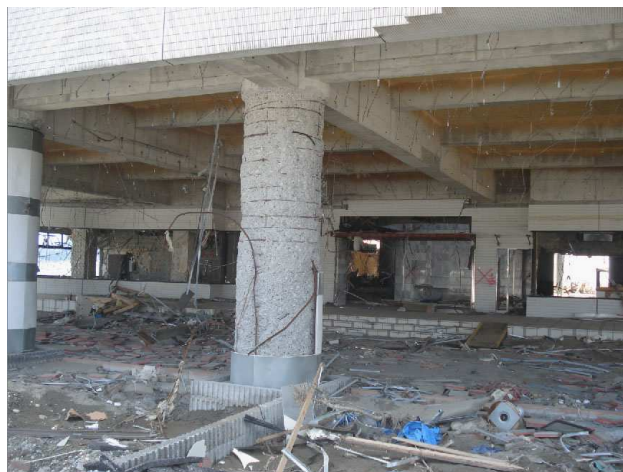
Fig. 20 Detail of RC columns

Fig. 19 and Fig. 20 show the condition of a hotel building located very near the shoreline in Rikuzentakata city. The building resists the tsunami attack however the lower floors suffered the destruction of the non-structural elements and also, as it is observed in the Fig. 19, the building suffered the damage of a reinforced concrete wall due to the lateral water pressure. In this building it was also observed that the cover concrete of structural elements of columns was spall-out probably due to a combination of earthquake vibration action and posterior tsunami as can be observed in Fig. 20

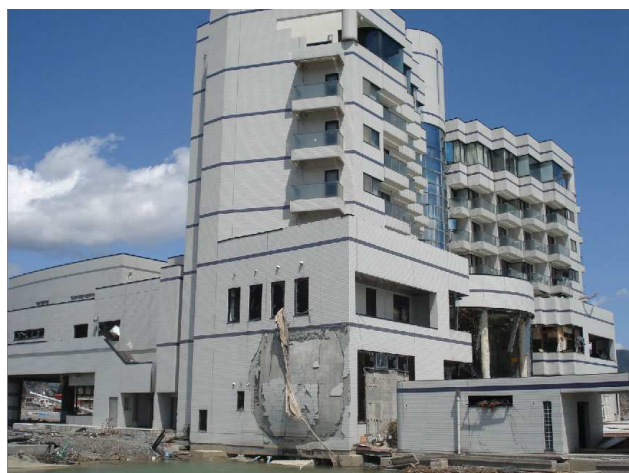
Fig. 19 RC building hotel

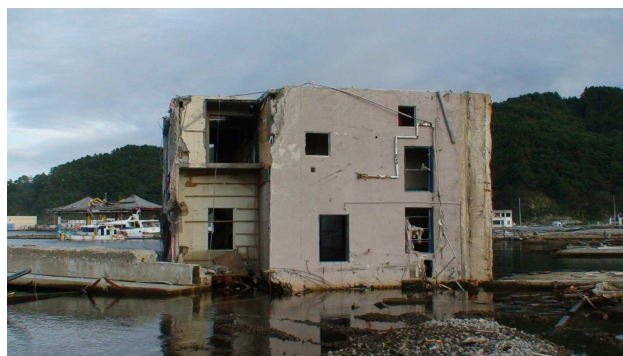
Fig. 21 shows an overturned 3-story building with a shape of box and few openings. This building was completely covered by the tsunami water and as it is shown in Fig. 22 it has a shallow slab foundation that together with the shape of the building facilitates the action of the floating forces.

Fig. 21 Overturning of RC building

If reinforced concrete buildings are intended to be used as refuge, buildings of more than four floors or more than 15 meters are recommend. It is also important to check the condition of the foundation of the structures that are designated as refuge since the failure of the foundation could originate the overturning of the building. Additionally, this selected building must be verified to resist some impact forces or in any case must be located in places where the impact of displaced ships or other building can be avoided.

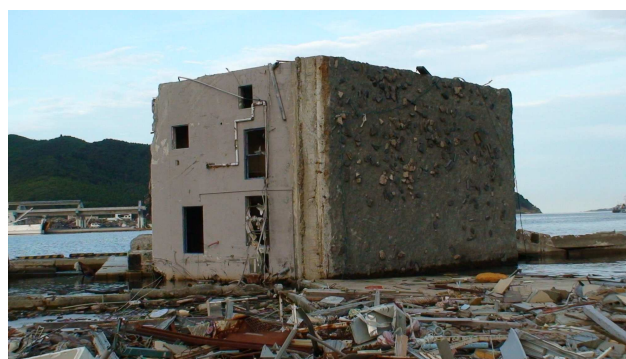
Fig. 22 Detail of slab foundation of collapsed building

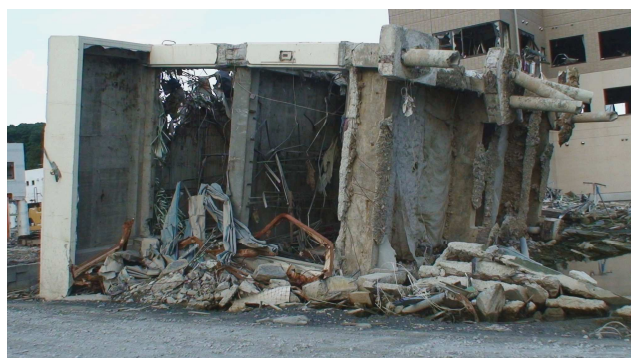
Fig. 23 shows the overturning of a 2-story building with exposition of the pile foundation. The use of piles for lower rise buildings indicates the poor quality of the foundation ground. On the other hand in the Fig. 24 it can be observed that the building has suffered the impact of some body (probably a ship) that could originate the overturning of the building.

Fig. 23 Collapse of 2 story RC building

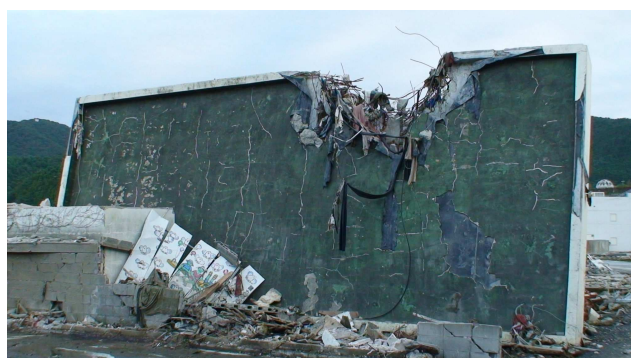
Fig. 24 Detail of impact on the building
