# Analysis of Surface Spalling on a First Intermediate Roll in Sendzimir Mills

**Abstract**—A first intermediate roll of Sendzimir mills was failure by surface spalling during operation. After analyzing by visual, stereo microscope, optical microscope, scanning electron microscope, glow-discharged spectrometer and hardness test, respectively, the results show that some voids and cracks existed on the contact surface as well as subsurface. Further examination verified inadequate hardness and inclusions were responsible for the failure of surface spalling.

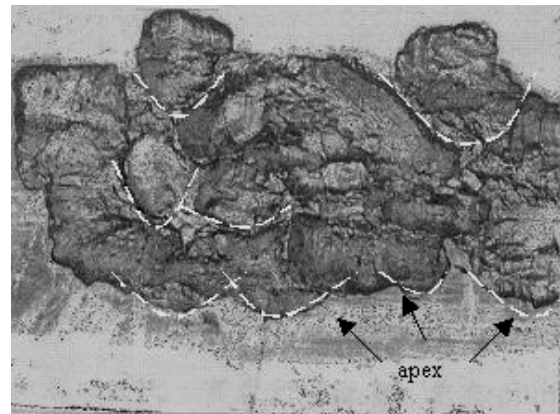
After visual and stereo-microscope observation, it is found that the spalling areas revealed by elongating along the axial direction of the roll and characterized with an "apex" tips, as indicated in Figs. 2 and 3. Meanwhile, there are some small pits and cracks existing on the surface which are located under the spalling areas, please see Fig. 4.

Fig. 3 A stereograph of the spalling area.( 8X )

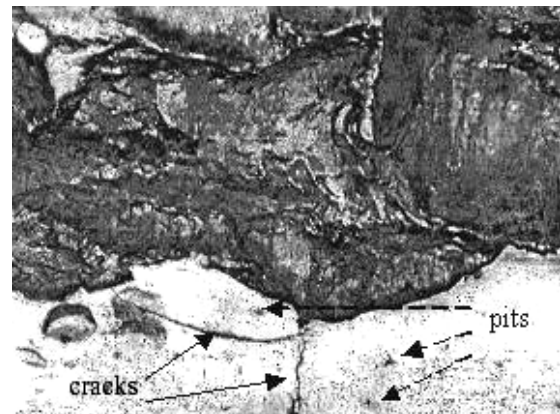
Fig. 4 The lower portion of the spalling area. (32X )

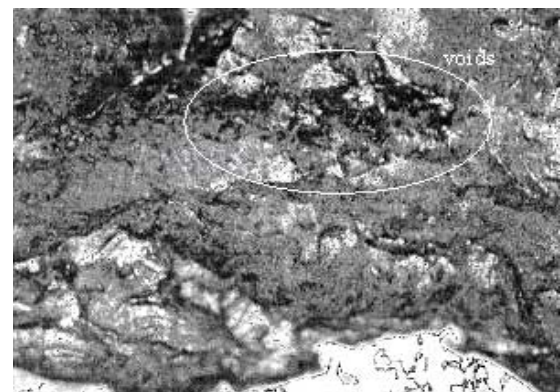
Fig. 5 A higher magnification of the spalling area. (64X )

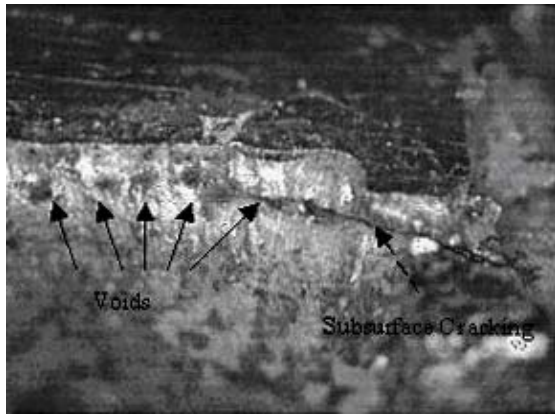
Fig. 6 The side-viewed of the spalling area. (64X )

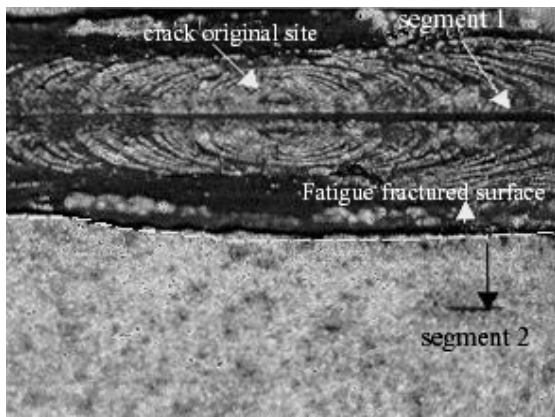
Fig. 7 An example of the fatigue fractured surface. (32X )

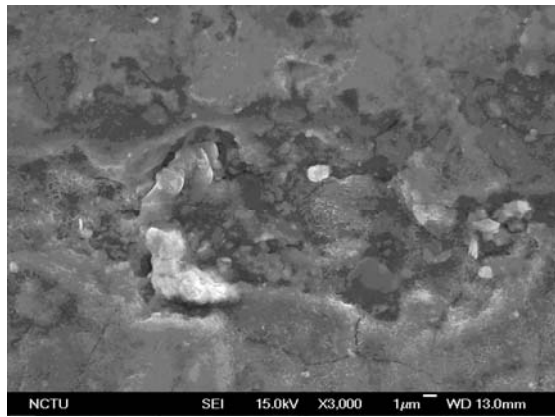
Fig. 8 A SEM micrograph of the origin of fatigue crack

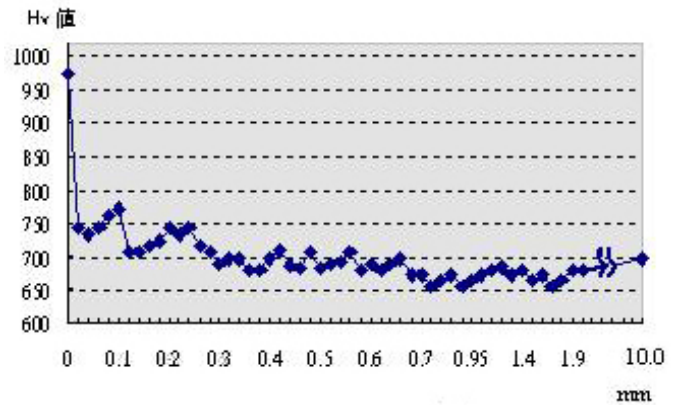
Fig. 9 The micro-hardness distribution of the subsurface

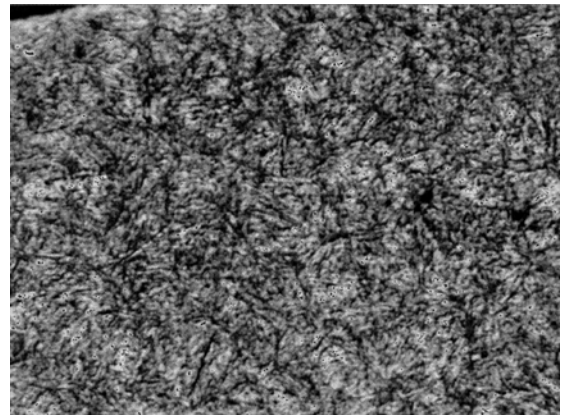
Fig. 10 A optical micrograph of the subsurface microstructure
