Analysis of Surface Spalling on a First Intermediate Roll in Sendzimir Mills

Abstract—A first intermediate roll of Sendzimir mills was failure by surface spalling during operation. After analyzing by visual, stereo microscope, optical microscope, scanning electron microscope, glow-discharged spectrometer and hardness test, respectively, the results show that some voids and cracks existed on the contact surface as well as subsurface. Further examination verified inadequate hardness and inclusions were responsible for the failure of surface spalling.

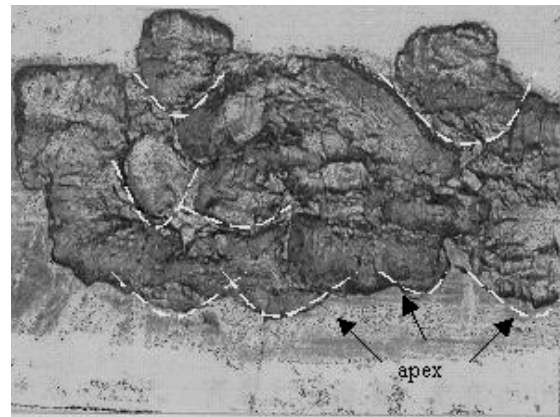
After visual and stereo-microscope observation, it is found that the spalling areas revealed by elongating along the axial direction of the roll and characterized with an "apex" tips, as indicated in Figs. 2 and 3. Meanwhile, there are some small pits and cracks existing on the surface which are located under the spalling areas, please see Fig. 4.

Fig. 3 A stereograph of the spalling area. (8X)

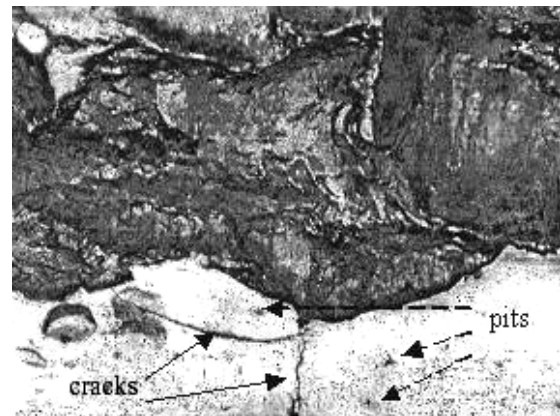
Fig. 4 The lower portion of the spalling area. (32X)

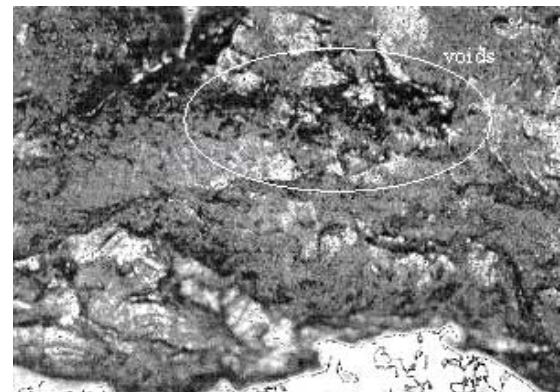
Fig. 5 A higher magnification of the spalling area. (64X)

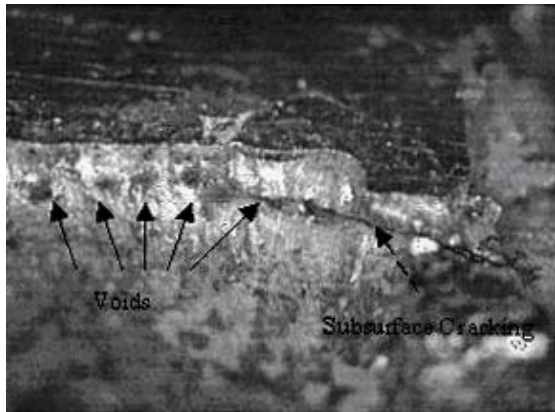
Fig. 6 The side-viewed of the spalling area. (64X)

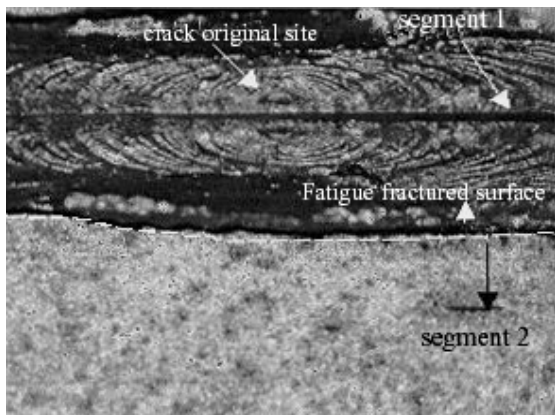
Fig. 7 An example of the fatigue fractured surface. (32X)

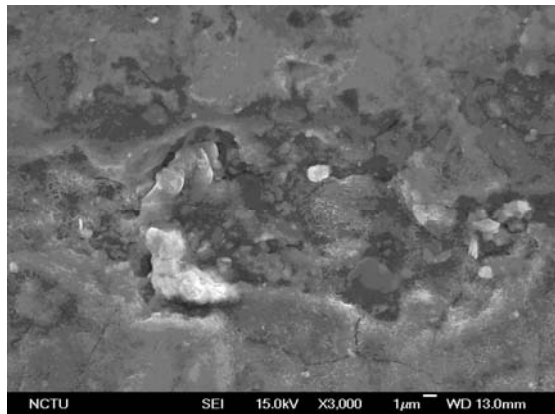
Fig. 8 A SEM micrograph of the origin of fatigue crack
