The Effects of Roots Action of Tropical Green Roofs—Replication of German FLL in Singapore

Kian. Kai. Tan, Michael. Yit. Lin. Chew, Nyuk. Hien. Wong

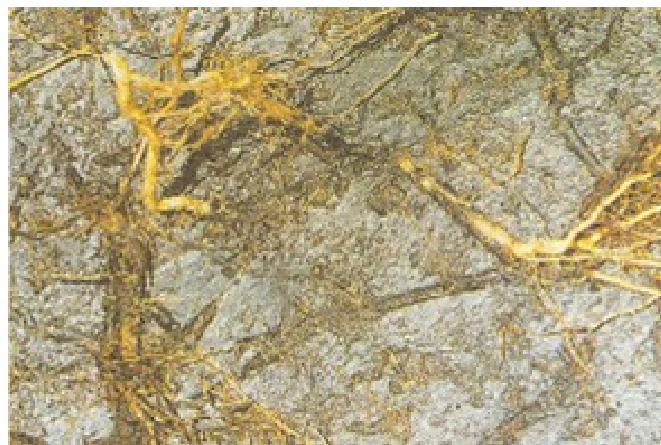
However, due to the nature of the construction industry and the scale of building projects, it is almost impossible for a building to be defect free, including green roofs. Defect on green roof waterproofing membranes are reported in [10], as shown in fig. 1.

Fig. 1 Roots leaving impression on waterproofing membrane, adapted [10]

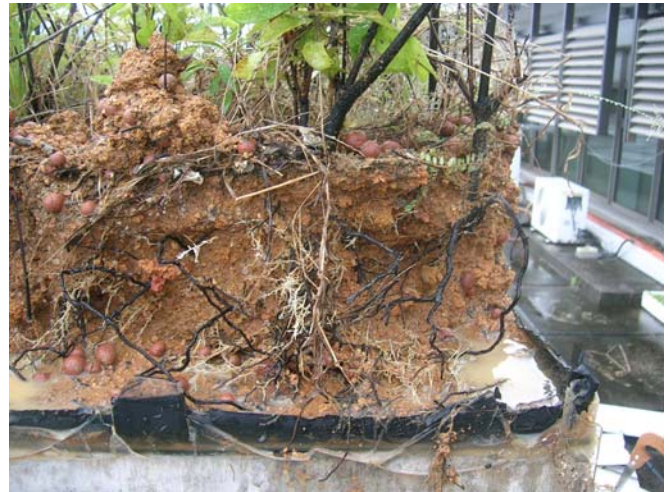
Soil was removed using a water jet. Jet pressure applied was held consistently low to prevent unwanted disturbance to the soil. Soil was removed at a rate of approximately 0.75mm/min for a surface area of 1,000mm×200mm or 150cm³/min. Roots structure exposed after 10mm of soil was removed was vast. This indicates that the duration of this sample was sufficient for roots growth. Exposed roots were approximately 2.5mm thick in diameter, of which covered about 20% of the exposed area (fig. 3).

Fig. 3 Initial exposure of roots

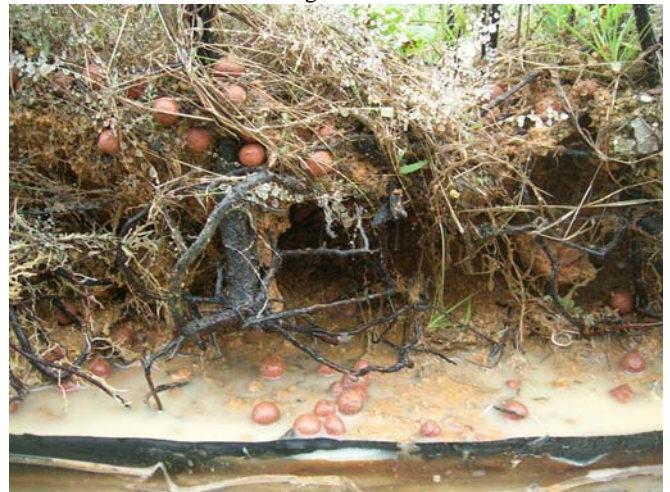
Further erosion revealed the main root of one of the plants of diameter about 12mm. This root terminated 15mm before it reached the membrane. Moreover, the secondary roots, of about 2mm diameter, also turned sideways when they reached the membrane as shown in fig. 4.

Fig. 4 Main root of one of the plants

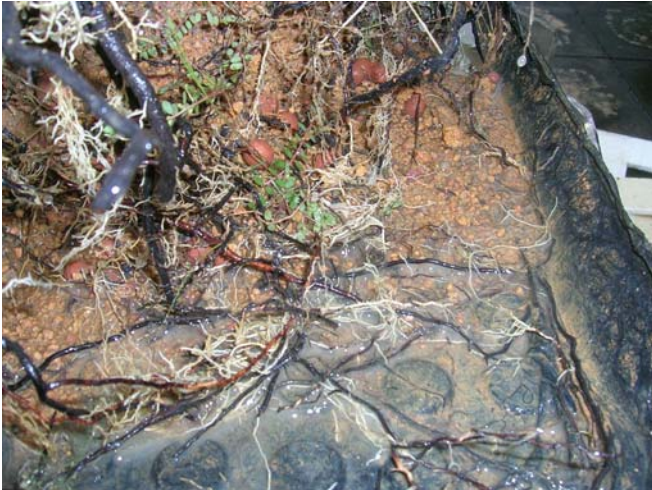
From fig. 5, coverage of secondary roots on the membrane was about 15%. This shows that main roots did not force its way across a membrane; main roots will grow above and do not damage the membrane.

Fig. 5 Secondary roots spreading on membrane surface

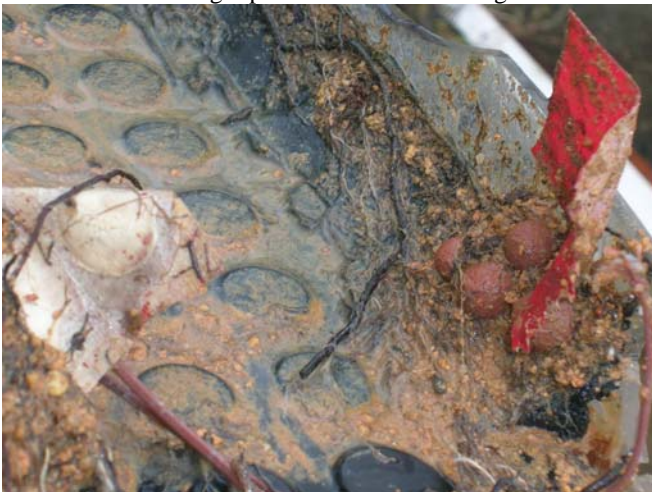
Roots did not grow into the membrane at this area but did seem to grow into the liquid applied waterproofing material used to seal the edges of the sample box. However, there was no evidence of outright penetration as seen in fig. 6.

Fig. 6 Roots seemed to have grown into the liquid applied waterproofing at the edge

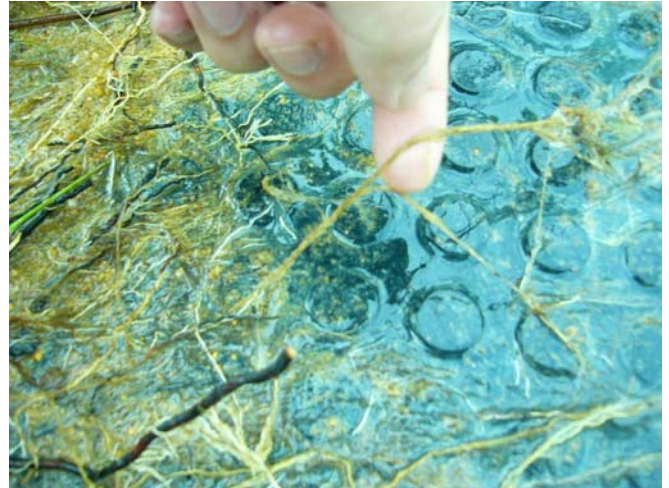
Further erosion reveals that there were some minor roots which seemed to have grown into the membrane (fig. 7).

Fig. 7 Roots which seemed to have anchored on the membrane

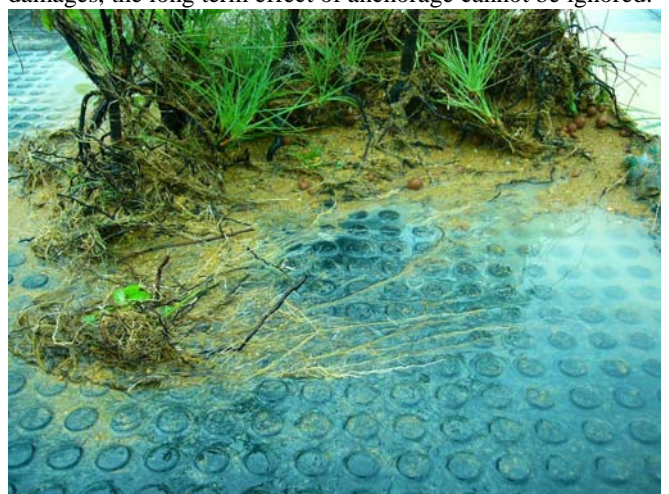
From fig. 8, minor roots which seemed to have anchored on the membrane can be seen. The coverage of these roots was about 40%. Though at closer examination, there was no sign of damages, the long term effect of anchorage cannot be ignored.

Fig. 8 Roots left on the membrane after some erosion; the plants are removed whereas roots which have anchored on the membrane are cut from the plant

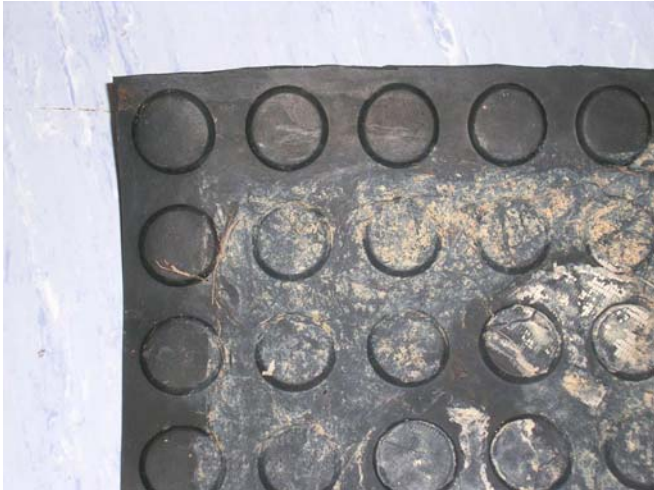
The liquid applied waterproofing was subsequently detached from the sheet membrane and it revealed that no root grew into the joint (fig. 9).

Fig. 9 Clean sheet membrane edges indicate no form of growth between the liquid applied waterproofing and sheet membrane

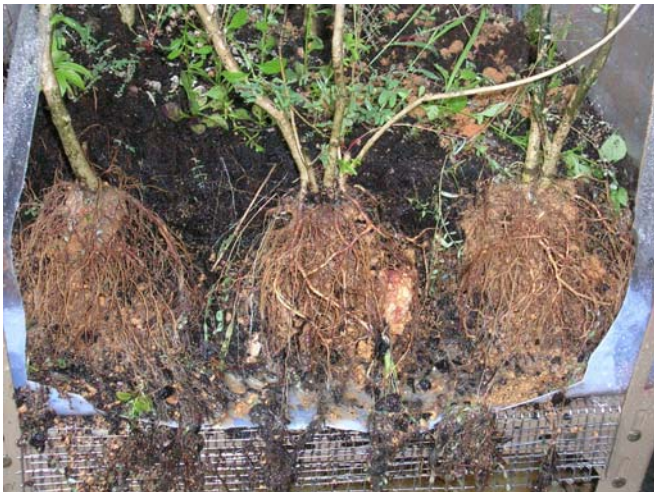
Soil was also removed with a water jet. Upon removal of the first 10mm of soil, substantial root structure was noticed. This again signifies extensive root structure. Further erosion of soil revealed that all the root structures were more well established than those in sample 1, indicating that there was good root growth and the artificial environment created for this sample was conducive for root growth. The root coverage was more than 50% throughout, which was more than sample 1 (15-20%), as seen in fig. 10.

Fig. 10 Vast root structures

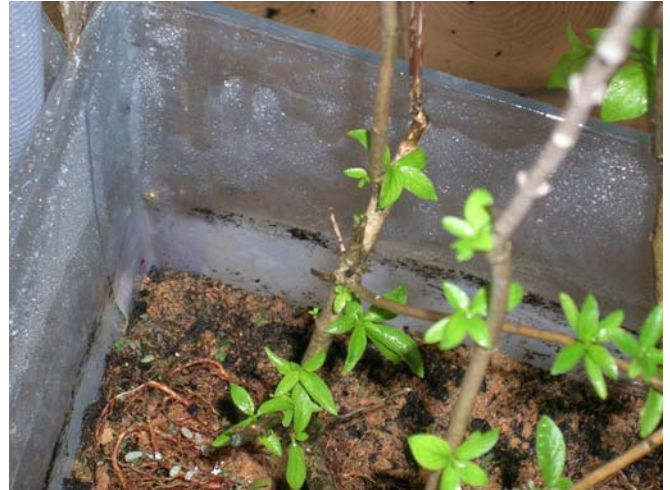
However, the size of roots in this sample was significantly smaller than those in sample 1. This also indicates that though the duration of this sample was sufficient for the root system to grow, the roots might not reach the optimum growth size. From the fig. 11 below, although roots did not anchor in the membrane, it indicates prying action of the roots. This could be due to the improper application of the sealant during the setting-up stage; sealant was not applied to the edge of the joint. The other possibility is simply plant roots poses a challenge to waterproofing systems.

Fig. 11 Growth observed between joints of the membranes

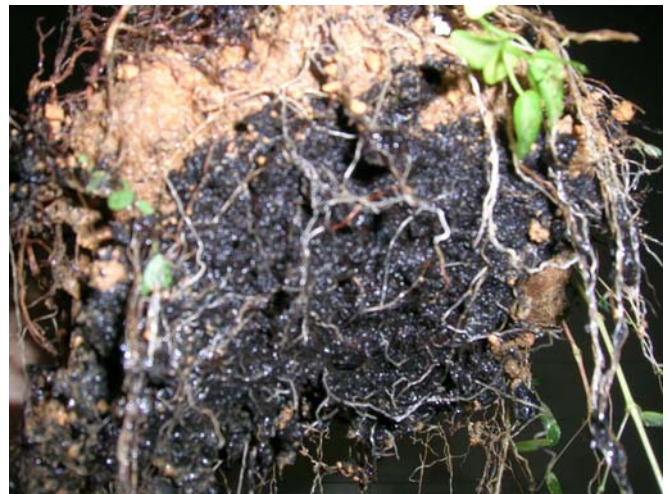
When erosion was sufficient, individual plants, together with some soil, could be lifted. This indicates that there was no anchorage of the plants onto the membrane. Furthermore, when observed from the bottom, roots could be seen, implying that roots have grown in and over the fresh plant compound lay below the pre-grown plants (fig. 12). Hence, there is sufficient evidence to indicate that the method of using pre-grown plants to accelerate the sample is viable.

Fig. 12 Roots growing through fresh planting compound

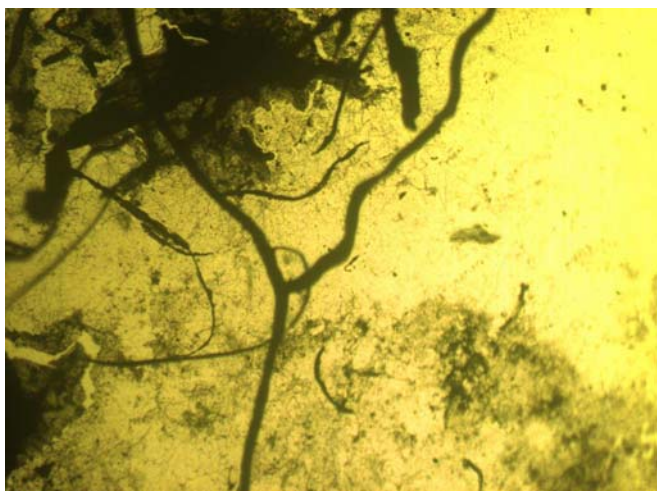
Subsequent erosion of the soil did not reveal other forms of damages inflicted on the membrane by the plant roots. Therefore, the membrane was preserved and studied under a microscope at a later time. Areas where there were significant amount of root growth were studied. These areas were isolated into sections of about 8x8mm. Fig. 13 shows the 2.5x magnification of the area.

Fig. 13 2.5× magnification of typical area (traces of soil seen at top center of fig; algae seen at bottom left of fig)

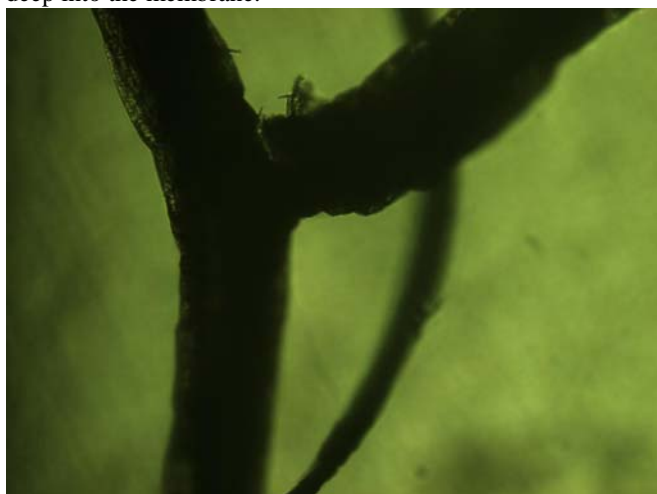
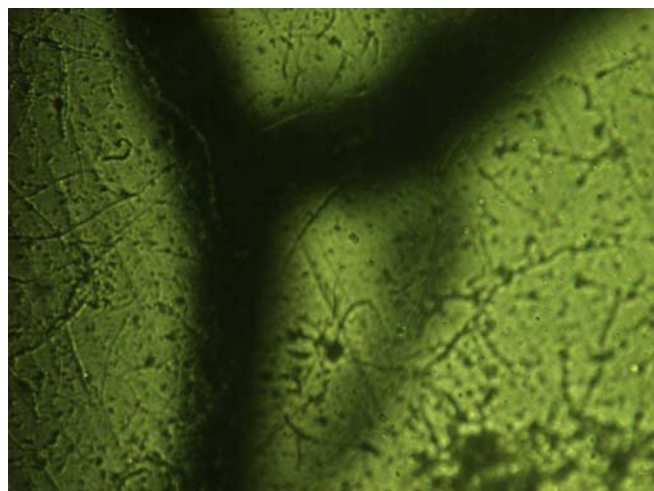
Fig. 14 shows an area under magnification, focusing at different heights. The top fig. focuses on the root while the bottom fig. focuses on the membrane. This implies that as there was an inability to focus on both the membrane and the root, there was a substantial difference in the level of the root and the membrane. This indicates that the root has not grown deep into the membrane.

Fig. 14 20× magnification of typical area focusing on the root

Fig. 15 20× magnification of typical area focusing on the membrane

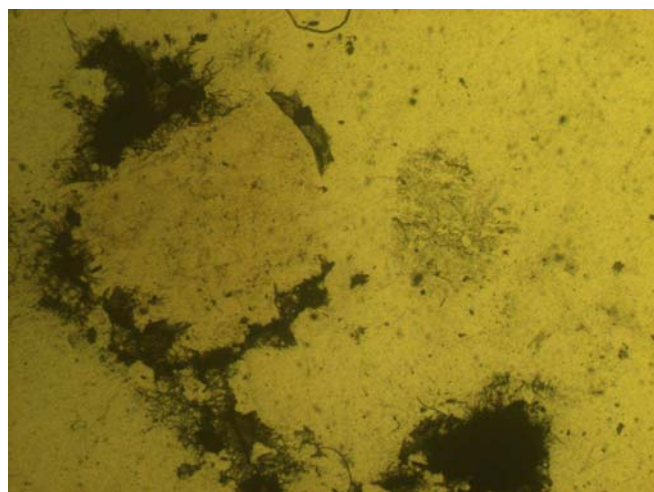
To verify the above inference, the root is removed under a running tap. It was observed that though there was some staining of the membrane under the root growth, there was no root growth mark left on the membrane (fig. 16).

Fig. 16 2.5× magnification of typical area with root cleared
