Causes of Rotor Distortions and Applicable Common Straightening Methods for Turbine Rotors and Shafts

Esmaeil Poursaeidi, Mostafa Kamalzadeh Yazdi

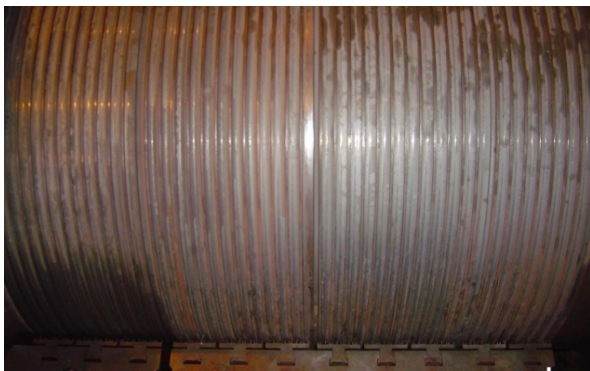
localized thermal expansion and the resultant rotor bend increases the pressure and extent of rubbing in a progressive and unstable manner (Fig. 1). The local thermal expansion is restricted by the cooler bulk of the rotor and an axial compressive stress is thereby set up in the area of the rub. At the same time the local friction lead to reduce the local yield stress by temperature increase, and compressive yielding eventually takes place. Local softening or hardening of rotor body is occurs. The rubbed zone is now permanently displaced leading to a reversed bend when the rotor finally cools to a uniform temperature.

Fig. 1 Effects of rubbing on rotor surface

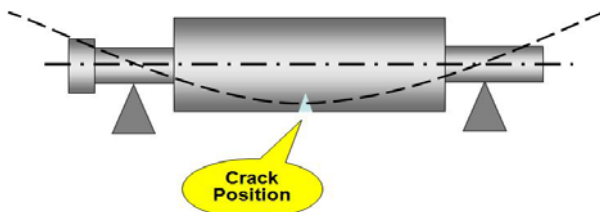
Transverse cracking in rotors can be initiated at surface stress concentrations by corrosion, pitting, thermal fatigue (starts related), or by high cycle fatigue due to self weight rotating bending stresses (Fig. 2). Transverse crack propagation is eventually driven by the bending stresses and this phase can take place over time scales in years. Because they do not directly affect the balance of a rotor, such cracks will not have much effect on normal vibration levels until they occupy a significant portion of the rotor cross section (e.g. 25%). Large cracks can have a sufficient effect in changing the compliance (transverse stiffness) of a rotor that clearances are lost and then rubbing, followed by the bending mechanisms described above takes place.

Fig. 2 Schematic of bending due to cracking

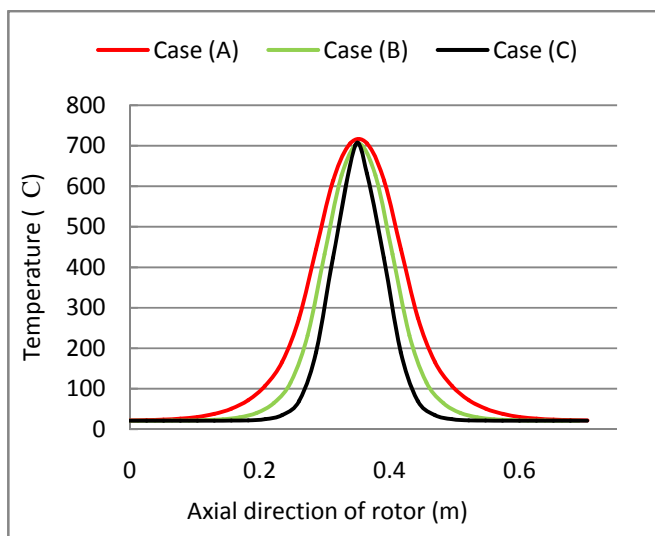
Simulation of hot spotting with three different hot spot areas and heat fluxes was done. The graph of thermal distribution along axial direction of rotor (Fig. 6) shows that the case (C) with the smallest hot spot area has the most thermal gradient between the hot spot area and its surrounding area which is ideal in straightening process but the amount of hot area (cherry red area) is too small to cause required bend. Also it shows that case (A) with the largest hot spot area has the least thermal gradient. The contour of plastic strain magnitude during hot spotting process for three aforementioned cases in Fig. 7 demonstrates that amount of plastic strain in case (A) is not enough to achieve required straightness. In contrast, magnitude of plastic strain in case (C) is the most rather than other cases which may cause some undesirable effects such as thermal shock and phase transformation of the rotor material. Therefore it is resulted that case (B) would cause the most satisfactory straightening effects.

Fig. 6 Thermal distribution along axial direction of rotor

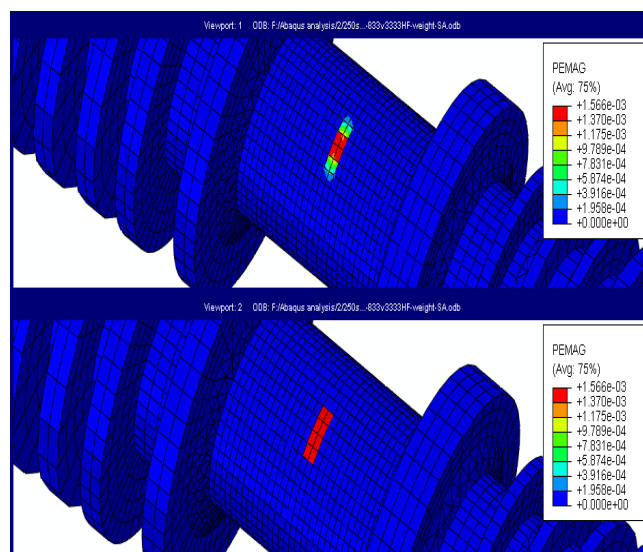
Fig. 8 Contour of plastic strain area at the temperature of (a) 705°C, (b) 750°C

Another simulation was done to investigate the effects of extra heating. Fig. 8 makes a comparison between the size of plastic area at two different temperatures of 705°C and 750°C. It illustrates that extra heating would significantly cause to develop the location of maximum plastic strain along the perimeter of the rotor. Yielding of the material through this large plastic area would contain extra energy to increase distortion of the rotor with no control. On the other hand, according to previous investigations exceeding permutation temperature will cause undesirable sequels on the material structure.

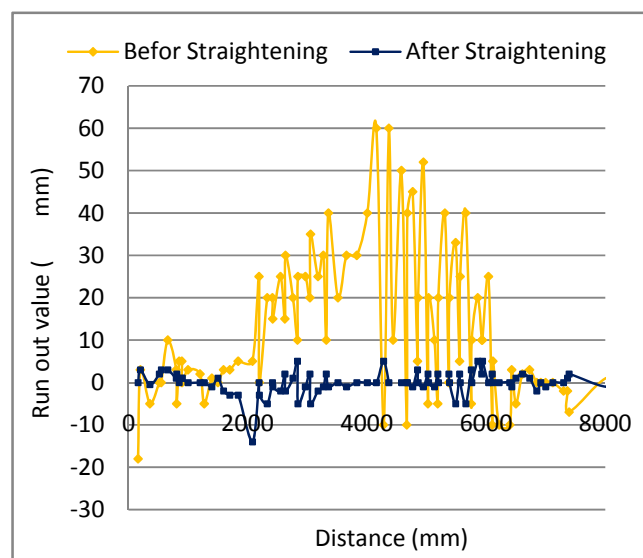
Fig. 9 Results of initial and final run out tests at an angle of 90°

A comparison between received experimental data from initial and final run out tests (Fig. 9) shows that performing the hot spotting execution according to simulated results, has been reduced the rotor eccentricity noticeably. Therefore we recommend using a numerical method before carrying out the selected straightening method.
