Analysis of the Root Causes of Transformer Bushing Failures

E. A. Feilat, I. A. Metwally, S. Al-Matri, and A. S. Al-Abri

Abstract—This paper presents the results of a comprehensive investigation of five blackouts that occurred on 28 August to 8 September 2011 due to bushing failures of the 132/33 kV, 125 MVA transformers at JBB Ali Grid station. The investigation aims to explore the root causes of the bushing failures and come up with recommendations that help in rectifying the problem and avoiding the reoccurrence of similar type of incidents. The incident reports about the failed bushings and the SCADA reports at this grid station were examined and analyzed. Moreover, comprehensive power quality field measurements at ten 33/11 kV substations (S/Ss) in JBB Ali area were conducted, and frequency scans were performed to verify any harmonic resonance frequencies due to power factor correction capacitors. Furthermore, the daily operations of the on-load tap changers (OLTCs) of both the 125 MVA and 20 MVA transformers at JBB Ali Grid station have been analyzed. The investigation showed that the five bushing failures were due to a local problem, i.e. internal degradation of the bushin

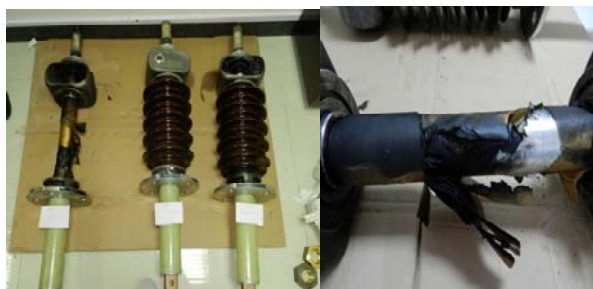
Five incidents of transformer-bushing failures occurred at JBB Ali Grid station on 28 August to 8 September 2011. Some of these incidents resulted in bushing explosion of the porcelain housing and its head. The transformers were in service since 2001 and they were running satisfactorily till the first Bushing failure which occurred after 10 years. A summary of the five incidents are presented in Table I. Mazoon Electricity Company along with consultants undertook detailed study to find root cause of failures.

To identify the root cause of the Grid station transformer bushing repeated failures, physical inspection and detailed simulation studies were conducted. The physical inspection includes viewing and analyzing the layers of the condenser foil and its paper insulation, installation practice, grounding points, maintenance records and tap changer operation. A visual inspection of the failed bushings is shown in Fig. 1, where there are burn-through marks on the bushing condenser paper and two melted spots on the HV central lead. These observations are considered as good indicators of localized internal insulation breakdown.

Fig. 1 Photo of three failed transformer bushings

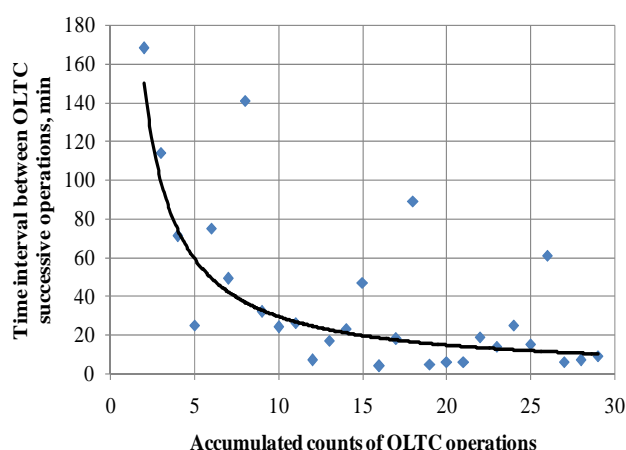
Fig. 3 JBB Grid station, TX1, 8-9-2011

Statistical analysis of the faulty operation of the OLTCs of JBB Ali Grid S/S is depicted in Fig. 3. Fig. 3 shows the time

interval between OLTC successive operations for the faulty JBB Ali Grid transformer. The results indicate that the OLTC time intervals are too small which implies an abnormal operation as a result of frequent variation of the 33 kV voltage level of the 125 MVA transformers. This fast variation could be attributed to successive partial discharges activities in the bushing insulation.

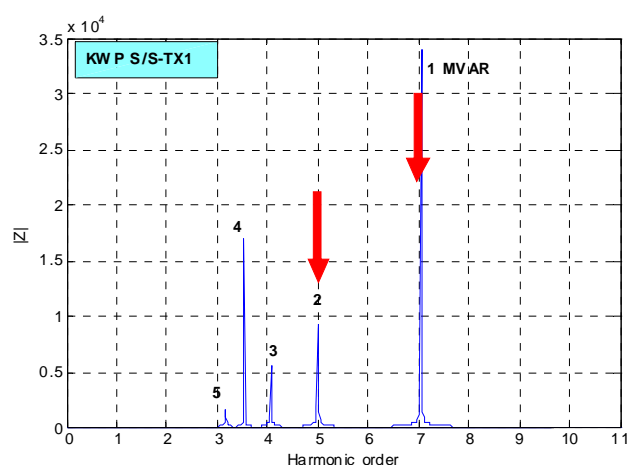
Fig. 4 Impedance scan- Al Kamel water pump S/S (TX1)

11 kV-bus where the capacitor banks are located has been computed for the ten S/Ss. Fig. 4 displays the frequency scan for Al Kamel water pump S/S. The results indicate that there is a possibility of resonance at the 5th and 7th harmonic frequencies. Therefore, if either the 5th or 7th harmonic current exists, the corresponding magnified harmonic voltage will be superimposed on the 50-Hz 11-kV bus.

Examining Fig. 4, it can be seen that harmonic parallel resonance at Al Kamel water pump S/S-TX1 is possible at the 5th and 7th harmonic frequencies corresponding to 3 and 1 MVAR compensation, respectively. The overall impedances of the combination of the capacitor bank and system equivalent short-circuit reactance as seen from the PCC $Z_{R5} = 90 \text{ k}\Omega$ $Z_{R7} = 34 \text{ k}\Omega$, respectively. For 5th and 7th harmonic currents $I_{h5} = 2.3\%$ and $I_{h7} = 0.7\%$, with $I_{h1} = 24 \text{ A}$, the corresponding magnitudes of the magnified 5th and 7th harmonic voltages are $V_{h5} = 75\%$ and $V_{h7} = 86\%$, respectively. However, the damping provided by resistance in the system and the overvoltage surge arresters are often sufficient to prevent catastrophic voltages and currents.

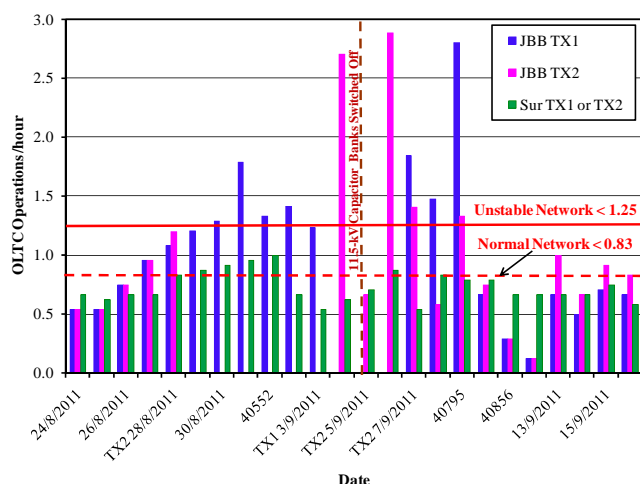
Fig. 5 Hourly-operations 132-kV OLTC at JBBA and Sur Grid S/Ss

The frequency of operations of the OLTCs of TX1 and TX2 of the 132/33 kV 125 MVA transformers at JBB Ali Grid S/S is compared to that of the healthy Sur Grid S/S during the time interval from 24/08/2011 to 16/09/2011 as depicted in Fig. 5. It can be seen that the OLTC of either Sur transformers (TX1 or TX2) hourly operation (i.e. number of tap changers operations per hour) are within the normal network operations i.e. 20 operations per day or <0.83 operations/hour [9]. On the other hand, the OLTC of either TX1 or TX2 at JBB Ali Grid S/S exhibits abnormal hourly operations i.e. above the normal network. This abnormal operation appeared on 27/08/2011 and 28/08/2011, which resulted in failure of TX2 on 28/08/2011 and TX1 on 03/09/2011, respectively.

Likewise, another severe abnormal operation that exceeds the unstable network i.e. 30 operations/day or >1.25 operation/hour was observed on 04/09/2011. As a result, TX2 failed on 05/09/2011. These abnormal operations continued and yielded to two failures of TX2 on 07/09/2011 and TX1 on 08/09/2011, respectively even after switching off the capacitor banks at the 11.5 kV bus of MZEC JBB Ali 33/11.5 kV S/S.

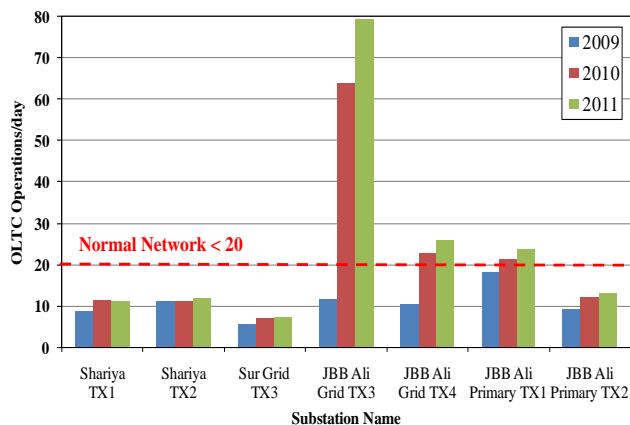
Fig. 6 Average daily operations of 33-kV OLTC in 2009, 2010 and 2011

For the sake of comparison, Fig. 6 shows the frequency of transformer OLTC operations at different 33/11.5 kV MZEC S/Ss including Sur Grid, JBB Ali Grid, JBB Ali primary and Shariya S/S in 2009, 2010 and 2011. It can be seen that TX3 transformer at JBB Ali Grid S/S exhibiting abnormal operation since 2010, where the number of daily operations

exceeds 20 indicating unstable network operations at the JBB Ali Grid S/S.

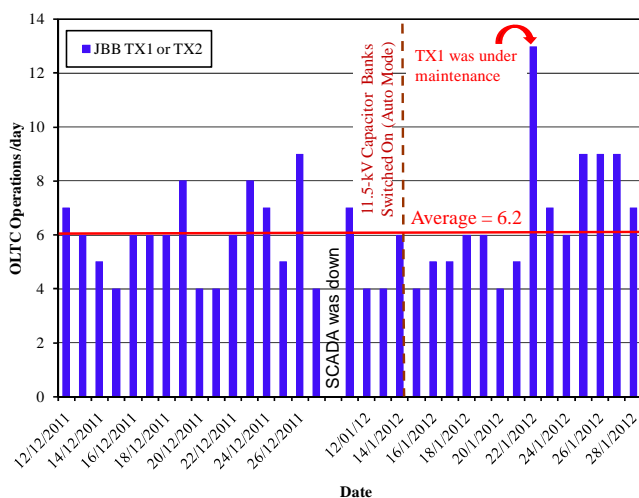
Fig. 7 Hourly 132-kV OLTC at JBB Grid S/S in Dec. 2011 and Jan. 2012 before and after switching-on of the 11.5-kV capacitor banks

This average number of operations was within the known operation range for normal networks [9] even after switching

on the 11 kV capacitor banks at JBB Ali grid S/S to the auto mode. No significant effect of switching on the capacitor banks on OLTC operations per day in Dec. 2011 and Jan. 2012.

Following the five failures of TX1 and TX2, the six 33 kV bushings were replaced. Accordingly, the daily operations of the OLTCs of both TX1 and TX2 during the time interval

from 12/12/2011 to 28/01/2012 fall within the stable network operation as demonstrated in Fig. 7. The average daily operations was 6.2 operations/day or 0.26/hour.
