# Artificial Accelerated Ageing Test of Silicone Rubber Housing Material for Lightning Arrester

W. Payakcho, J. Grasaesom, S. Thong-om and B. Marungsri\*

**Abstract**— This paper presents the experimental results of silicone rubber housing material for 24kV lightning arrester under artificial accelerated ageing test based on IEC 61109 specifications. Specimens having inclined and alternated shed made of HTV silicone rubber with ATH content and having leakage distance 625 mm were tested continuously 1000 hrs in artificial salt fog chamber. After 1000 hrs of salt fog ageing test, obviously surface erosion was observed on trunk between the upper large shed and the lower small shed near the energized end. Decreasing in hydrophobicity and increasing in hardness were measured on tested specimen comparing with new specimen. Chemical analysis by ATR-FTIR confirmed the observation results.

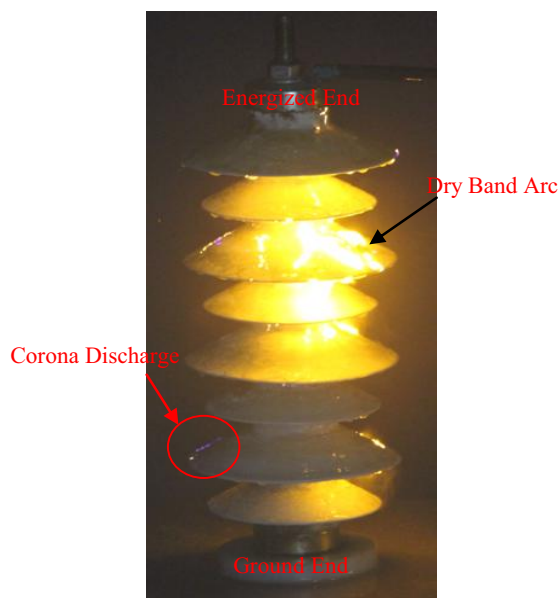
Fig. 4 Discharge Activities

During artificial salt fog ageing test, discharge activities as shown in Fig. 4 were observed. As shown in Fig. 4, yellow light for dry band arcing was observed. Such discharge indicated that large dry band arc discharge occurred on the specimen surface near the energized end. Low power discharge or corona discharge was also observed.

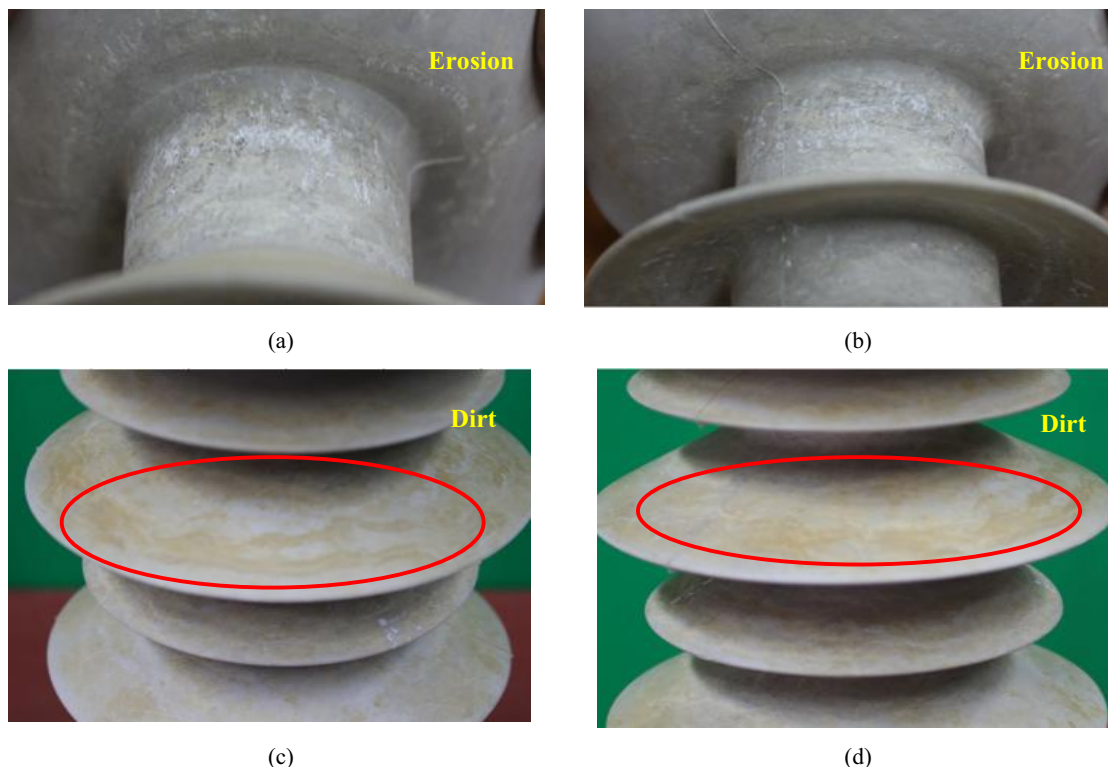
Fig. 5 Visual observation on the surface for lightning arrester.

After 1000 hrs salt fog ageing test, obviously surface erosion was observed on the trunk surface between small and large shed near the energized end of all specimen, as shown in Figure 5 (a) and (b). Slightly surface erosion was also observed on the other trunk portion along the specimen surface. Also, slightly erosion was observed on all shed surface. As shown in Fig. 5 (a), erosion zone on trunk surface occurred close to shed surface and erosion zone on shed surface occurred close to trunk surface. The explanation for such occurring is shown in Fig. 6. In border of wetting zone, dry band arcing easily occurred due to easier formation of dry band than drying and wetting zone. This explanation is supported by no erosion surface on drying and wetting zone.

As shown in Figure 5 (c) and (d), no erosion was observed on the upper shed surface. However, dirt was only observed on such portion.

(1) Surface erosion was observed on the trunk surface between the upper large shed and the lower small shed more than on the trunk surface between the upper small shed and the lower large shed.

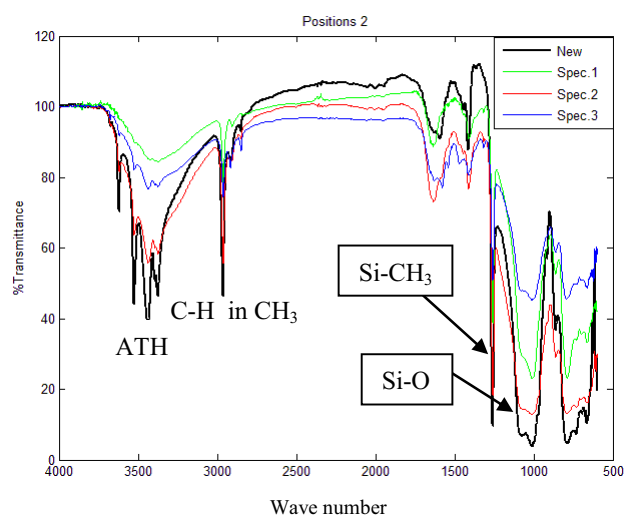
Fig. 8 ATR – FTIR analysis result (Position 2).

In order to confirmed surface ageing, chemical analysis by ATR–FTIR (attenuated total reflection fourier transform infrared spectroscopy) was conducted to evaluate the chemical changed on tested specimen surface. Decreasing in Si – CH<sub>3</sub> bonds (wave number 1260 cm<sup>-1</sup>) indicate that side chains are cleaved. Decreasing of Si – O bonds (wave number 1011 cm<sup>-1</sup>) indicate that back bones are broken or depolymerization.

For comparison ATR–FTIR analysis result of new specimen is defined as 100% and is used to comparing with tested specimen. ATR – FTIR analysis results of position 2 are shown in Fig. 8. ATR – FTIR analysis results for all portion of tested specimen are shown in Table V. Decreasing of side chain and back bonds confirmed surface ageing.
