Stress Corrosion Crack Identification with Direct Assessment Method in Pipeline Downstream from a Compressor Station

H. Gholami, M. Jalali Azizpour

The assessment covers approximately 7.700 km of gas line as named E-Branch in Ahwaz region with 16" pipe diameter, pipe material 5L-X65, pipe wall thickness 19.05 mm, design pressure 250 BAR and Design temperature 60°C. The pipeline was constructed and commissioned in 1978 and was externally coated with PVC cold wrapping. The pipe line is not piggable, so and located downstream of compressor station.

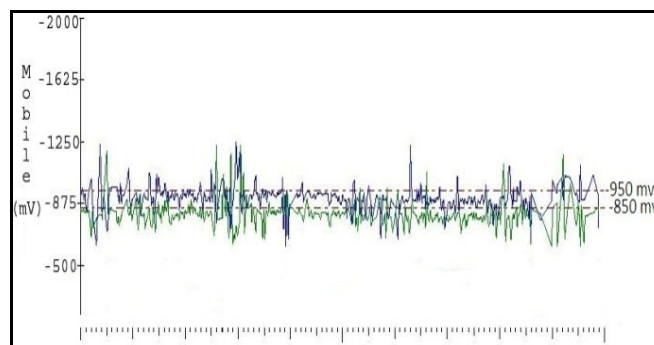
Inadequate cathodic protection level was detected in through of the pipeline according to the (-850mV) instant-off potential criterion, generally (Graph 1). This graph is a sample of CIPS results in this pipeline.

Fig. 1 CIPS results

All the factors discussed in NACE standard are met in this pipe line. In addition, SCC is typically found in locations where CP is shielded from the pipe surface or is inadequate. CIPS results showed that potential is under-protection according to (-850 m.v "off"). So, results of CIPS show that this pipeline is susceptible to SCC.

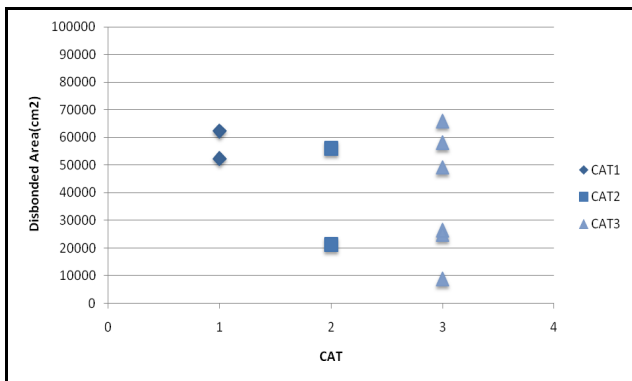
Fig. 2 illustrates disbondment area close to coating defects for a pipeline with PVC cold wrap coating and after 38 years from construction year. Extent of disbondment area next to the DCVG category 1 is approximately same in compare with category 3.

Fig. 2 The extent of disbondment in compare with the coating defect category

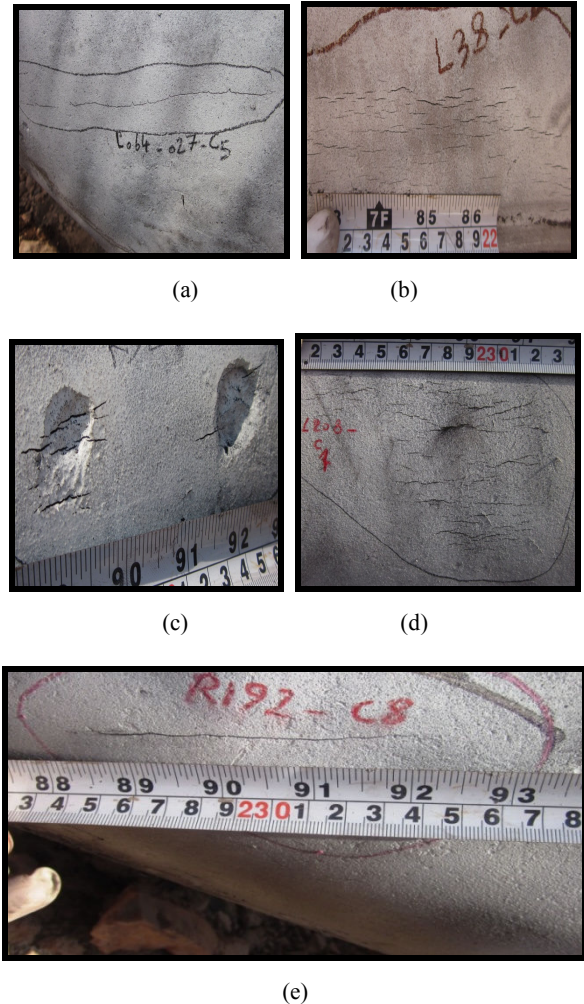
Fig. 3 (a), (b), (c), (d) and (e) Samples of SCC shapes, found place and orientation for E- Branch pipeline

SCC occurred in places with corrosion metal loss. The SCC was typically within areas of general corrosion and/or pitting (Fig. 3 (b)). SCC can occur in individual or colony form. Colonies typically contain from a few to thousands of individual cracks (Figs. 3 (c) & (d)). Cracks are essentially parallel to one-another and oriented perpendicular to the local direction of maximum stress on the pipe. Typically cracks are axially-oriented where the operation hoop stress is the dominant stress. Where external bending loads act on the pipe or where local stress raisers (i.e. dents) are present, the dominant stress directions can shift to the circumferential-oriented or some intermediate angle (Figs. 3 (a) & (e)).

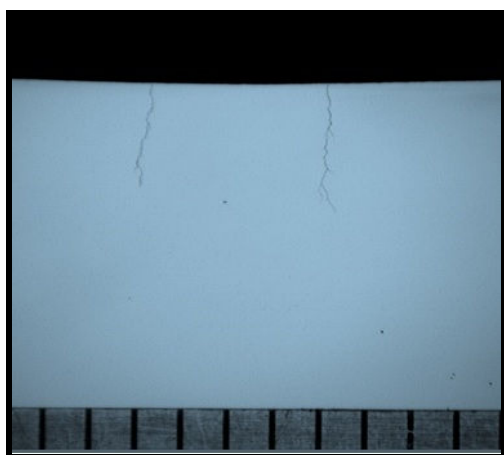
standard metallographic techniques and examined using an optical microscopic. Fig. 4 shows these results. Intergranular phenomenon was detected in SCC sample. This type of SCC morphology considered in high-pH SCC. But, there is potential for neutral pH SCC in this pipeline, too.

(a) Macrograph sample section

Fig. 4 Morphology of SCC in E-Branch pipeline

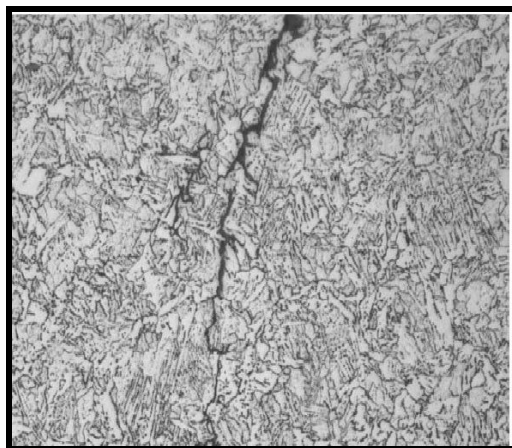
(b) Intergranular phenomenon
