Comparing Repaired and Undamaged Specimens Test Results of Post-Tensioned Beam to Column Connections

Keywords—Precast beam to column connection, moment-resisting connection; post-tensioned connections, repair of precast connections.

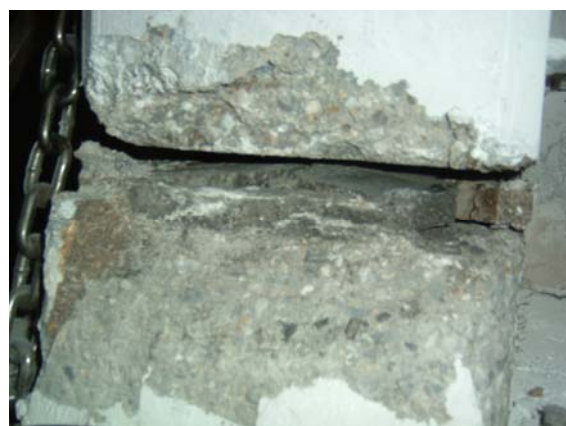
In repetitive loadings, the loading capacity of the AP1R specimen reached average 52 % of the loading capacity of the AP1 when a 1.5 % drift was applied, and a maximum loading capacity of the AP1R specimen reached average 73,50 of the loading capacity of the AP1 specimen. The initial stiffness of the AP1R specimen was seen to be higher than the initial stiffness of the reference specimen. After a load of nearly 7.8 kN the epoxy filling between the column and beam from the surfaces of the column and beam began cracking and this caused a decrease in the stiffness of the specimen. The experimental specimen continued to carry the load during the later cycles at a lower stiffness. Excessive damage was not observed at the concrete side of the specimen during the test (Fig. 1).

Fig. 1 Cracking of the corbel of the AP1R test specimen

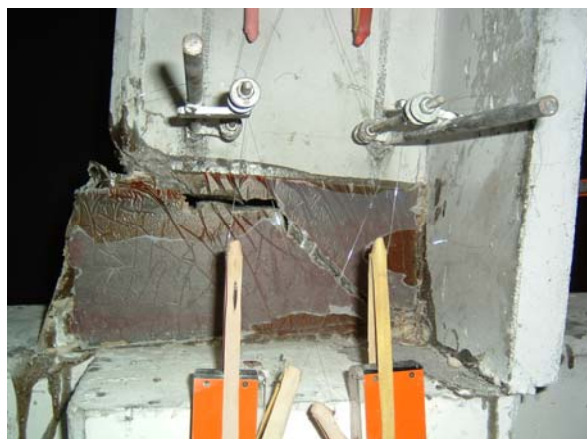
When the load applied to the specimen reached nearly 7.6 kN the loss of the initial stiffness of the specimen decreased due to the cracking of the epoxy resin at the bottom surface of the beam. In spite of observing a loss in the stiffness of the CP1R specimen, the test was completed without excessive damage at the connection (Fig. 2).

Fig. 2 A view of corbel and bottom side of the beam at the CP1R specimen after experiment

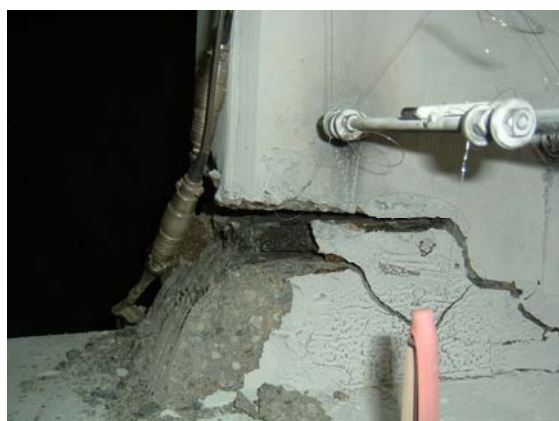
Fig. 3 Fallen state of the parts of the concrete at the upper corner of the corbel of the DP1R specimen

In repetitive loadings, the loading capacity of the DP1U specimen reached average 54 % of the loading capacity of the DP1 when a 1.5 % drift was applied, and a maximum loading capacity of the DP1R specimen reached average 77,00 of the loading capacity of the DP1 specimen. The initial stiffness of the DP1R specimen was seen to be higher than the initial stiffness of the reference specimen. After a nearly 7.5 kN load, the cracking of the epoxy resin caused a decrease in the stiffness of the specimen. The experimental specimen continued to carry the load during the later cycles at a lower stiffness. The bottom edge of the beam touching the corbel at the corbel side was crushed during the backward loading of the last cycle. The cracking of the concrete at the bottom part of the beam caused a 6 kN load loss of the specimen at this loading (Fig. 3).
