# Concrete Sewer Pipe Corrosion Induced by Sulphuric Acid Environment

Anna Romanova, Mojtaba Mahmoodian, Upul Chandrasekara, Morteza A. Alani

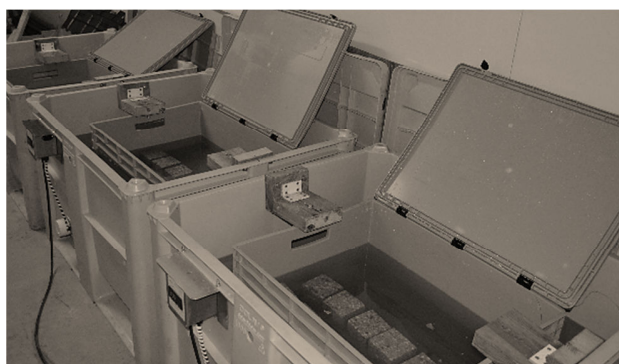
Fig. 1 Experimental set up of cubes being submerged into diluted sulphuric acid

The chamber hosted three 500L HDPE tanks where two of them were curing tanks and could autonomously control the fluid temperature inside them. Each of the tanks had a further 120L HDPE container, which was submerged by 2/3 into the fluid contained by 500L tank. This was done to create a thermal bath type effect and control a constant temperature of the solution in 120L containers. To avoid any fluctuation or displacement of the containers they were attached to the sides of the tanks by the use of L-type brackets. Three tanks: Tank 1, Tank 2 and Tank 3 maintained a constant temperature of solution located in containers of 10°C, 20°C and 30°C, respectively. The temperatures were chosen to represent the common range of effluent temperatures found in sewer pipes at different climate conditions. The temperature of Tank 1 was controlled by the environmental chamber which was set to deliver 10°C at a humidity level of 70%. Tank 2 and 3 temperatures were controlled autonomously by heating elements.

A total number of 45 cubes, cut out from brand-new circular concrete pipe were used in these experiments. Each cube had a measurement of 100x100x100mm and was cut with diamond-blade rotating saw, however as the process of cutting a circular pipe is very challenging and labour consuming a tolerance of 10% in each side measurement of the cube was allowed for. A number of 15 cubes were fully submerged into 0.5 pH solution of sulphuric acid in each of the containers in Tanks 1, 2 and 3. Further they were extracted at different points in time and assessed using different techniques to account for the corrosion level. Fig. 1 demonstrates a setup of tanks, containers and cubes located in the environmental chamber.

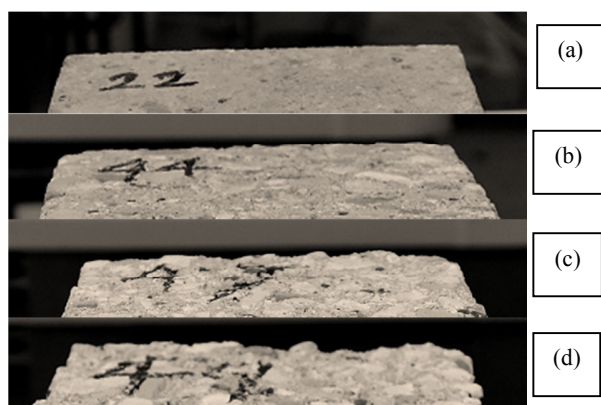
Fig. 2 Cube sample 22 before immersion (a), cube samples 44 after 28 days (b), cube sample 47 after 42 days (c) and cube sample 49 after 56 days of immersion (d)

A high resolution camera (Nikon D3200 SLR with 18-15 VR Lens) was used, where for each cube a picture at 45° angle to the top plane focusing on plane side was taken. These pictures were used to digitally estimate the roughness of the cube as a standard deviation of cube height from the edge-to-edge plane. In this study the calculated roughness was assumed to represent the level of corrosion. For each cube the corrosion depth was calculated as a difference of cube roughness before and after immersion.

The result of this study are summarised in Table I, where column 1 identifies the tank number (ABI are ‘all cubes before immersion’ and AAI are ‘all cubes after immersion’), followed by the number of days the cube was submerged in the solution and associated cube numbers. Column 4 shows the average of three cube’s mass after exposure into acid solution, followed by mass loss compared to original mass values and bulk density after exposure. Last column shows the corrosion level obtained from the digital photo-tests (Fig. 2 shows one cube side before immersion and three cubes ejected from acid solution at different days).

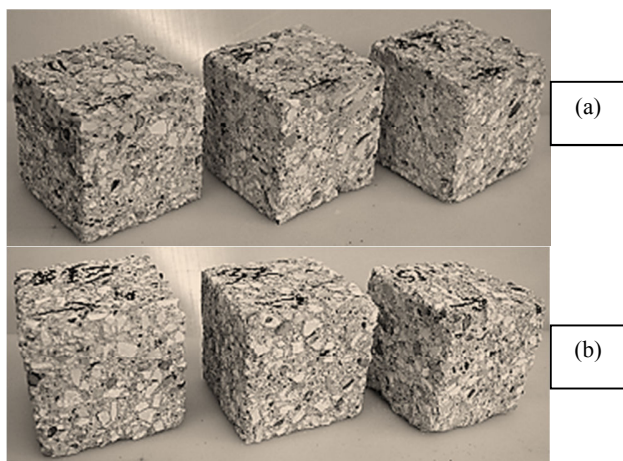
Fig. 5 Cube samples 11, 30 and 47 (left to right) after 42 days immersion into 0.5 pH sulphuric acid solution and temperatures of 10°C, 20°C and 30°C, respectively (a) and cube samples 13, 32 and 51 (left to right) after 56 days immersion into 0.5 pH sulphuric acid solution and temperatures of 10°C, 20°C and 30°C, respectively (b)

Interestingly that the leap between the cubes corrosion depth doubled in periods from 28 days to 42 days and then further between 42 days to 56 days which could be visibly assessed. Examples of such can we seen in Fig. 5.
