# Deformation Characteristics of Fire Damaged and Rehabilitated Normal Strength Concrete Beams

Yeo Kyeong Lee, Hae Won Min, Ji Yeon Kang, Hee Sun Kim, Yeong Soo Shin

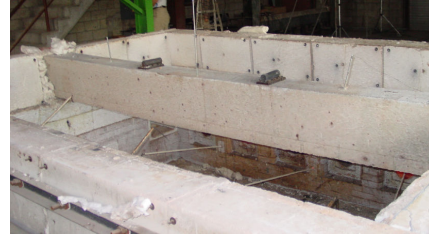
Fig. 2 Specimen installed on the horizontal heating furnace

After 3 months curing, the specimens were installed on the horizontal heating furnace for the fire tests as shown in Fig. 2. The surfaces exposed to heating were 3 faces except the upper face. The fire test was performed according to ISO-834 standard fire curve, Fig. 3, for 1 or 2 hours maintaining 87kN of the initial load corresponding to live load of general office building. Distance from hinge to roller was 4500mm and distance between 2 loading points for four points loading was 1200mm.

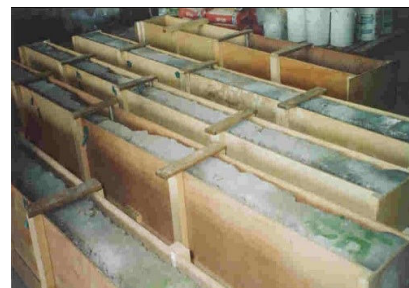
Fig. 5 Curing of rehabilitated beams with polymeric cement mortar

Four specimens were tested after 2 months air-recurring to investigate residual strength of fire damaged RC beams. Other four specimens were rehabilitated with polymeric cement mortar after being removed the fire damaged part of concrete cover as illustrated in Fig. 4. As shown in Fig. 5, these rehabilitated beams were cured for 1 month to get rehabilitation effects enough. The test specimens were tabulated in Table III.

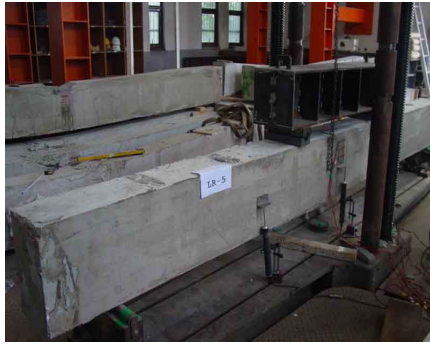
Fig. 6 Four point loading test set up

Four points loading tests were performed in simple support condition for both fire damaged and rehabilitated beams as shown in Fig. 6. Test span was 4000mm and distance between 2 loading points was 1200mm as illustrated in Fig. 7.
