Investigation of Rehabilitation Effects on Fire Damaged High Strength Concrete Beams

Eun Mi Ryu, Ah Young An, Ji Yeon Kang, Yeong Soo Shin, Hee Sun Kim

Keywords—Fire, High strength concrete, Rehabilitation, Reinforced concrete beam.

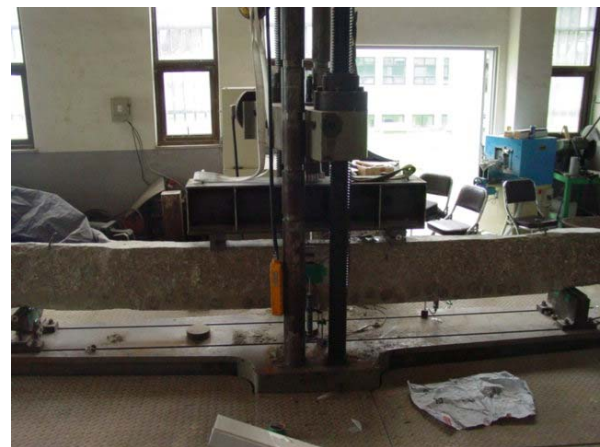
Fig. 5 Four-point loading test of rehabilitated beam

Specimens are simply supported with an effective span of 3750mm and subject to four-point loading. The vertical deflection of the specimen is measured at midspan using a linear variable displacement transducer (LVDT). And the load increases with a gradual rate and is recorded through a data logger. Figs. 3 and 5 illustrate the instrumentation used for the test.

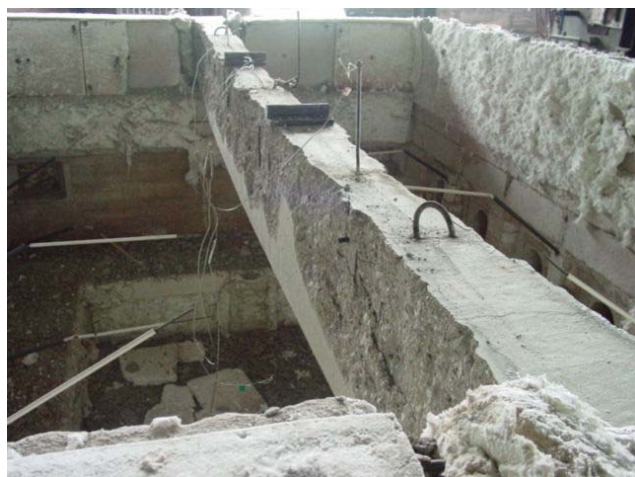
Fig. 6 Specimen on the horizontal heating furnace after fire test

After fire test, the specimens are damaged as shown in Fig. 6 and are left during one month. For comparing residual strength and strength of rehabilitated beam, rehabilitation is performed. Fire damaged U-shaped concrete cover is removed. And, removed part is filled with polymeric cement mortar.

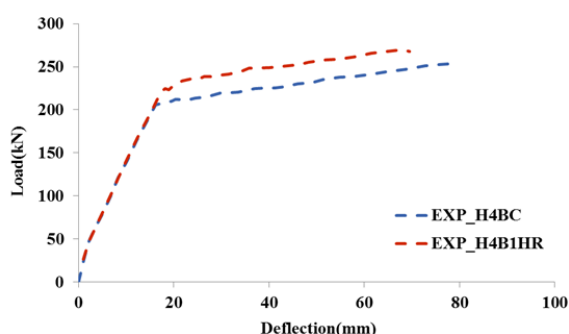
Fig. 9 Experimental load-deflection curves for specimen having cover thickness of 40 mm

After fire test, the ultimate loads of damaged beams such as H4B1H and H5B1H are 13.4% and 28.6% lower than those of control beams respectively. But as shown in Figs. 9 and 10, the ultimate loads of rehabilitated beams are higher than those of control beams. The ultimate loads of H4B1HR and H5B1HR are 5.4% and 0.7% higher than those of H4BC and H5BC respectively. And structural behaviors are analogous between specimen having cover thickness 40mm and 50mm. The ultimate loads from experiments are listed in Table IV.

It can be seen that stiffness of rehabilitated beams are recovered similar to that of control beams. For beams having cover thickness of 40mm and 50mm, the slopes of H4B1HR and H5B1HR is 1.8% higher than H4BC and H5BC,
