Influence of Thermal Damage on the Mechanical Strength of Trimmed CFRP

Guillaume Mullier, Jean François Chatelain

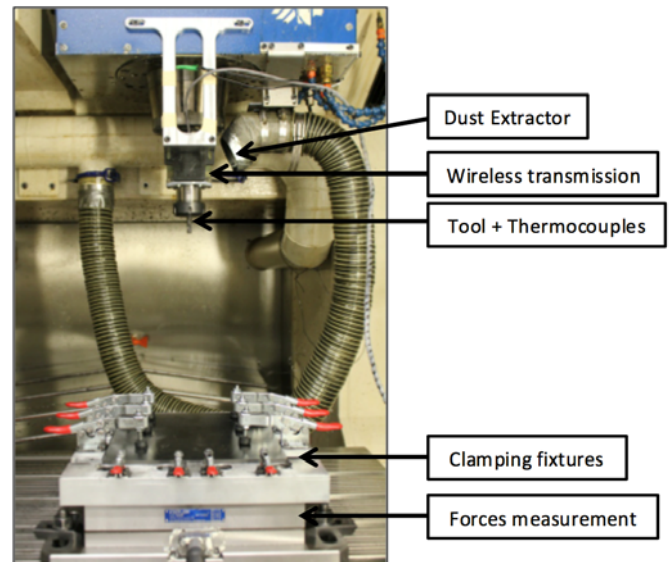
Fig. 1 Experimental set-up for dry trimming of CFRP

It was experimentally determined that a distance of 1.7mm between the cutting area and the welded tip position was suitable for the thermocouple to remain stuck on the tool, resisting the chip flow and the variation in temperature throughout the cutting. As shown in Fig. 1, the temperature data was collected and wirelessly transmitted using a module

embedded in the spindle (Michigan Scientific Corporation M-320). In addition, cutting forces were recorded using a 3-axis dynamometer table (type Kistler 9255B). The trimming operations were performed using a 3-axis CNC high speed center Huron K2X10 with a maximum spindle speed of 28000rpm at 30kW. The up-milling cutting mode at full radial and axial depths of cut was utilized, so as to minimize macroscopic mechanical defects.

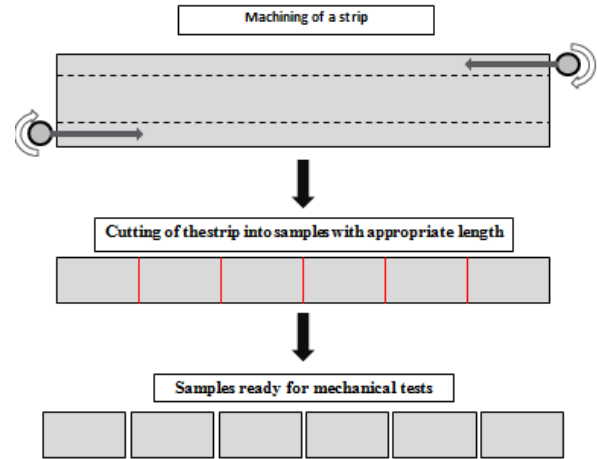
Fig. 2 Trimming of samples

The machined samples were rectangular strips of constant width, cut into smaller test samples of desired length using an abrasive diamond saw (Fig. 2). The final samples will exhibit symmetrical damage (thermal and mechanical) on both bending edges (Fig. 3). Damage which may have been introduced by abrasive cutting have no particular impact as it is out from the supports.

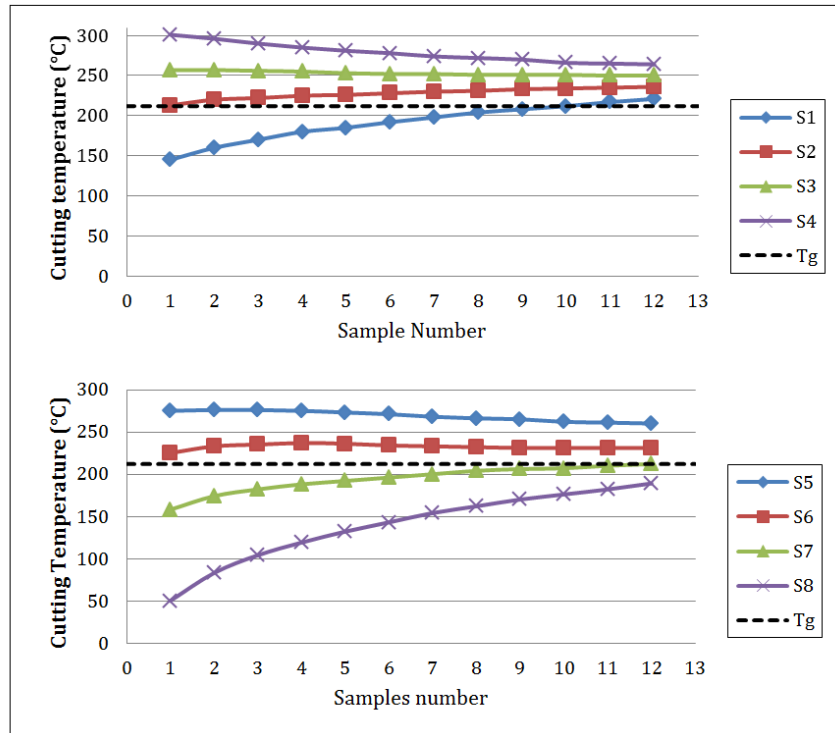
Fig. 5 Cutting temperatures of short beam samples (new tools)

produced (Table II). Strips S2 to S6 were machined with temperatures exceeding the glass transition temperature of the epoxy. The cutting temperature is converging towards the natural cutting temperature of the tool (which is function of the cutting parameters) for both series: it was found to be around 250°C (Fig. 5).

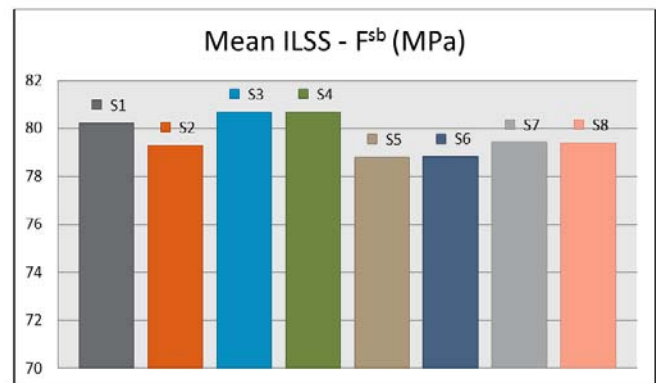
Fig. 6 Averaged ILSS values for each strip (new tools)

As shown in Fig. 6, results regarding interlaminar shear stress resistance for new tools could not show any trend regarding cutting temperature and length of cut. Looking at a single strip, there is no particular trend from sample number 1 to 12. Also, the mean ILSS value of each strip is comprised between 79 and 81MPa, which is due to ordinary variation. This phenomenon indicates that the cutting temperature has no influence on the ILSS resistance of the material when using a new tool.

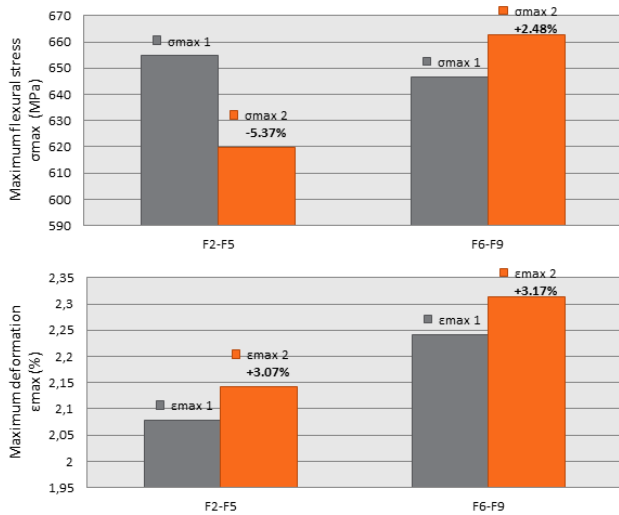
Fig. 7 Mean values from three point bending tests (new tools)

Results coming from the three point bending test show little variation: the trend regarding mean maximum flexural stress reverses, while the trend regarding maximum deformation is

too low to be attributed to the effect of rising cutting temperature (Fig. 7).

In Fig. 7, the mean values are calculated as:

The stress $\sigma \max 1$ and deformation $\varepsilon \max 1$ relates to first sample machined (lower cutting temperature) while $\sigma \max 2$ and $\varepsilon \max 2$ relates to second machined sample (higher cutting temperature) on a given strip.

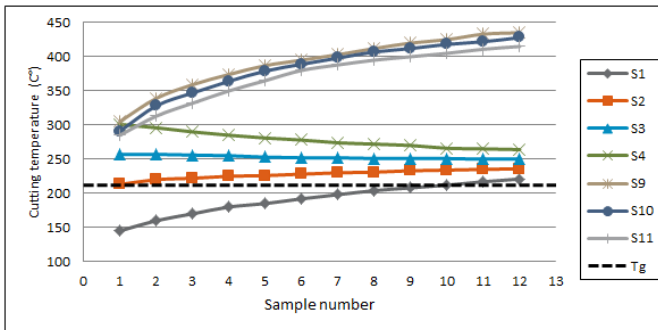
Fig. 8 Cutting temperature of short beam samples (new and worn tools)

The second approach proposes to proceed with the same methodology as previous, but using worn tools and an approximately constant preheating temperature. A total of 36 samples were machined using 3 worn tools exhibiting different levels of flank wear (Vb), coating integrity and cutting edge radii (Table IV). The cutting temperature now peaks up to 425°C at the end of the cutting process (Fig. 8). Globally, the temperature at which samples are machined is a lot higher than the glass transition temperature of the resin, thus thermal damage is likely to occur.

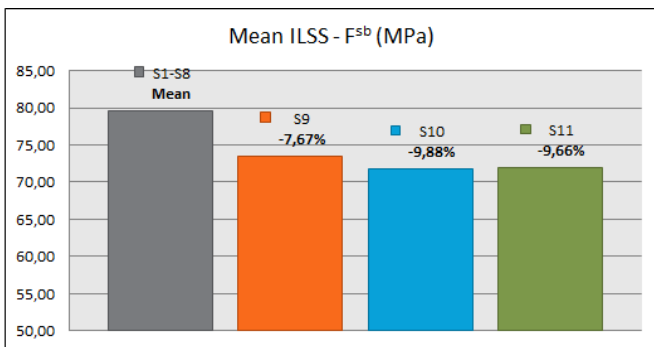
Fig. 9 Comparison between mean ILSS values of samples machined using new and worn tools

As shown in Fig. 9, ILSS did not show any conclusive variation with the cutting temperature on a given strip. However, the mean value of each strip (S9 to S11) compared to the averaged ILSS value over S1 to S8 strips shows that substantial amount of both thermal and mechanical damage occurs during machining. The loss of resistance ranges from -7.67 to -9.88%.

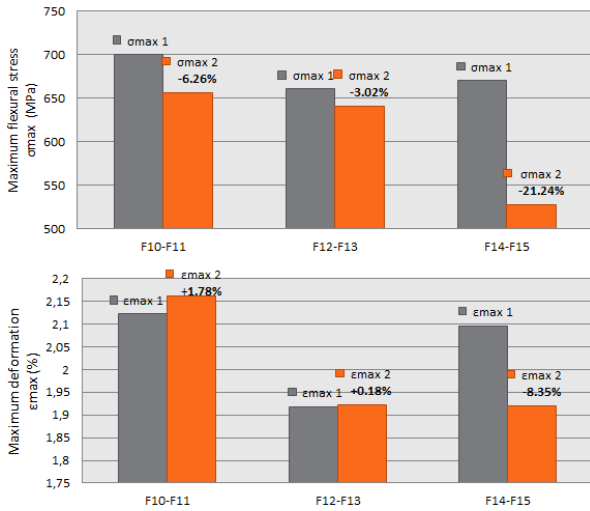
Fig. 10 Calculated mean values from three point bending tests

In Fig. 10, the mean values calculated are nearly equal to the mean results from samples machined using new tools. However, trends regarding the cutting temperature can be seen for all the tools when considering the maximum flexural stress. The second machined sample always exhibits a lower maximum flexural stress than the first one ($\sigma \max 2 VS \sigma \max 1 = -3\%$ to -21%). This phenomenon indicates that the rising temperature during the cutting induces increasing thermal damage: this explains why the second

portion of a given strip exhibits lower resistance than the first one.

In Fig. 10, the mean values are calculated as:

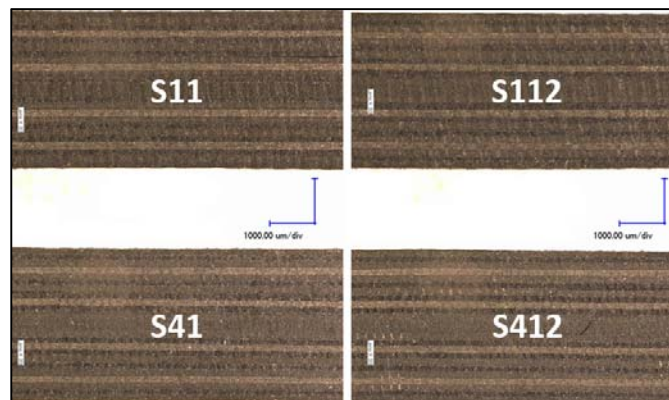
Inspection of the surface finish is an interesting way to anticipate or understand a reduction of the mechanical strength of the material. In this case, great surface integrity can be observed for the specimens trimmed with a new tool, regardless of the cutting temperature (Fig. 11). The -45° plies show some fibres pull-out, which is a typical defect when dealing with CFRP machining. As tool wear increases, degradation of the matrix occurs and the different plies become harder to differentiate from each other (Fig. 12). This strongly indicates that the resin went through deterioration, resulting in a softened and more homogeneous surface. Also, the surface appears to be darker, which suggests charring of

Fig. 11 Constant damage induced on the machined surface of short beam samples regardless of the cutting temperature (new tools)

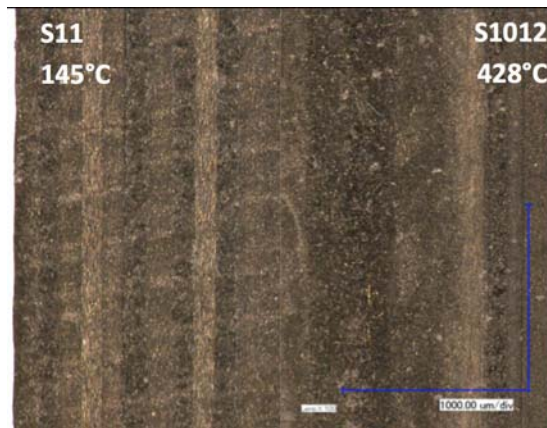
the matrix. In addition, little delamination on the surface plies and some fiber reorientation can be noticed. Also, looking at the surface of the laminate machined using worn tools, increasing degradation in the near zone of the cutting can be seen with the increase of the cutting speed: resin moves back towards the middle of the sample, leaving fibers out of the resin, resulting in some kind of delamination from thermal origin (Fig. 13). Damage on the surface plies for samples machined using new tools was constant and of brittle nature: simultaneous snatching of both fibers and resin and absence of delamination

Fig. 12 Comparison between the machined surface using a new tool at low cutting temperature and a worn tool at high cutting temperature

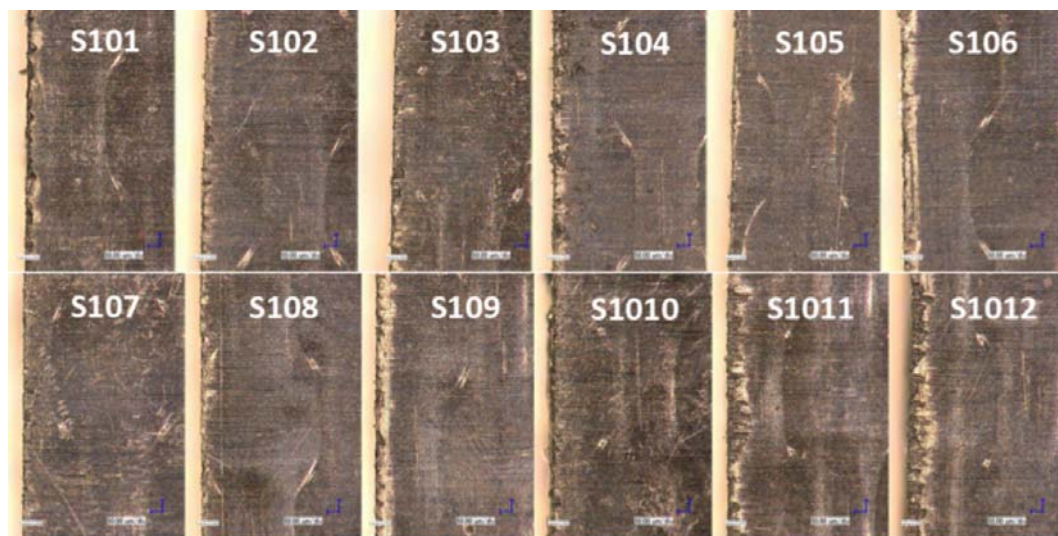
Fig. 13 Increasing damage on the surface ply of short beam samples (strip S10)
