# Detection of Leaks in Water Mains Using Ground Penetrating Radar

Alaa Al Hawari, Mohammad Khader, Tarek Zayed, Osama Moselhi

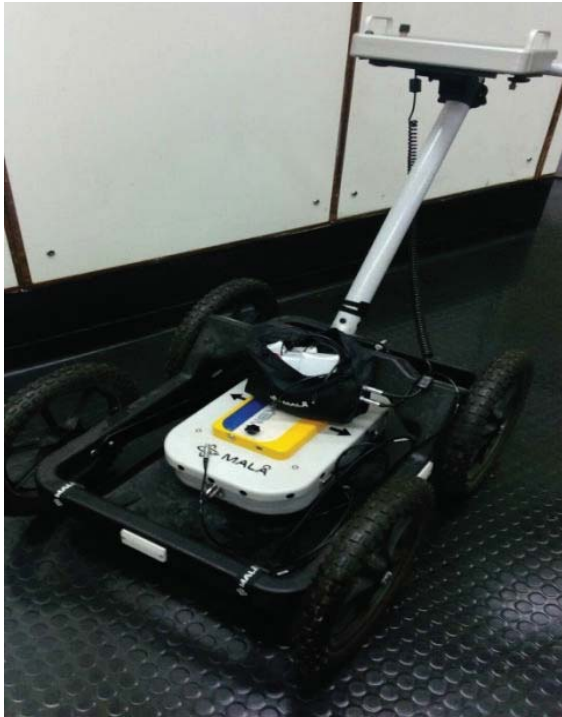
Fig. 1 GPR on a Terraplug Rough Terrain Cart

GPR sends EMs through the ground to the subsurface then reflections from the underground objects will be received again by the radar [8]. The waves are emitted and received back through an antenna, creating a profile of the subsurface. In 1929, the first attempt to determine the depth of ice in a glacier was performed in Austria using GPR demonstrating that electromagnetic energy is capable of traveling in media other than air [8]. Forty-three years later, NASA had built a prototype GPR system to be sent on Apollo17 to the moon to study the geological and electrical properties of the moon's crust [8]. The potential of using GPR had become attractive to the archeological community because of its ability to detect buried archeological features and associated sediments. Thus, in 1975 the first application of GPR in archeology was conducted in Chaco Canyon New Mexico [8]. From the late 1970s to the mid-1980s, several surveys had been conducted in Cyprus, El Salvador and Japan to locate burial rises and buried houses [8]. Cultural resource management projects (CRM) gained some attention in the period between the late 1980s and early 1990s that encouraged the use of GPR in some archeological contexts [8]. In the late 1990s to mid-2000s extra efforts were performed in the area of GPR data processing, where various research had been implemented to demonstrate the differences in data collection and analysis [8], [9]. A MALÅ GPR, placed on a Terraplus Rough Terrain Cart (RTC), was used in this study (Fig. 1). The MALÅ GPR was equipped with two shielded antennas, 250 MHz antenna (Dimensions: 0.74 x 0.44 x 0.16 m – Weight: 7.85 kg) and the shielded 500 MHz antenna (Dimensions: 0.50 x 0.30 x 0.16 m – Weight: 5.0 kg).
