Application Problems of Anchor Dowels in Reinforced Concrete Shear Wall and Frame Connections

Musa H. Arslan

Abstract—Strengthening of the existing seismically deficient reinforced concrete (RC) buildings is an important issue in earthquake prone regions. Addition of RC shear wall as infill or external walls into the structural system has been a commonly preferred strengthening technique since the Big Erzincan Earthquake occurred in Turkey, 1992. The newly added rigid infill walls act primarily as shear walls and relieve the non-ductile existing frames from being subjected to large shear demands providing that new RC inner or external walls are adequately anchored to the existing weak RC frame. The performance of the RC shear walls-RC weak frame connections by steel anchor dowels depends on some parameters such as compressive strength of the existing RC frame concrete, diameter and embedment length of anchored rebar, type of rebar, yielding stress of bar, properties of used chemicals, position of the anchor bars in RC. In this study, application problems of the steel anchor dowels have been checked with some field studies such as tensile test. Two different RC buildings which wil

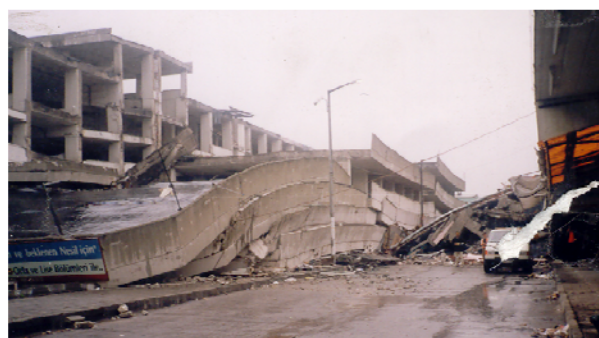
Fig. 1 A seriously damaged RC building in Marmara region

The seismic performance analysis of the buildings, which was lastly renovated in 2007, is conducted in accordance with the Turkish Earthquake Code (TEC – 2007, hereafter) [4] regulations. Structural performance outputs of the buildings are obtained immediately with this analysis. If the performance of the structure is not sufficient for the related seismic effects, strengthening or demolition orders are given by the engineers. In Figs. 1 and 2, a seriously damaged RC

building in Marmara Region of Turkey and the effect of strengthening are given, respectively.

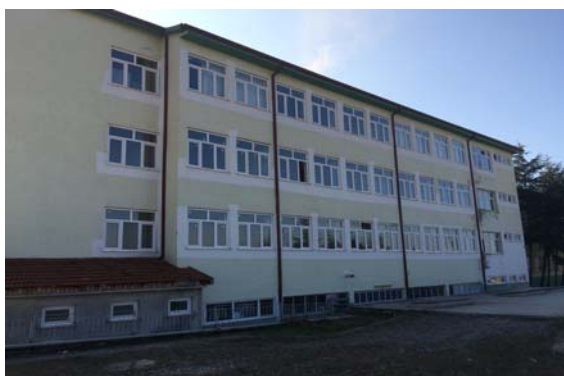
Fig. 3 Weak framed typical school building in Turkey

The building data given in Fig. 3 below are from a school building in Turkey, which is planned to be reinforced. The structure consists of two blocks. Block A is composed of Ground Floor + 2 Normal Floors, and Block B is composed of Basement + Ground Floor + 2 Normal Floors. The structure was completed in 1978. The structure is in first seismic zone according to the zoning map of Turkey. The load carrier system is a RC frame system. According to the concrete core samples taken from the load carrier system of the structure, the average concrete compression strength has proven to be 5.2 MPa (52 kg/cm²). Based the analysis carried out in accordance with the TEC-2007 [4] principles, a strengthening project was prepared since the current situation remains inadequate for the seismic performance.

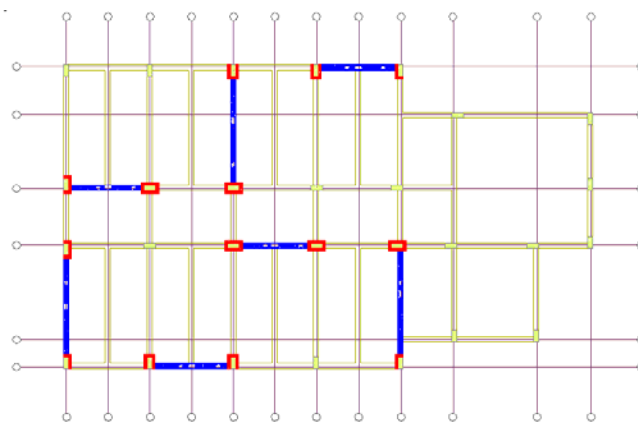
Fig. 4 The first story plan of the strengthening building

The strengthening is constituted of two parts, namely superstructure and infrastructure. Since the single foundation forming the infrastructure was insufficient, the foundation system is completely strengthened. As for the superstructure, due to the lack of stiffness, RC shear wall added in both two directions on the carrier system and the columns in the related were jacketed with RC. According to the analysis carried out after the strengthening, the structures have reached to the desired theoretical performance level analytically. In Fig. 4, the first story plan of the building is given. In the plan, red and

blue labels show the added strengthening member such as shear walls and column jacketing to the weak RC frame. The foundation system is proposed to be completely strengthened in the project.

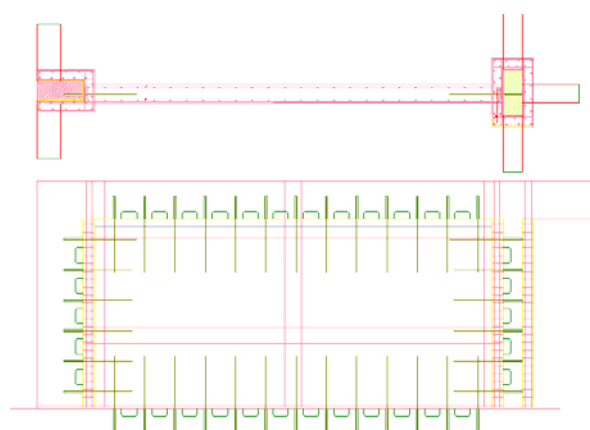
Fig. 5 Typical shear wall-frame connection anchorage details and section in project

It is expected that, since the concrete strength of the structure is too low, some problems will occur related to the application of the anchorages and the anchorage performance mentioned in the project. The proposed anchorage details of shear wall-frame connection are given in Figs. 5 and 6. Also a typical anchorage application of a foundation is also given in Fig. 7.

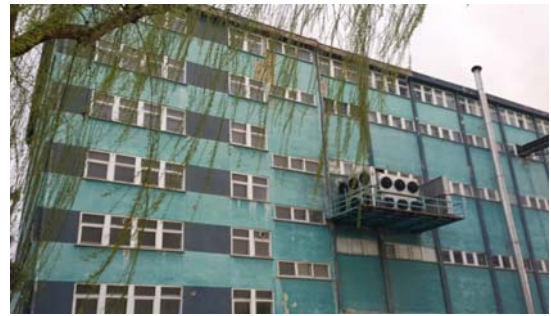
Fig. 9 Weak framed typical official building in Turkey

As for the tests carried out in another building given in Fig. 9, in Turkey with the same compression strength (average value of the compressive strength of concrete is 5.5 MPa), a brand "B" epoxy was used instead of the brand "A" one. The anchorage placement procedure is the same as the first example. As a result of the anchorage placing operation, it has found that the anchorages were able to hold the load to the desired capacity.

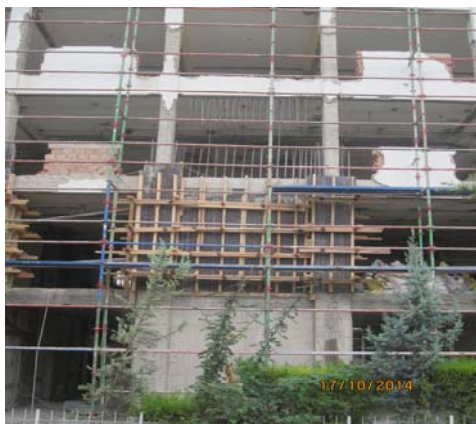
Fig. 6 A typical anchorage details in RC shear wall and frame connection

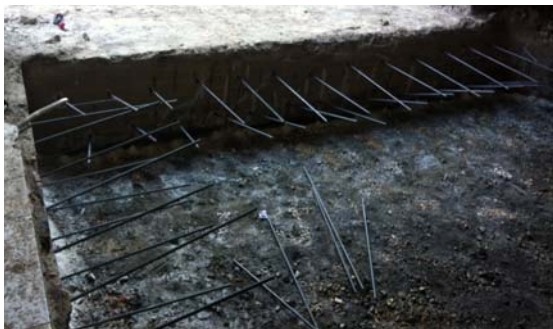
Fig. 7 A typical anchorage details in RC foundation connection

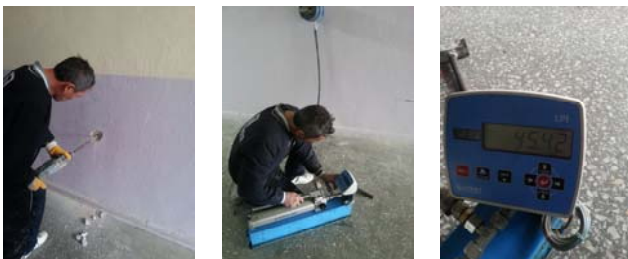
Fig. 8 Anchorage pull out test

The greatest expected risk is the anchorages stripping out from the concrete before reaching shear and bending the capacity of a new added member. For this reason, pull-out tests were carried out on the anchorages. In this experiment, 12 $\phi 20$ anchorages were tested. Firstly, holes with 24 mm diameter were drilled, they were cleaned with compressed air and later a brand "A" epoxy filled the hole by squeezing the anchorage bars.

The sample anchorage bars are inserted by rotating, to the hole filled with the brand "A" epoxy. After the placing, one day later, the pull-out test was conducted. Some steps of the

operation are given in Fig. 8. The test results showed that all fittings were stripping out before reaching to the required strength. According to the tests carried out, since the concrete strength is considerably low in this building, the operating of the steel anchorages placed on both foundation and beams-columns at the desired capacity will be prevented. Anchorages will be stripped out before reaching the capacity.

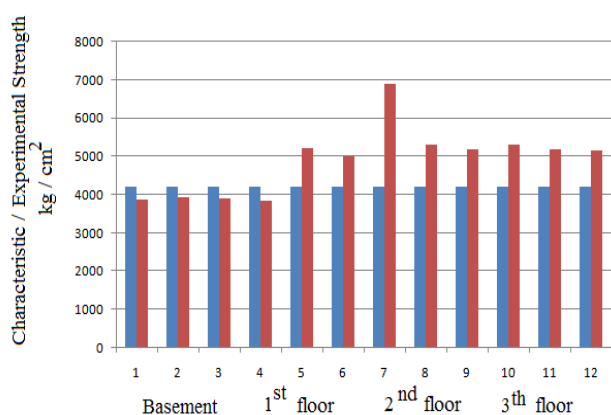
Fig. 11 Pull-out test results for brand "B" epoxy (The average concrete compressive strength is 5.5 MPa)
