Modal Analysis for Study of Minor Historical Architecture

Milorad Pavlovic, Anna Manzato, Antonella Cecchi

Keywords—FEM, masonry, minor historical architecture, modal analysis.

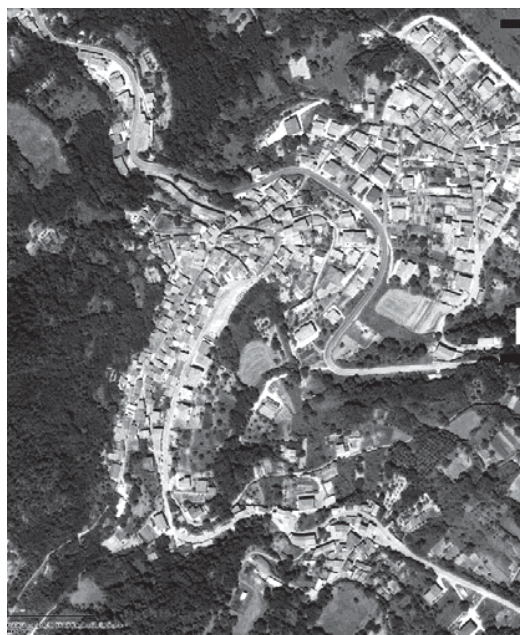
Fig. 1 Aerial view of Bagno Grande

The village of Bagno Grande, located on the South-East side of L'Aquila, rises at an altitude between 600 m and 800 m above sea level. The shape development of the village (Fig. 1), as same as building typologies evolution, followed the orographic configuration of the area and economic conditions, passing from rural buildings to contemporary urban types. The village developed its shape along the main street, whereas the
