Modal Analysis for Study of Minor Historical Architecture

Milorad Pavlovic, Anna Manzato, Antonella Cecchi

Keywords—FEM, masonry, minor historical architecture, modal analysis.

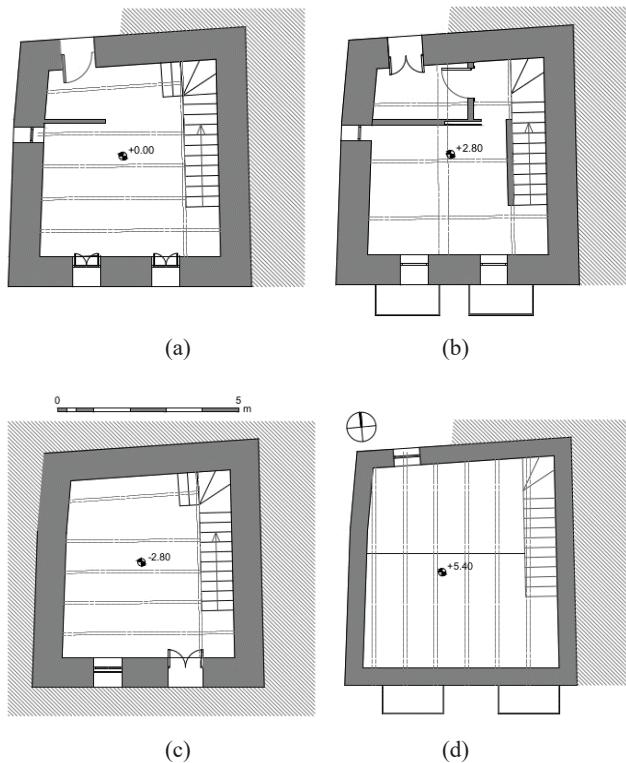
Fig. 2 Plans: (a) Ground level, (b) 1st level, (c) basement, (d) attic area

The building studied in this research is a masonry construction composed of a residential and a storage part. According to local use, the building includes two residential levels (Figs. 2 (a) and (b)), a partially underground floor (Fig. 2 (c)) originally used for agricultural purposes and an attic area (Fig. 2 (d)), whereas the roof has a mono slope shape, which spans from the northern side to the southern façade.

The external dimensions of the plan are nearly equal (6.43 m x 6.42 m), whereas floors have an average height of 2.8 m each. Following traditional use, the external walls are made of rubble masonry (average thickness 0.65 m), constituted by local sandstone and lime mortar. As a characteristic of long term building processes, many buildings present the attic level that has been added successively, using industry produced clay blocks and air lime mortar (Fig. 3).

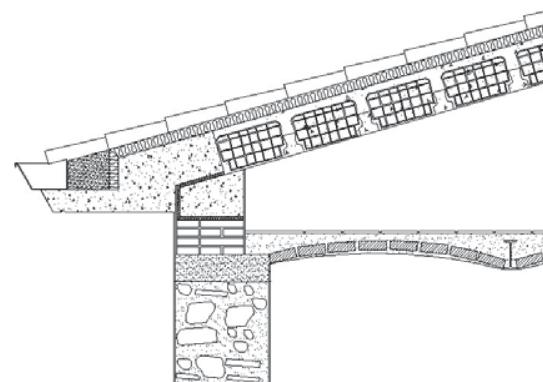
Fig. 4 Attic level section, particular

Another emblem of building transformation is represented by the roofs built with steel beams and masonry vaults (Fig. 4). This technique was particularly diffused during the 2nd half of the XIX Century and many examples are still available in the L'Aquila area. For this study case, steel girder were set up with a wheelbase of 0.85m and fixed into the masonry walls. Each couple of steel beams is connected by masonry vaults,

constituted by a single course of clay bricks. Over the vaults, a thin layer of mortar and various building material was set down to ensure the horizontality and provide the finishing level for flooring.

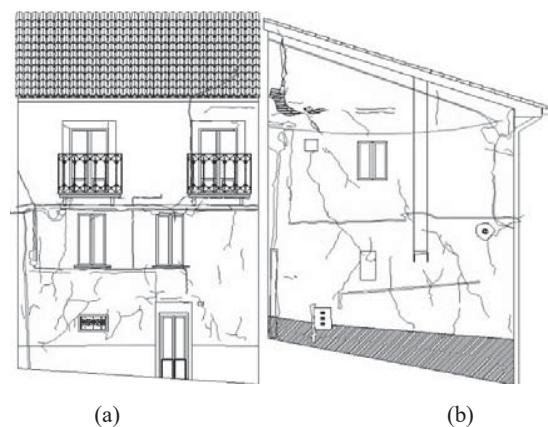
Fig. 5 Crack pattern after the earthquake: (a) damages on the lower part of the building, (b) façade rocking mechanism

Observing the crack pattern carried on after the earthquake, it is possible to observe that the main cracks developed in the lower part of the building (Fig. 5 (a)), whereas a vertical crack (Fig. 5 (b)) emanates from the beginning of a façade rocking mechanism, probably induced by the roof's thrust and weak angular connection [5].

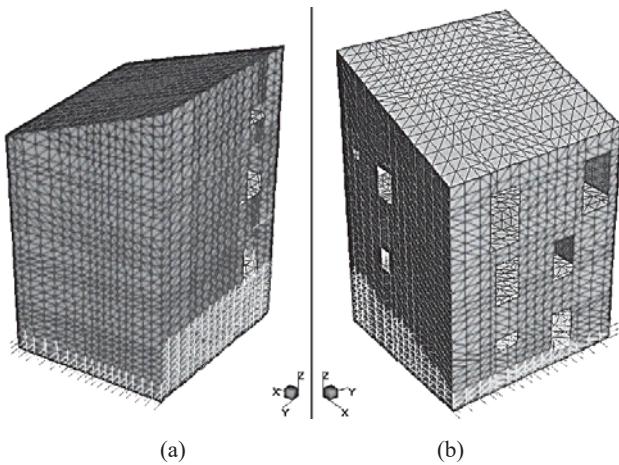
Fig. 6 Model 1: (a) North – East sides, (b) South – West sides

Starting from these structural considerations, attention has been paid on the influence of boundary conditions to the seismic behavior of the building. In particular is proposed a Finite Element model with two different boundary conditions: i) Model 1 (Fig. 6), with vertical and two horizontal translations avoided; ii) Model 2 (Fig. 8), as Model 1 enhanced with the eastern façade bonded and northern façade partially bonded.

The purpose of developing Model 1 is to evaluate the structural behavior of the building, in the case that the eastern and northern façades are completely free (Fig. 8). This condition aims to simulate the global behavior of the structure free from the urban aggregate.

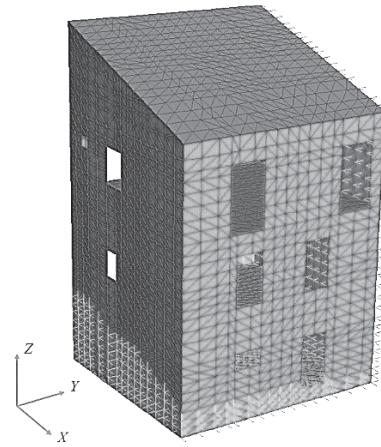
Fig. 7 Modal analysis axes reference

vibrating modes and the corresponding frequencies. Moreover, for each vibrating mode, the percentages of participant mass (PFs - Participation Factors) have been evaluated in X and Y horizontal directions (Fig. 7). These values allow to define the main vibration modes and to evaluate the oscillating direction of the model. For simplicity, the mass participation in Z axis (Fig. 7) has been ignored, since the structural behavior in the vertical direction is less significant than the others in the plan.

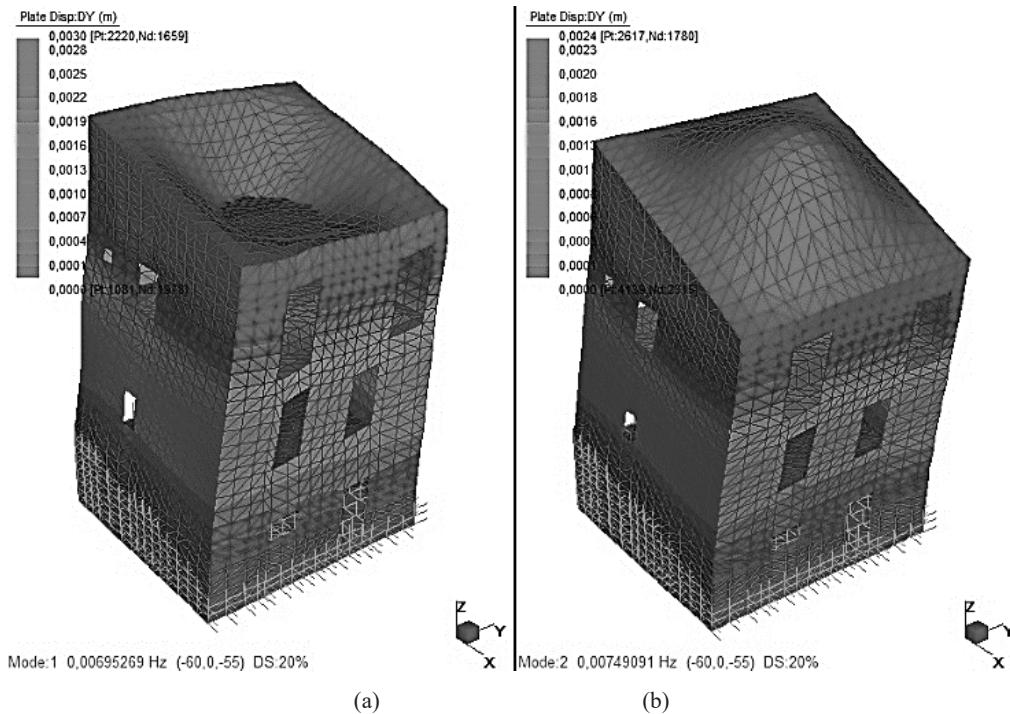
Fig. 8 Modal analysis: (a) Mode 1, (b) Mode 2

In Table II are collected the results of modal analysis. It is possible to observe that modes 1 and 2 have nearly the same frequency (0.7 Hz), whereas the participant mass factors are major in the Y direction. Both modes have bending trends following a sinusoidal deformation with one half-wave. Since most of the openings concentrate in the X direction, Mode 1 involves major participant mass in the Y direction (41.5%), whereas Mode 2 mobilizes nearly the same mass percentage in both directions.

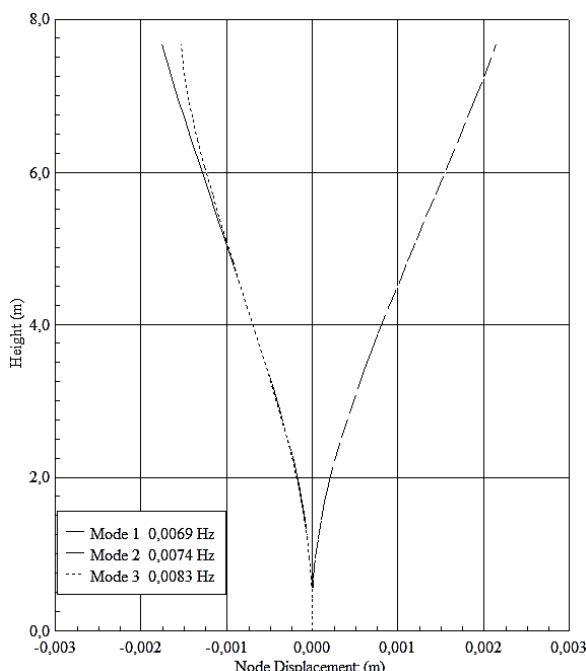
Fig. 9 Displacement evaluation on Model 1

Successive modes involve less than 1% of the total mass, hence they should be related to local modes and are not significant for the global behavior, even if Mode 3 follows the same modal shape of Mode 1 (Fig. 9).

In Fig. 9 is proposed an evaluation of the maximum displacement of the structure due the natural frequencies. From the graph, we can observe that for main modes, the maximum displacement is lower than 3 mm.

Table IV focus the attention has been focused on the evaluation of the maximum displacement in X direction for the first three modes.

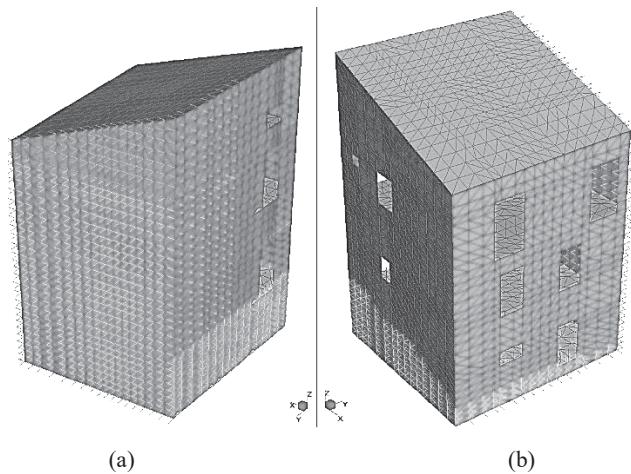
Fig. 10 Model 2: (a) North – East sides, (b) South – West sides

A second modal analysis has been performed on the model with bounded base, partially bonded northern side, in X direction, and completely bonded eastern side, in Y direction (Fig. 10). The results are reported in Table III.

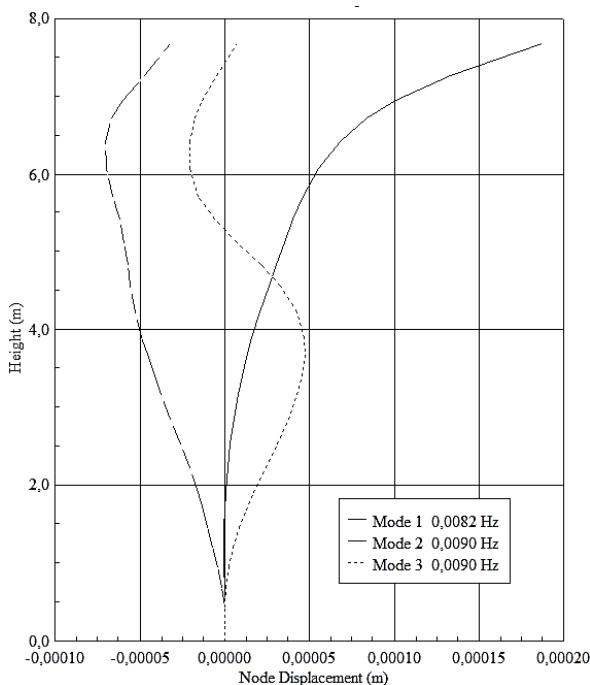
Fig. 11 Displacement evaluation on Model 2

first three modes, an evaluation of maximum displacement in X direction has been carried out (Fig. 11).

The analysis showed that, for Mode 1, the maximum displacement is lower than 0.2 mm, whereas the modal shape, like in the previous case, is sinusoidal with one-half wave. On the contrary, Modes 2 and 3 registered displacements lower than 0.1 mm, following different modal shapes. In particular, Mode 2 follows a sinusoidal deformation with one half-wave, whereas Mode 3 follows a sinusoidal deformation.
