Metallurgy of Friction Welding of Porous Stainless Steel-Solid Iron Billets

S. D. El Wakil

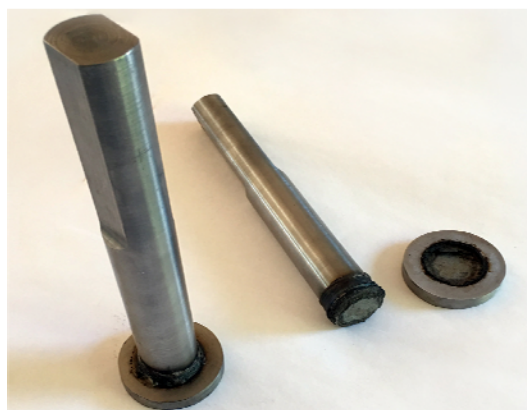
Fig. 1 shows a friction-welded specimen before and after being subjected to tensile testing. As can be seen in the figure, failure did not occur in the welded joint but rather in the porous stainless steel disc at a distance of about 2 mm away from the edge of the wrought iron tube, producing a very rough surface characterizing brittle fracture. In fact, it revealed that the solid iron tubular end penetrated into the porous disc,

allowing some porous stainless steel to intrude into it and block that tube. The results obtained for the load-carrying capacity of the tensile test specimens was, therefore, not an indication of the strength of the friction-welded joint, but of the sintered porous stainless steel. As it is always the case with sintered porous metals, values of the load-carrying capacity showed a scatter around an average of 35 kN. Evidently, that value cannot be used to determine the strength of the friction-welded joint as previously mentioned.

Fig. 1 A friction-welded specimen before and after a tension test

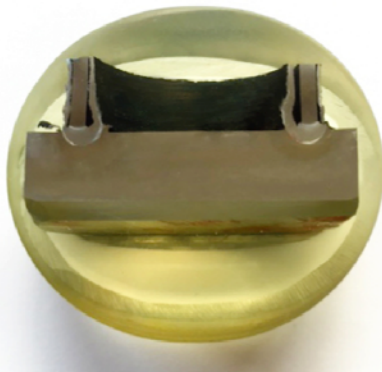
An axial macroscopic section of a friction-welded joint is shown in Fig. 3. The line along which friction welding took place appears as a well-defined trapezoid with a convex base. In fact, it is actually the edge of the wall of the iron tube, which sank into the sintered porous stainless steel disc during the friction welding process, producing an interlocking between those two parts. The heat-affected (HAZ) zone in the sintered porous stainless steel appears as an arch-shaped narrow layer under that trapezoid. Naturally, the picture shows just a cross section, and the HAZ is actually a ring coaxial with the iron tube and having that cross section. The figure also indicates that part of the iron tube was bent inside the tube creating a short thin tube coaxial with the original one.

Fig. 3 An axial macroscopic section of a friction-welded joint
