Self-Help Adaptation to Flooding in Low-Income Settlements in Chiang Mai, Thailand

Abstract—This study aimed to determine low-income housing adaptations for flooding, which causes living problems and housing damage, and the results from improvement. Three low-income settlements in Chiang Mai which experienced different flood types, i.e. flash floods in Samukeepattana, drainage floods in Bansanku, and river floods in Kampangam, were chosen for the study. Almost all of the residents improved their houses to protect the property from flood damage by changing building materials to flood damage resistant materials for walls, floors, and other parts of the structure that were below the base of annual flood elevation. They could only build some parts of their own homes, so hiring skilled workers or contractors was still important. Building materials which have no need for any special tools and are easy to access and use for construction, as well as low cost, are selected for construction. The residents in the three slums faced living problems for only a short time and were able to cope with them. This may be due to the location of the three slums near the city where assistance is readily

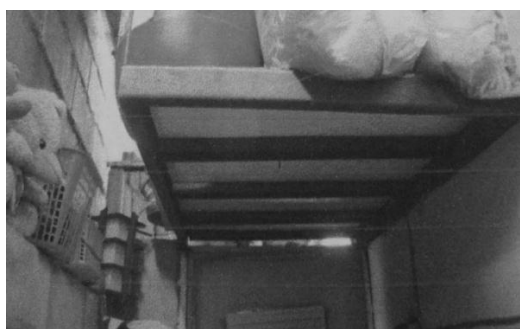
Fig. 2 Shelf preparation for protection of personal belongings

evacuate from the low-income settlements. Shortage of drinking water and food rarely occurred during floods with the three low-income settlements, because there were short flood duration and the residents could access retail stores around their houses or public assistance. This is an advantage of low-income settlements in urban areas. In the case of problems with the toilets, they solved the problem by using the neighbor's toilet or defecating into plastic bags. Even when they cannot use electricity, residence can normally still live in their houses since they have fewer home appliances. The strong furniture, such as beds, tables, cabinets, and shelves, were adapted to become the floor for living when 1-storey houses flooded less than 1.00 m. In addition, they prepared to protect things by lifting them above the water or put them on the shelves, which were built on the wall (Fig. 2). However, the shelves cannot be built in every house due to a lack of structural strength, and therefore in some cases, property and furniture remained in the flood waters.
