# Use of Short Piles for Stabilizing the Side Slope of the Road Embankment along the Canal

**Abstract**—This research presents the behavior of slope of the road along the canal stabilized by short piles. In this investigation, the centrifuge machine was used, modelling the condition of the water levels in the canal. The centrifuge tests were performed at 35 g. To observe the movement of the soil, visual analysis was performed to evaluate the failure behavior. Conclusively, the use of short piles to stabilize the canal slope proved to be an effective solution. However, the certain amount of settlement was found behind the short pile rows.

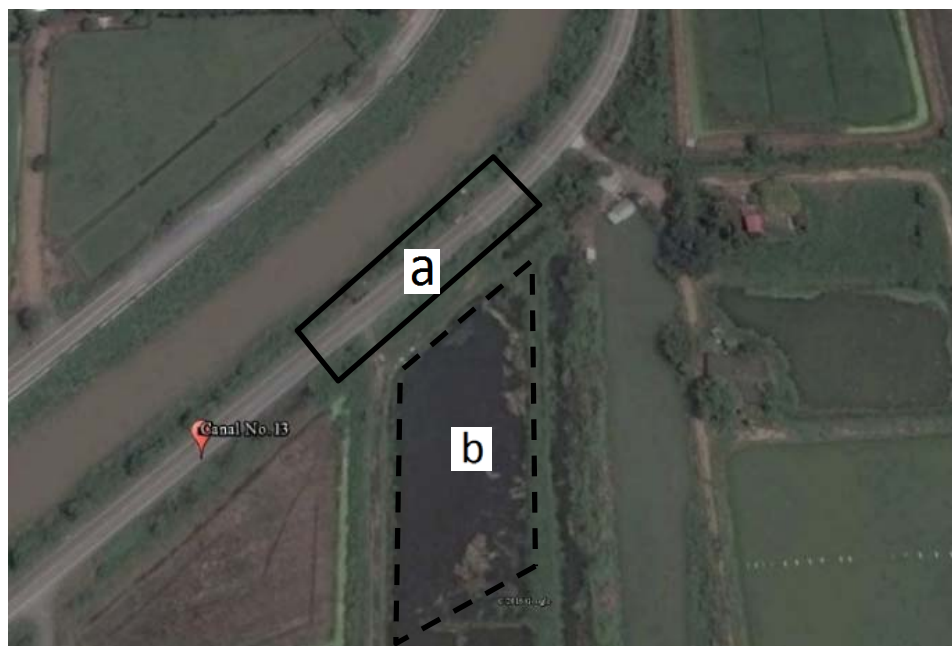
Fig. 2 a. The collapsed areas b. Shrimp ponds

On the 2<sup>nd</sup> of March 2016, the road embankment along Canal no.13 (Klong 13) collapsed (Fig. 1) for approximately 100 m long. The canal at the failure area was found to be nearly dry, and a large water pond was found to be located near the failure section (Fig. 2).

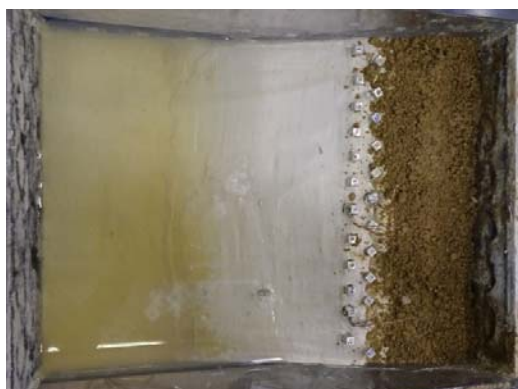
Fig. 5 Top view of piles group box

When the piles were placed alternately, the soil between these piles were virtually not moving because of soil arching, expectedly that the two pile rows will acted as a retaining wall (Figs. 4 and 5).

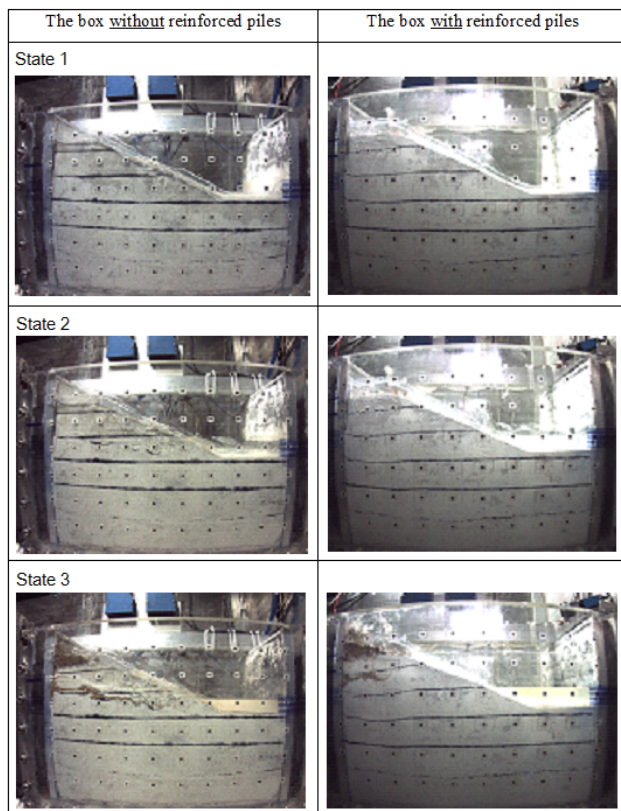
Fig. 6 The results of testing

The results of the centrifuge test can be classified into three states as (Fig. 6):

- State 1: Initial state, after soil preparation but before being spun up to 35 g.
- State 2: Water level changes according to test plan but before CDG was added:
  1. In the box without reinforced piles, the soil moved down the slope, and the failure plane was found.
  2. In the box with reinforced piles, the soil behind short pile rows moved vertically, but no failure plane was observed.
- State 3: The final step, CDG was added to represent the embankment road:
  1. In the box without reinforced pile, the slope failure was clearly shown (Fig. 7).
  2. In the box with reinforced pile, the soil behind short pile rows moved vertically. Although, more settlement was found and the piles moved slightly, failure plane was not found (Fig. 8).
