# Use of Short Piles for Stabilizing the Side Slope of the Road Embankment along the Canal

**Abstract**—This research presents the behavior of slope of the road along the canal stabilized by short piles. In this investigation, the centrifuge machine was used, modelling the condition of the water levels in the canal. The centrifuge tests were performed at 35 g. To observe the movement of the soil, visual analysis was performed to evaluate the failure behavior. Conclusively, the use of short piles to stabilize the canal slope proved to be an effective solution. However, the certain amount of settlement was found behind the short pile rows.

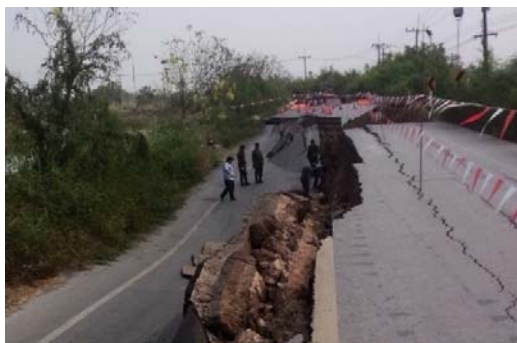
Fig. 1 Road along the canal no.13 collapsed

On the 2<sup>nd</sup> of March 2016, the road embankment along Canal no.13 (Klong 13) collapsed (Fig. 1) for approximately 100 m long. The canal at the failure area was found to be nearly dry, and a large water pond was found to be located near the failure section (Fig. 2).

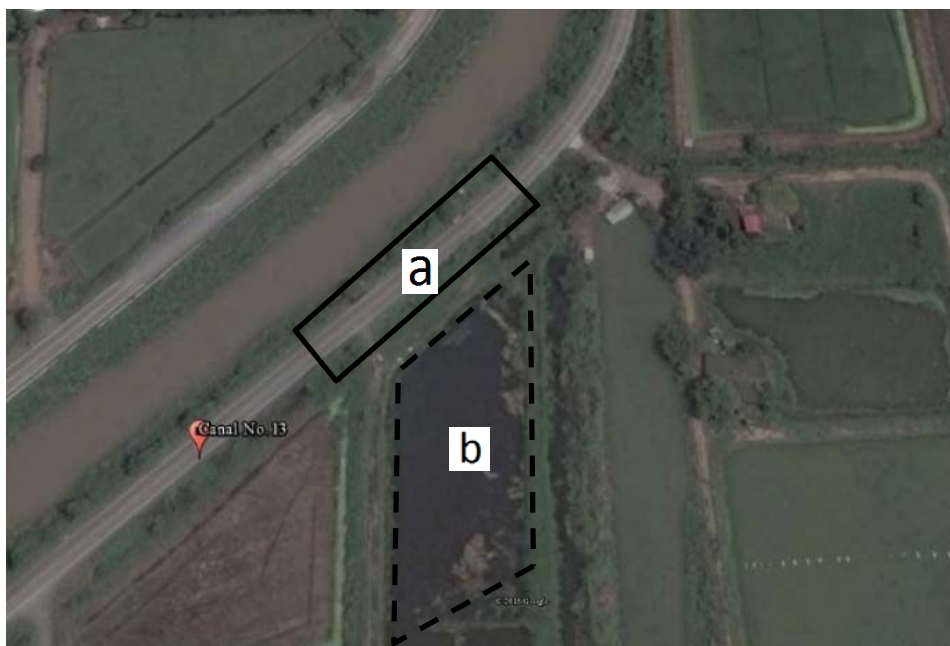
Fig. 2 a. The collapsed areas b. Shrimp ponds

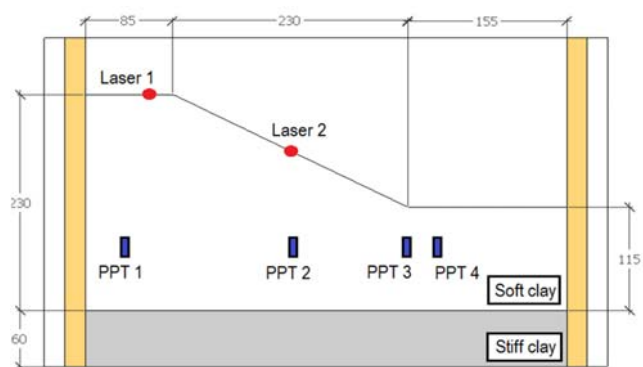
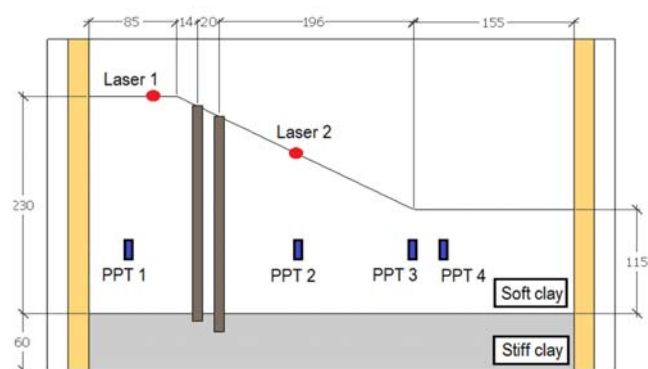
Fig. 3 The setup of instrumentations in both boxes (a) The box without reinforced piles (b) The box with reinforced piles

- PIV Camera: Located in front of the box to record the direction of soil movement.
- Laser: Record the settlement data.
- Pore Pressure water (PPT): Record the changes of water pressure.
- Water Tanks with flow control valve: Control the head of water while testing and the flow rate.

Fig. 3 illustrates the setup of instrumentations of both boxes.

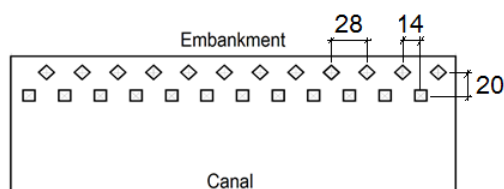
Fig. 4 Pattern of piles group

When the piles were placed alternately, the soil between these piles were virtually not moving because of soil arching, expectedly that the two pile rows will acted as a retaining wall (Figs. 4 and 5).

- Pile length: 8 m (230 mm)
- Material: Aluminium
- Amount: 24 pieces

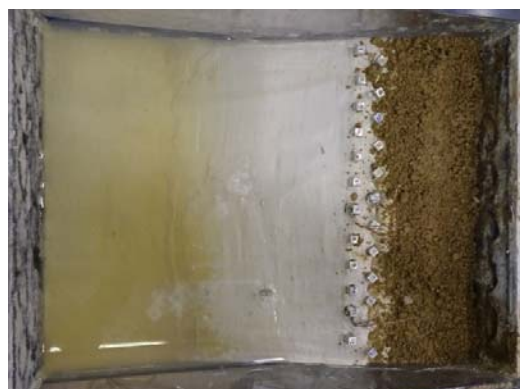
Fig. 5 Top view of piles group box

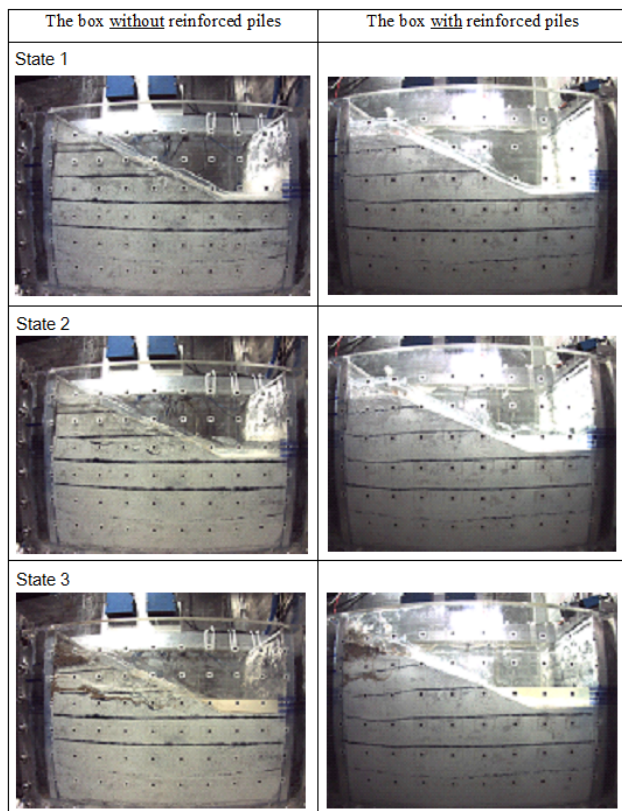
Fig. 6 The results of testing

The results of the centrifuge test can be classified into three states as (Fig. 6):

- State 1: Initial state, after soil preparation but before being spun up to 35 g.
- State 2: Water level changes according to test plan but before CDG was added:
  1. In the box without reinforced piles, the soil moved down the slope, and the failure plane was found.
  2. In the box with reinforced piles, the soil behind short pile rows moved vertically, but no failure plane was observed.
- State 3: The final step, CDG was added to represent the embankment road:
  1. In the box without reinforced pile, the slope failure was clearly shown (Fig. 7).
  2. In the box with reinforced pile, the soil behind short pile rows moved vertically. Although, more settlement was found and the piles moved slightly, failure plane was not found (Fig. 8).

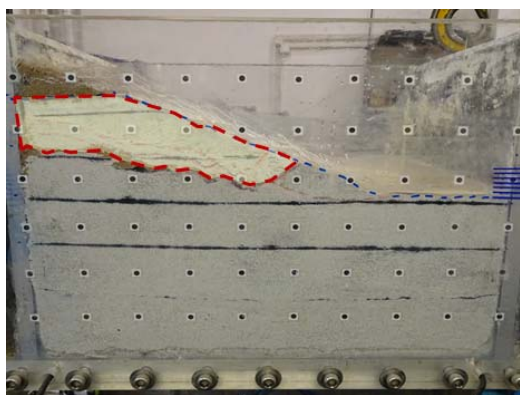
Fig. 7 Failure plane in the box without reinforced piles

1. The slope failure was found in the unreinforced slope when groundwater was raised up because of the delay flow.
2. Reinforced piles forced the road embankment to road embankment moved vertically instead of horizontally.
3. CDG weight exerted on the road embankment affected both horizontal and vertical movements.
4. The alternated piles presented the piles group behaved as a retaining wall.

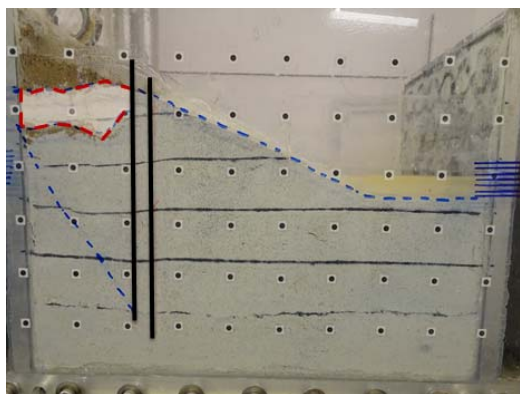
Fig. 8 The vertical settlement area in the box with reinforced piles
