# Reinforced Concrete Bridge Deck Condition Assessment Methods Using Ground Penetrating Radar and Infrared Thermography

Nicole M. Martino

**Keywords**—Bridge deck deterioration, ground penetrating radar, infrared thermography, NDT of bridge decks.

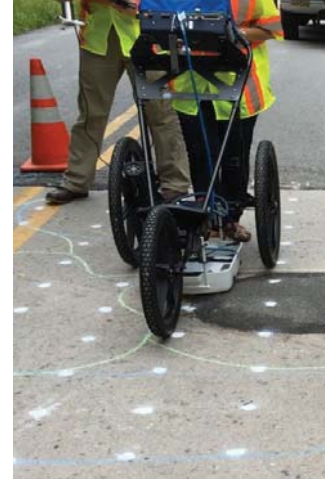
Fig. 1 Picture one of GPR data collection

Ground penetrating radar works by sending electromagnetic pulses through the subsurface of the deck with a high frequency antenna that travels over the deck, and in the direction of vehicular traffic. When those pulses come into contact with a material of differing dielectric property, like the concrete rebar interface, some of the signal is scattered and captured by the antenna’s receiver. Two examples of data collection using this method can be seen in Figs. 1 and 2.

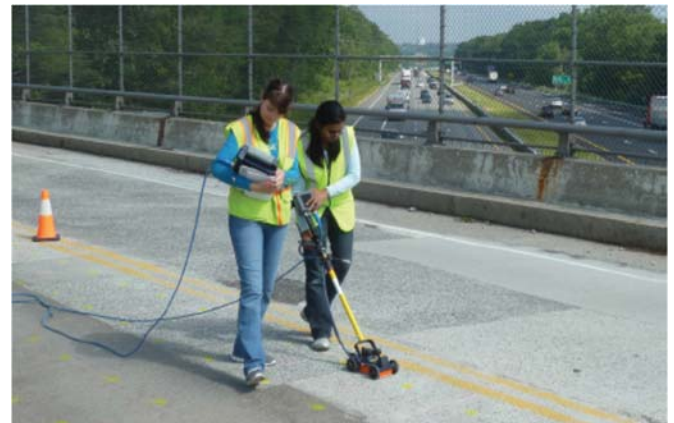
Fig. 2 Picture two of GPR data collection

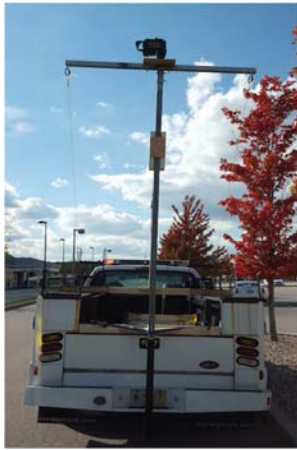
Infrared thermography works by collecting emitted infrared energy, in the form of temperatures (degrees F), from the surface of the deck using an infrared camera mounted onto a vehicle, about 12-13ft above the surface (Fig. 4). The surface temperatures vary when a delamination is present within the subsurface. Since a delamination is an air pocket, it acts as an insulator for that location of the deck. So as the ambient air temperature rises early in the day, the delaminated area will heat up quicker than an area free from damage and appear as a hot spot.

Fig. 4 IR Setup
