# Triplet Shear Tests on Retrofitted Brickwork Masonry Walls

Berna Istegun, Erkan Celebi

**Keywords**—Triplet shears tests, retrofitting, seismic fabric, perforated brickwork, expanded glass granular.

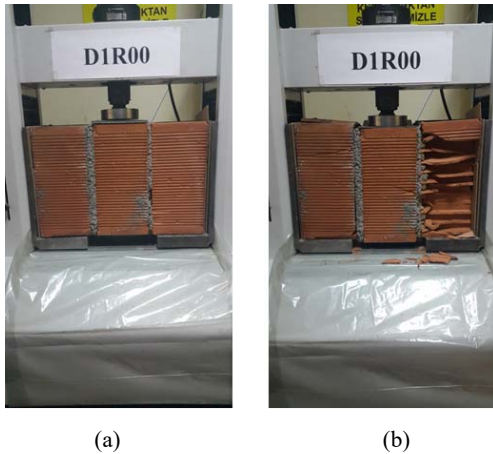
Fig. 6 (a) Initial state and (b) final state of D1R00-2

Similarly, triplet shear tests were performed for the D1R00-2 and D1R00-3 and the resulting crack forms are shown in Figs. 6 and 8, respectively.

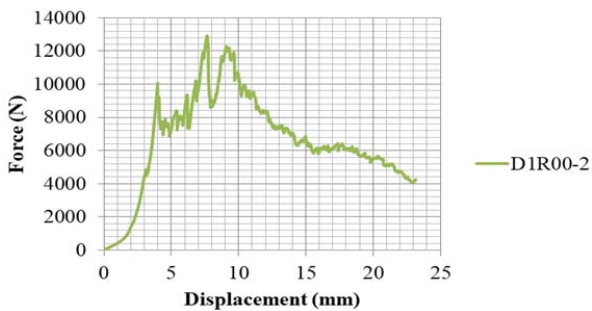
Fig. 7 Force-displacement diagram of the D1R00-2

As can be seen from Figs. 7 and 9, due to lack of ductility, the shear strength of the brick units suddenly decreased and brittle fractures occurred rapidly under stress. These damages are abrupt. The failure surface of specimen exhibits little degradation before the fracture occurs.

In this case, the shear strength,  $f_v$  are calculated as 0.117 MPa and 0.138 MPa by considering the experimentally

obtained maximum force of 12920 N and 15316 N, respectively.

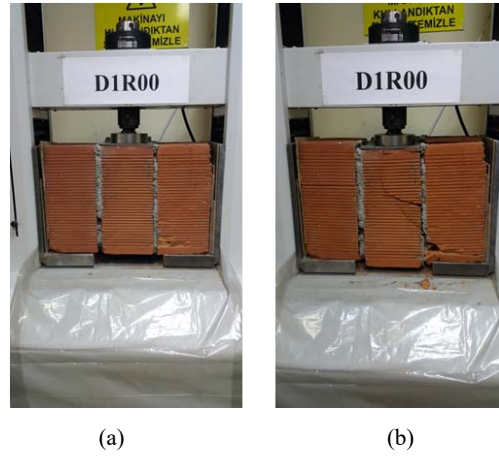
Fig. 8 (a) Initial state and (b) final state of D1R00-3

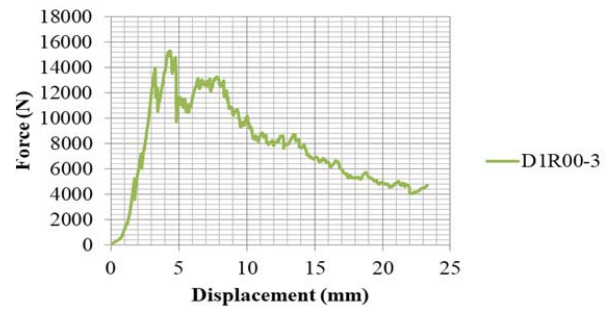
Fig. 9 Force-displacement diagram of the D1R00-3

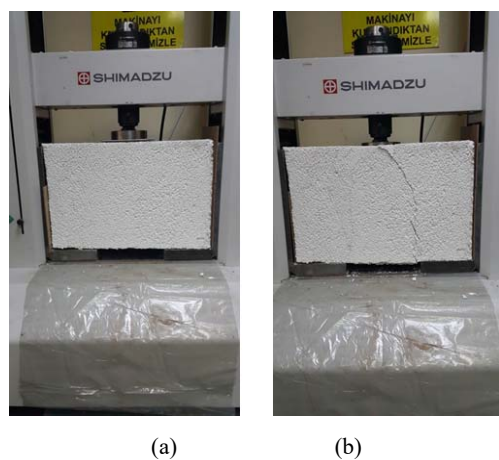
Fig. 10 (a) Initial state and (b) final state of D1G03-1

In the second stage of the experimental study, the effect of the applied seismic textile and the plaster made of expanded glass granular on the shear capacity of mortar joints was investigated. Hereby, the one-sided retrofitted brick specimen with 20 mm reinforcing layer is named as D1G03 for triplet shear test. Firstly, D1G03-1 was tested. The crack pattern of this specimen can be seen in Fig. 10.

The first cracks on the specimens under shear forces were

experienced in vertical form and occurred in brick-mortar interface. When the imposed load reached close to the shear strength capacity of the specimen, the crack widths increased and the middle block separated from the joint plane.

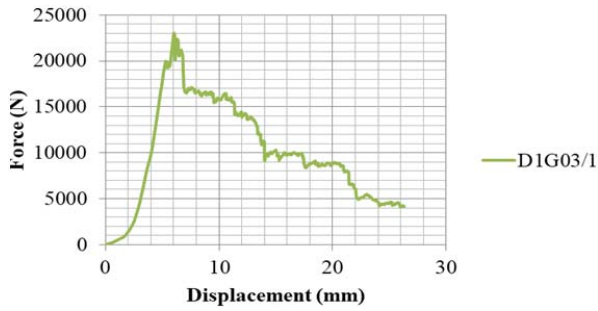
Fig. 11 Force-displacement diagram of the D1G03-1

As shown in Fig. 11, the maximum shear force  $F_{max}$  is obtained as 23033 N and the corresponding shear stress value  $f_v$  is calculated as 0.209 MPa for specimen of D1G03-1.

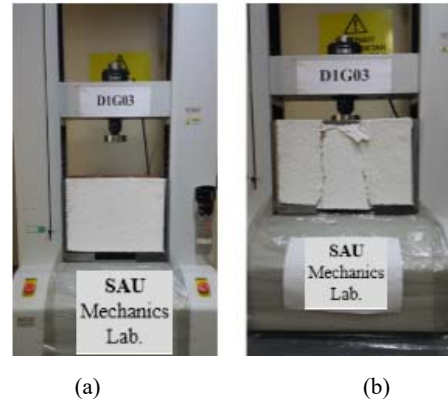
Fig. 14 (a) Initial state and (b) final state of D1G03-3

For the D1G03-2 and D1G03-3 specimens; crack patterns, maximum shear loads and strength parameters were similarly determined. The failure mechanism of the test specimens under the vertical load is shown in Figs. 12 and 14. The maximum shear forces of the second and third sample of the D1G03 test set are equal to 24548 N and 29427 N, respectively (Figs. 13 and 15).

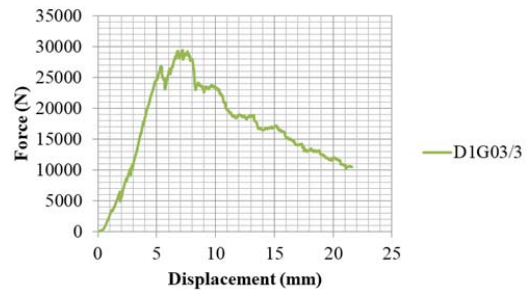
Fig. 15 Force-displacement diagram of the D1G03-3

The values of  $f_v$  are 0.220 MPa and 0.267 MPa for D1G03-2

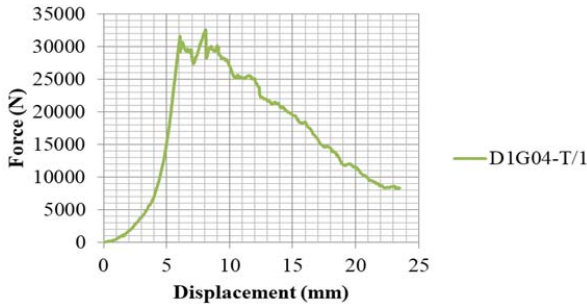
Fig. 17 Force-displacement diagram of the D1G04-T/1

and D1G03-3, respectively. Single-sided retrofitted triplets exhibited more ductile behavior when compared to the reference samples. Furthermore, it was clearly observed that the unilateral strengthening application significantly increased the shear capacity of the masonry building units. The measured value of  $F_{max}$  is 32611 N for this case. Also,  $f_v$  is calculated as 0.296 MPa. The curve of force-displacement relationship for D1G04-T/1 is depicted in Fig. 17.

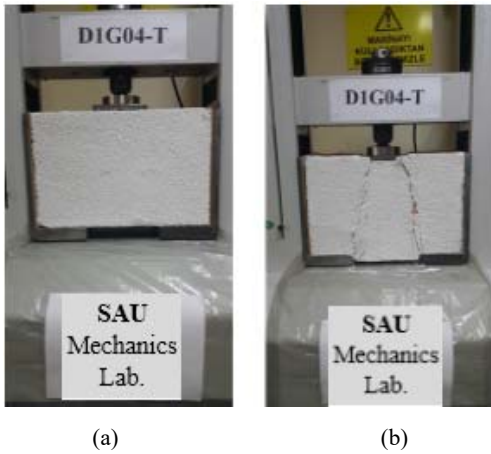
Fig. 18 (a) Initial state and (b) final state of D1G04-T/2

The second and third specimens of the D1G04-T set were also tested. At all specimens in this experiment group, it was obviously seen that the damage started in a similar way to the D1G03 set (Fig. 18).

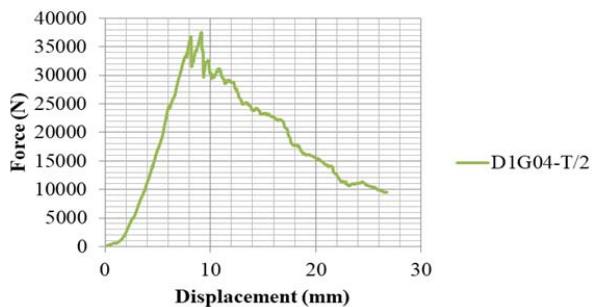
Fig. 19 Force-displacement diagram of the D1G04-T/2

The  $F_{max}$  values were determined for these specimens as 37544 N and 36394 N, respectively. The shear strengths were calculated as 0.340 MPa and 0.330 MPa, respectively. The experimental shear force-displacement curve for D1G04-T/2 and D1G04-T/3 are illustrated in Figs. 19 and 21.

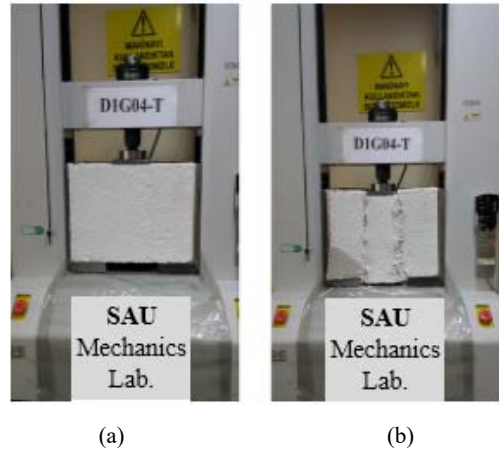
Fig. 20 (a) Initial state and (b) final state of D1G04-T/3

The failure modes of all plastered specimens were similar due to vertical cracks in the direction of loading, which followed the interface between the bricks and joint mortar (Fig. 20).

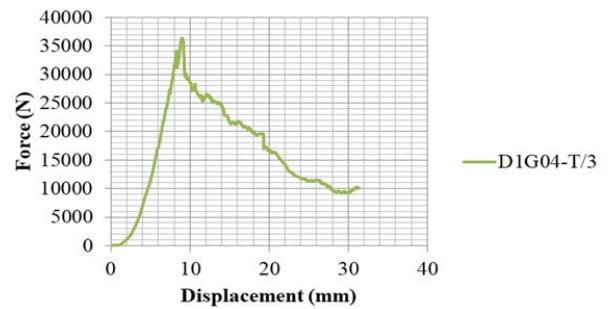
Fig. 21 Force-displacement diagram of the D1G04-T/3

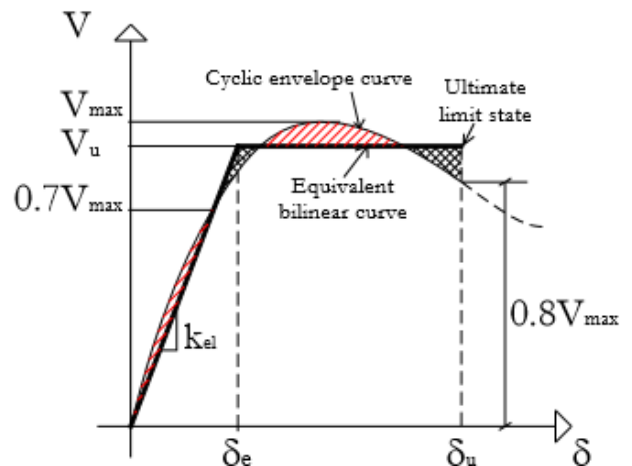
Fig. 22 Bilinear Idealization

Magenes and Morandi [11] calculated the ductility coefficients by idealizing the envelope curve obtained from the experiment with equivalent bilinear curves (Fig. 22). In a similar way, the energy-dissipation capacities of the samples were determined (3), with the force-displacement curves being idealized in this research.

$$\mu = \frac{\delta_u}{\delta_e} \quad (3)$$
