Tensile Test of Corroded Strand and Maintenance of Corroded Prestressed Concrete Girders

Jeon Chi-Ho, Lee Jae-Bin, Shim Chang-Su

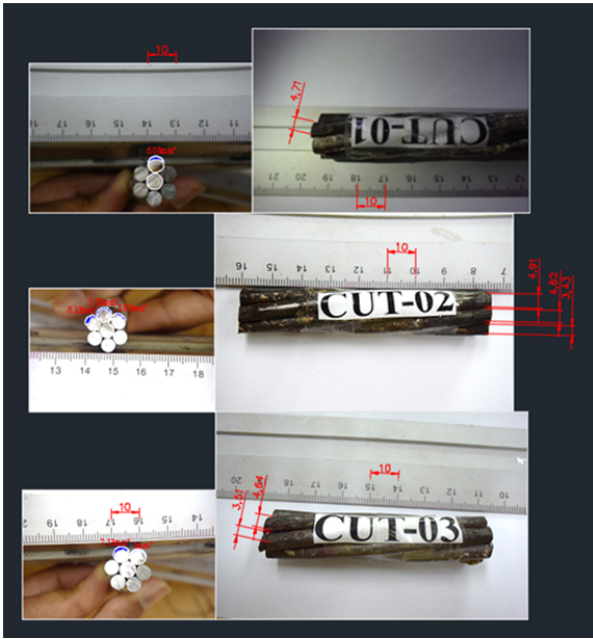
Fig. 3 Evaluation of corroded section

Corroded strands were collected from real bridges. After clearing corroded part of the strands, section reduction of the strand was evaluated as shown in Fig. 3. The section loss of most corroded part and measured mechanical properties from tensile test are listed in Table I. The 'RT' means reference strand which has no corrosion, and 'CT' means corroded strand. The section loss is calculated from corroded section area divided by gross section area. The used specimens are seven wire strands with nominal diameter of 15.2 mm and nominal area of 138.7 mm². The nominal strength is 1,860 MPa.
