# Safety Conditions Analysis of Scaffolding on Construction Sites

**Abstract**—This paper presents the results of analysis of 100 full-scale scaffolding structures in terms of compliance with legal acts and safety of use. In 2016 and 2017, authors examined scaffolds in Poland located at buildings which were at construction or renovation stage. The basic elements affecting the safety of scaffolding use such as anchors, supports, platforms, guardrails and toe-boards have been taken into account. All of these elements were checked in each of considered scaffolding. Based on the analyzed scaffoldings, the most common errors concerning assembly process and use of scaffolding were collected. Legal acts on the scaffoldings are not always clear, and this causes many issues. In practice, people realize how dangerous the use of incomplete scaffolds is only when the accident occurs. Despite the fact that the scaffolding should ensure the safety of its users, most accidents on construction sites are caused by fall from a height.

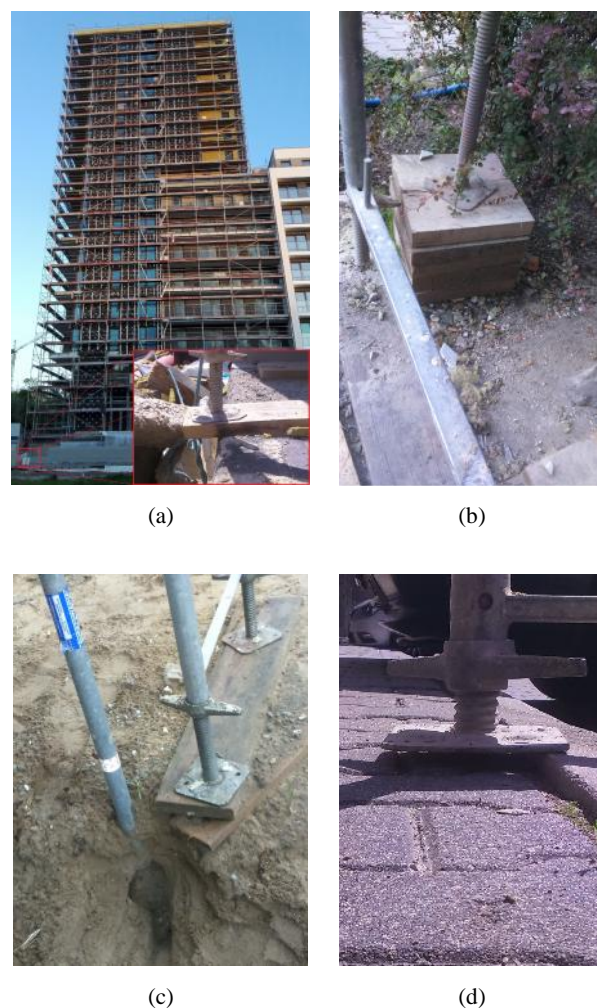
Fig. 2 Errors in scaffolding supports; (a) strained mudsill, (b) multi-level wooden mudsills, (c) unstable substrate, (d) base jack without support

The quality of the scaffolding support depends on the condition of the soil substrate. Scaffolding in many cases is placed on pavement or concrete. Such type of support guarantees that the frame will not subside. If the scaffold is planned to be set directly on the ground it should be leveled and compacted earlier. The research shows that ground substrate is usually not properly prepared, especially not compacted. When the scaffold was placed on ground, the quotient of the minimum value to the maximum compressibility modulus was in the range of 0.1 to 0.75. Such differences in soil compaction result in very large differences in subsidence between each scaffold frameworks. Normally structure of a scaffolding is not sensitive to such differences because of looseness in connections between elements. But, if the scaffold has bracing, differences in subsidence of stands placed on two separate base plates, lead to suspension of the frame on the other frame. Fig. 2 shows examples of errors in scaffolding supports. The extreme case is the situation shown in Fig. 2 (a). The 54-m high scaffolding was set on a base plate put out beyond the concrete ceiling of the underground garage. We can see strained base plate. Such a situation can

result in a complete loss of supports thus leading to collapse of the construction. The set of base plate depicted in Fig. 2 (b), in which the scaffold is supported, looks quite stable, but the individual elements can move without guaranteeing the transfer of horizontal forces. In the situation illustrated in Fig. 2 (c), due to vibration caused by machines operating in the immediate vicinity of the structure, a landslide can occur. The ground substrates have not been prepared in any way and have not been profiled to discharge rainwater. The situation shown in Fig. 2 (d) seems to be appropriate, however, due to differences in the levels between the curb and the pavement, the base jack is based on a very small surface that does not provide the load transfer.
