The Fracture Resistance of Zirconia Based Dental Crowns from Cyclic Loading: A Function of Relative Wear Depth

T. Qasim, B. El Masoud, D. Ailabouni

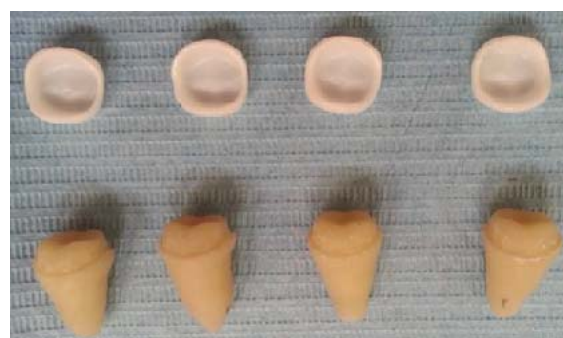
Fig. 2 Lateral view of fabricated abutments

To reduce shrinkage stress and cuspal deflection, the crown-fitting surface was filled with resin-based composites using the incremental layering technique buildup, and consequently, optimal adaptation to the crown can be achieved [17]. Each layer (about 2 mm thickness) was light cured for 40 seconds according to manufacturer's instructions using light curing device at 450 nm. The dies had a length not less than 8 mm below the gingival line to be able to embed them in the acrylic resin, and were checked visually to determine whether voids and defects are present, as shown in Fig. 2.

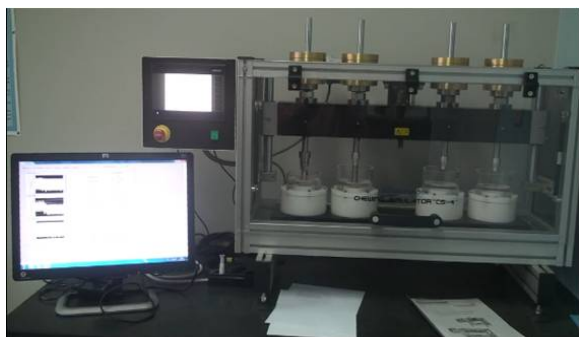
Fig. 3 Chewing simulator with the testing system's computer monitoring software

Specimens were subjected to cyclic fatigue and fracture testing using CS-4.2 SD Mechatronik chewing simulator (SD Mechatronik, Germany) as shown in Fig 3. The chewing simulator contains four test chambers, each chamber having an individual weight with a loading bar. A transverse bar that is mechanically driven by a stepping motor controls the horizontal and vertical movement links all bars. All chambers were filled with room temperature distilled water. To simulate the excursive movement of the human jaw, the sample's

buccal surface was mounted facing forward with the direction of the lateral. The simulator's movement is normally based on four biaxial movements: downward movement of the antagonist, lateral movement of the X-axis, upward movement and then movement of the X axis back to the starting point.

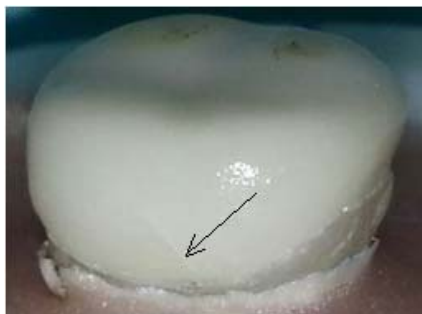
Fig. 6 Lingual surface of sample no. 1 of 0.5 mm group after mouth-motion fatigue testing indicating its crack pattern

Extensive crack was observed in one sample in the 0.5-mm

veneering layer thickness group. This crack was observed first at 250×10^3 cycles with one cracking behavior. This crack occurred on the crown's lingual surface starting at the surface's margin and extended occlusally indicating the presence of a radial crack, shown in Fig. 6 with arrow pointing to radial cracks.
